3.0 BACKGROUND

- Environmental Site Assessment & Screening Risk Assessment – ‘Audit Area 1’ Portion of Former Hills Industries Site, Corner of South Road & Ackland Street, Edwardstown, South Australia. Prepared by AEC Environmental (Report Reference: 3698/AA1/01). September 2015. Referred to herein as the AA1 ESA/SRA.

- Detailed Risk Assessment – ‘Audit Area 1’ Portion of Former Hills Industries Site, Corner of South Road & Ackland Street, Edwardstown, South Australia. Prepared by AEC Environmental (Report Reference: 3698/DRA/01). September 2015. Referred to herein as the AA1 DRA.

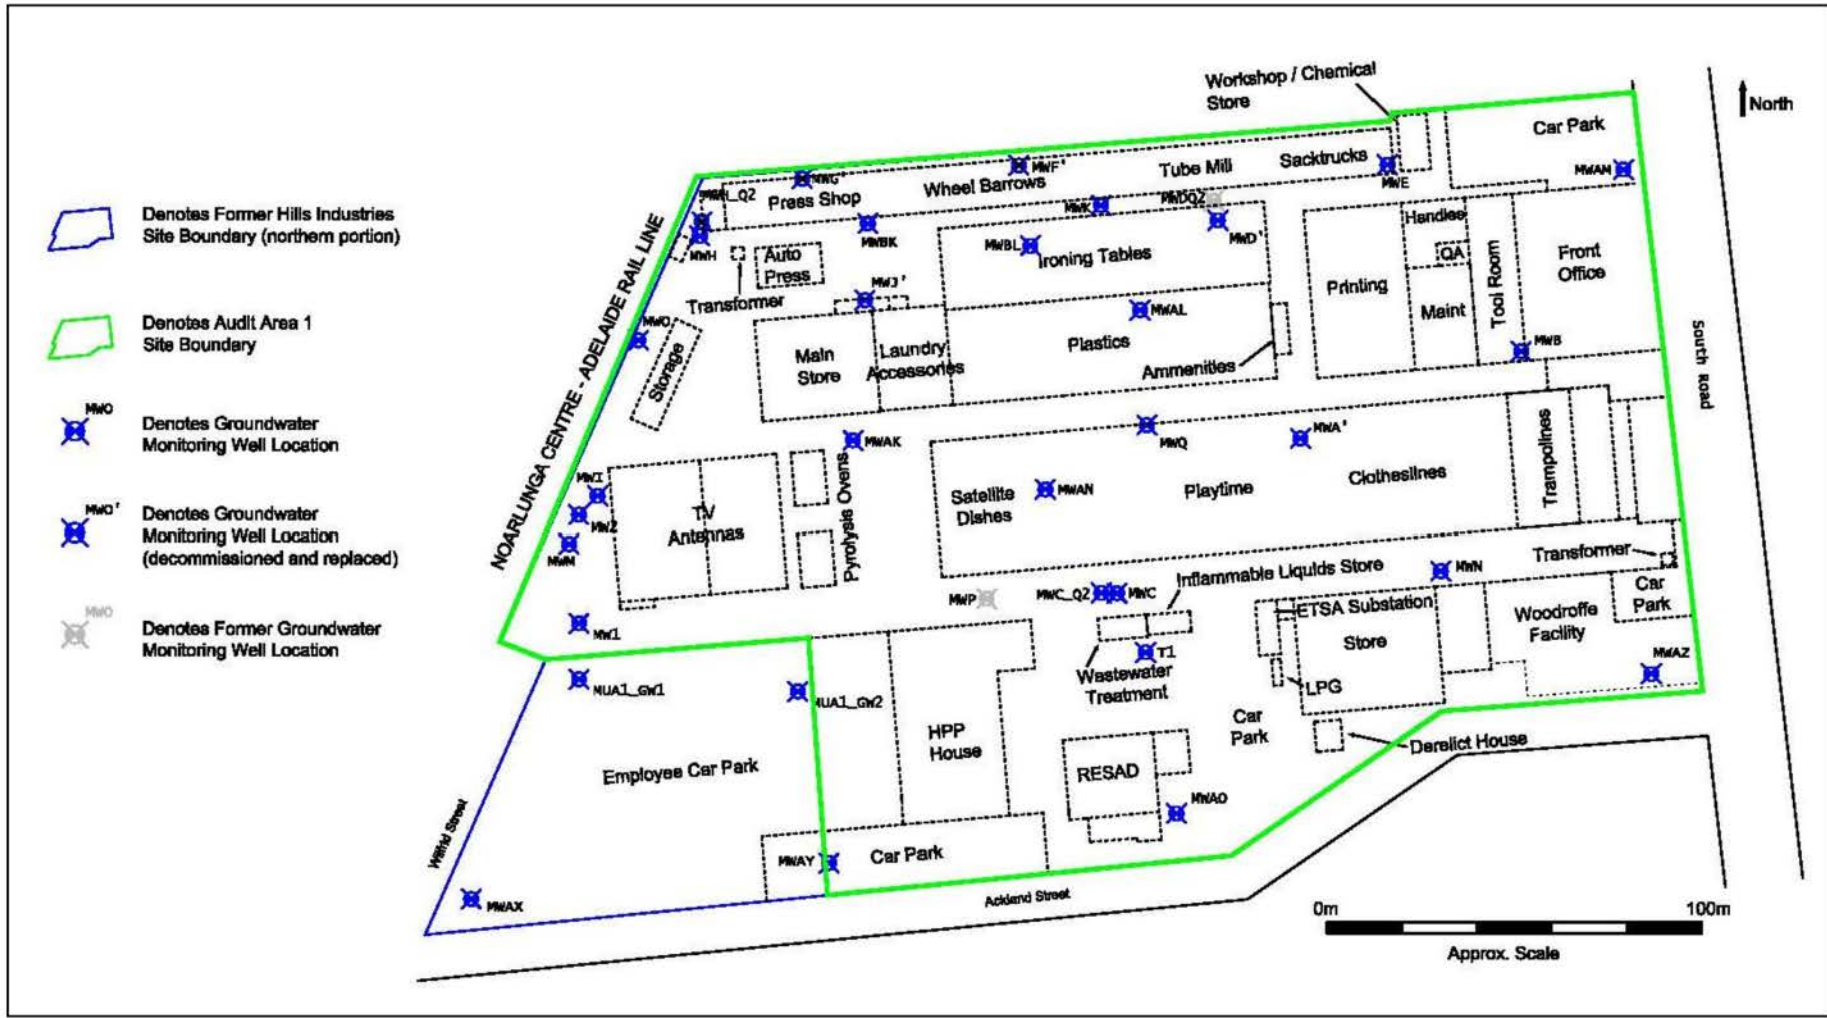
Figure 5 – Audit Area 1 Groundwater Monitoring Well Locations

Onsite groundwater investigations comprised the installation and sampling of 28 groundwater monitoring wells and the sampling of two existing groundwater monitoring wells. The locations of the wells are shown on Figure 5.

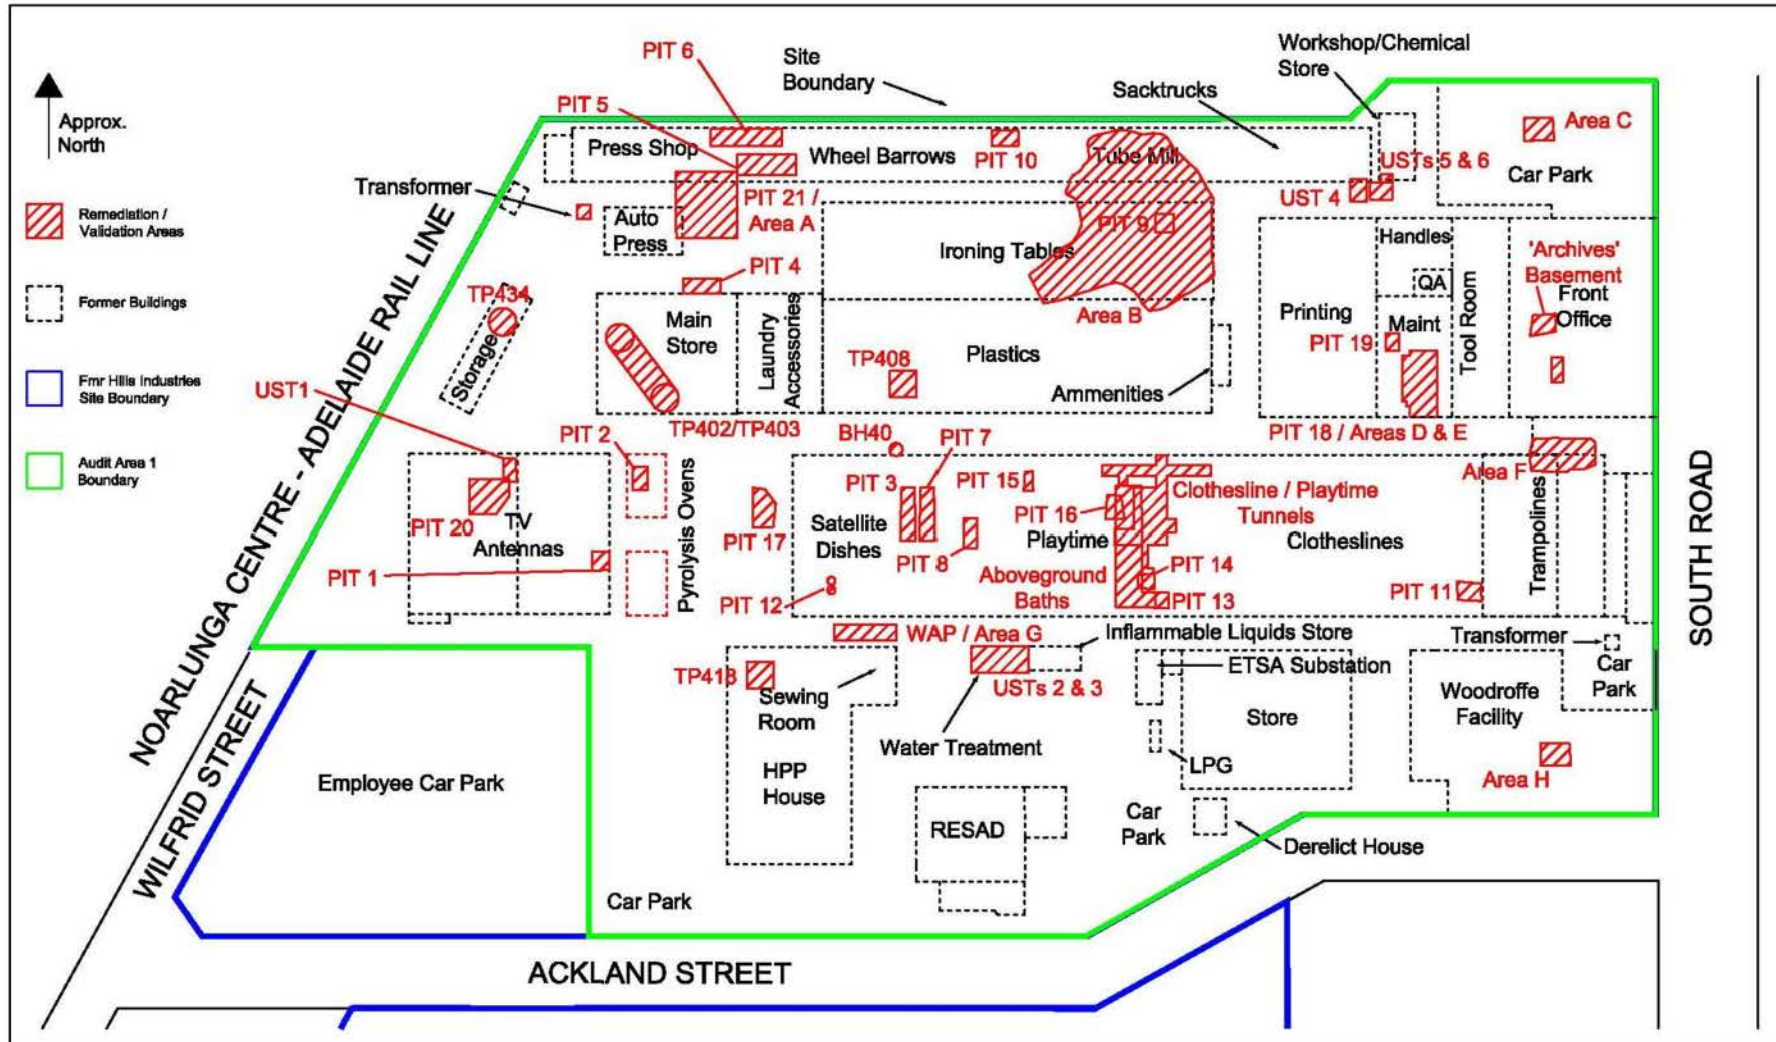
Figure 6 – Remediation and Validation Works locations

Completed remediation works are detailed in the AA1 ESA/SRA report and the locations of these works are presented in Figure 6.

Bulk solvent-impacted material excavation works were completed in this area (see Figure 6). The excavation was extended to approximately 5m below ground level and validated in accordance with an approved Remediation Management Plan (RMP).

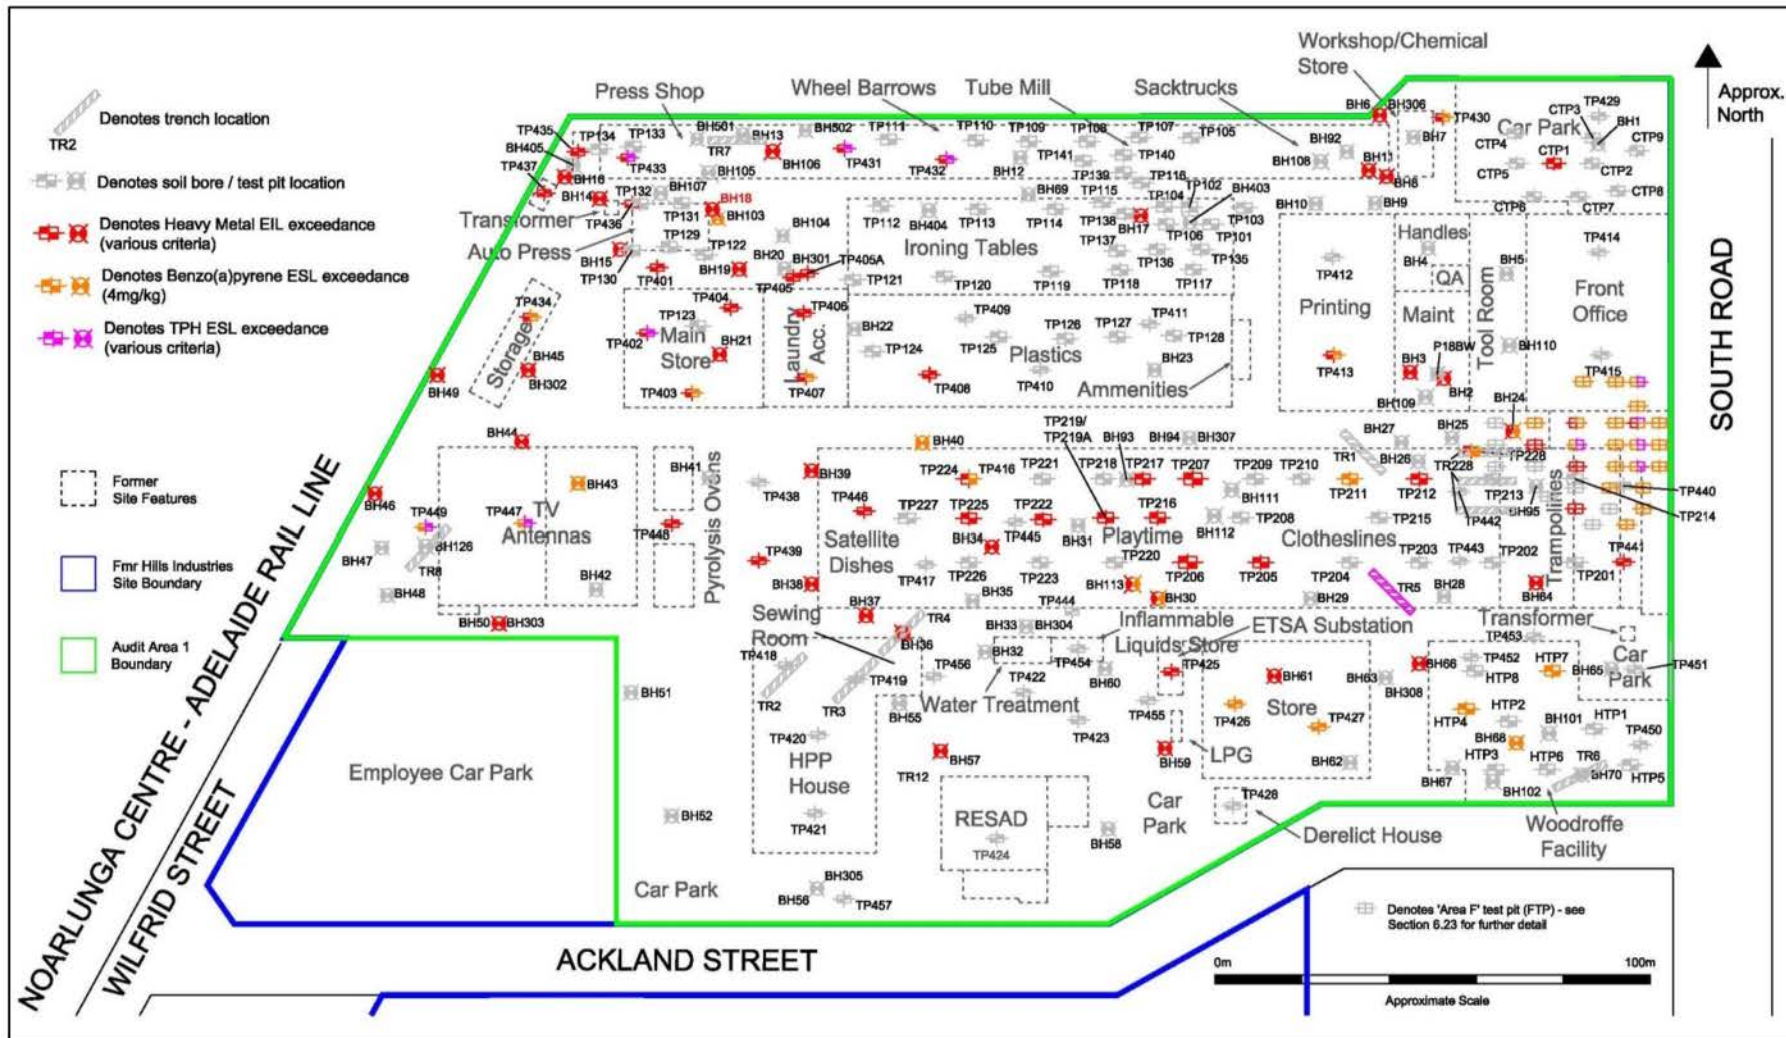
Figure 7 – Soil EIL/ESL Exceedences (former site layout overlay)

Various EIL exceedences are scattered across the site (see Section 5.3.1 of AA1 ESA/SRA) and as presented in Figure 7.

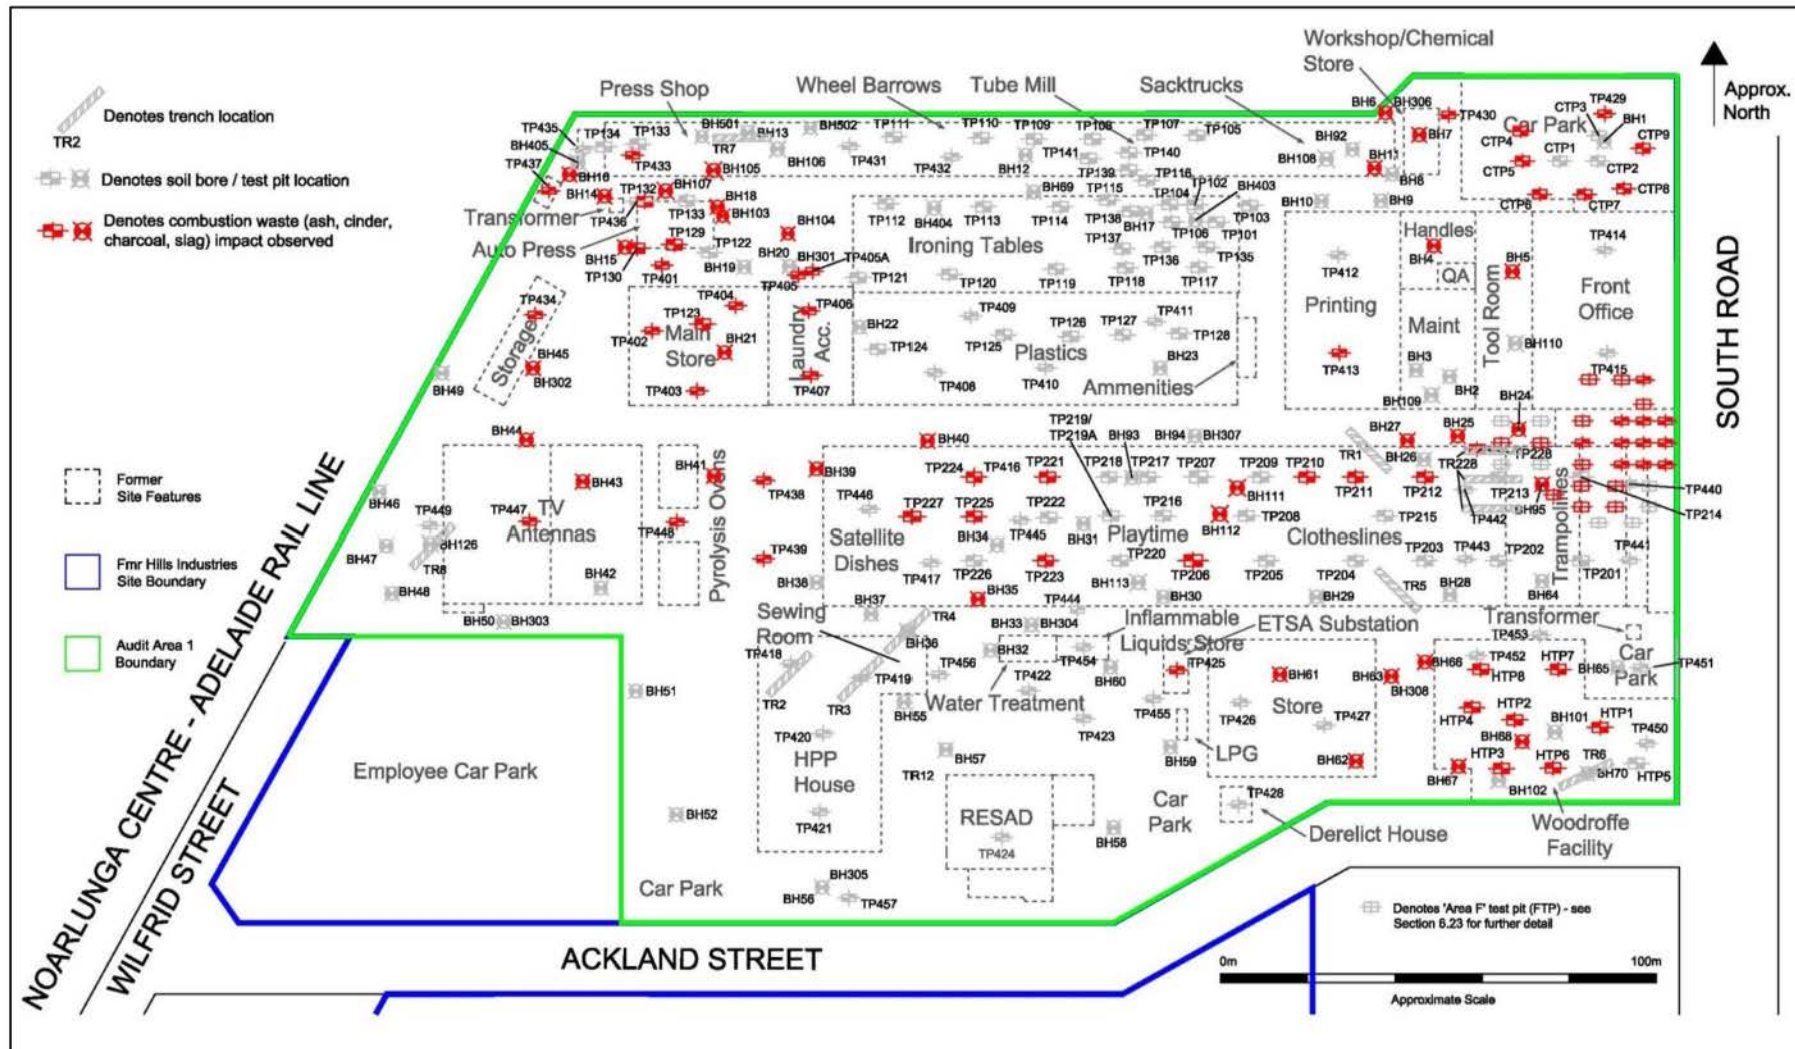
Figure 8 – Approximate Distribution of Combustion Waste Impacts (typically within fill material in upper 0.5m)

Combustion waste (typically ashy fill material) is scattered across the site. The approximate distribution of this material is presented in Figure 8. It is noted that this material has been adequately assessed and is considered suitable to remain on the site for the proposed development. Remaining impacts, including isolated pockets of ashy material on site for which HIL/HSL exceedences exist are summarised in Table 3 and presented in Figures 9 and 10.

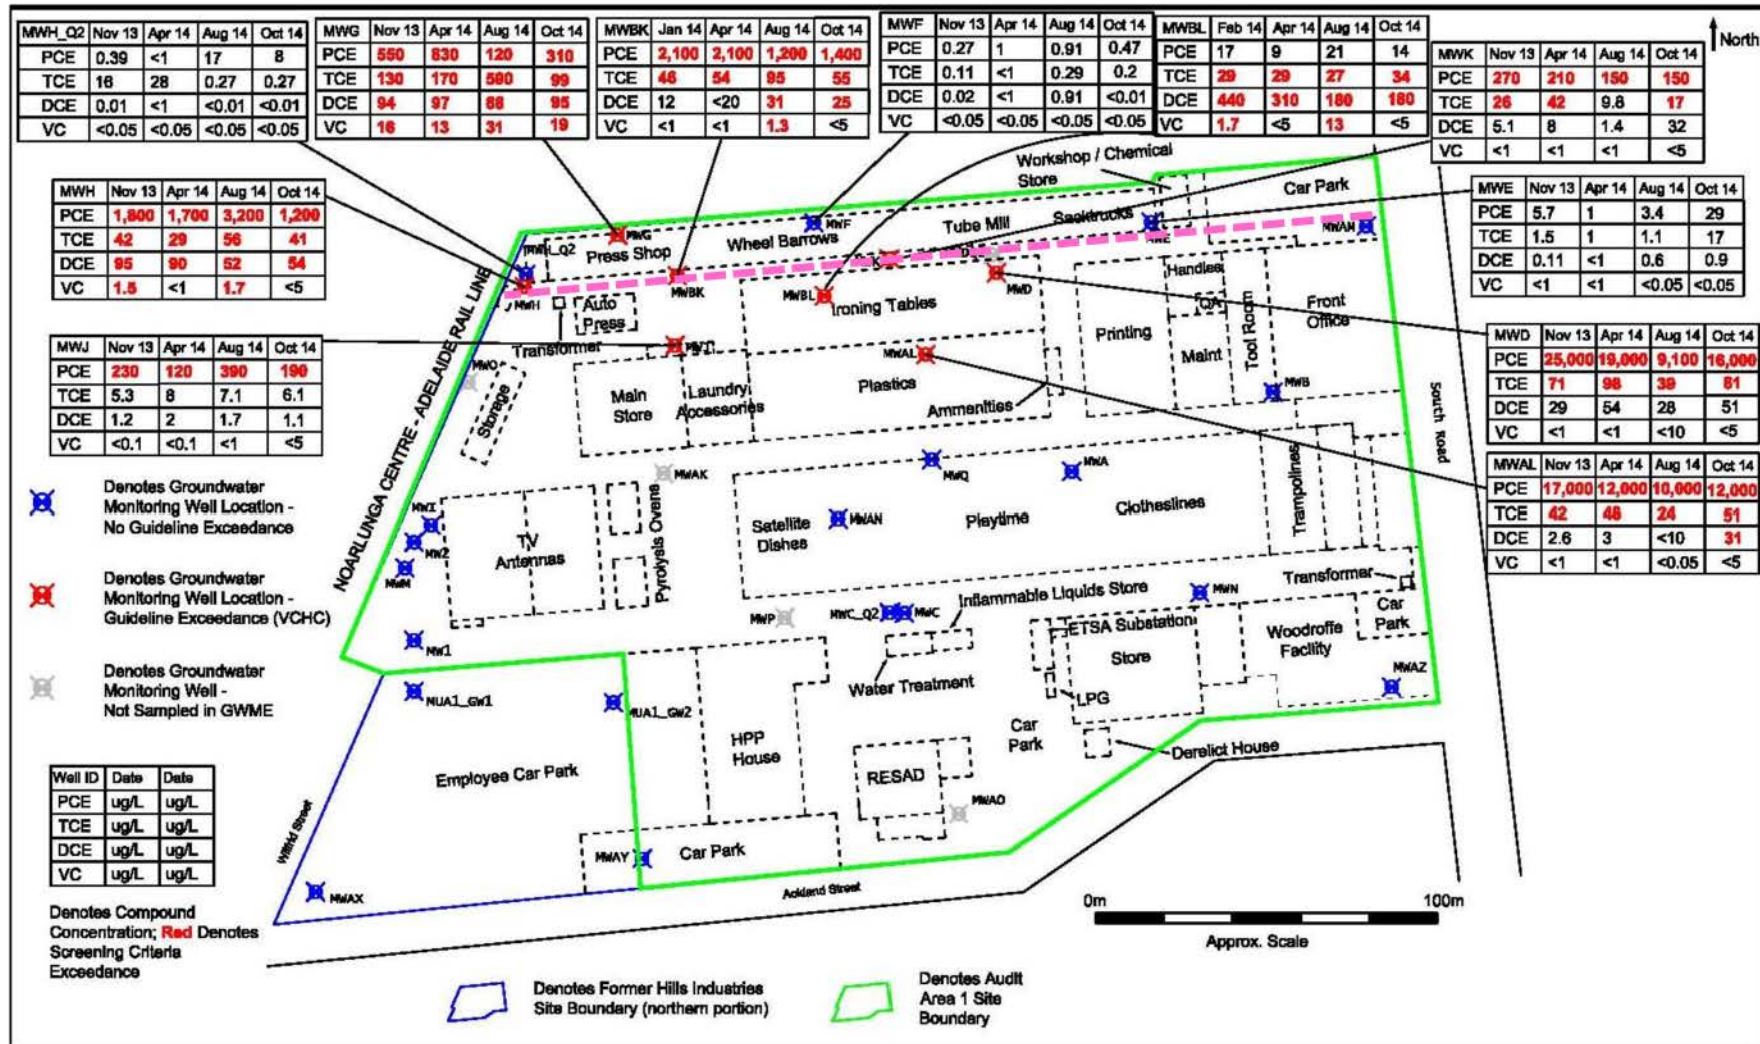
The location of the groundwater solvent impacts are presented in Figure 11, a hydrogeological cross-section of the solvent impacted area (along the northern boundary of the site) is presented in Figure 12.

Figure 11 – Chlorinated Hydrocarbon Exceedances in Groundwater 2013-2014 (dashed line represents location of cross-section presented in Figure 12)

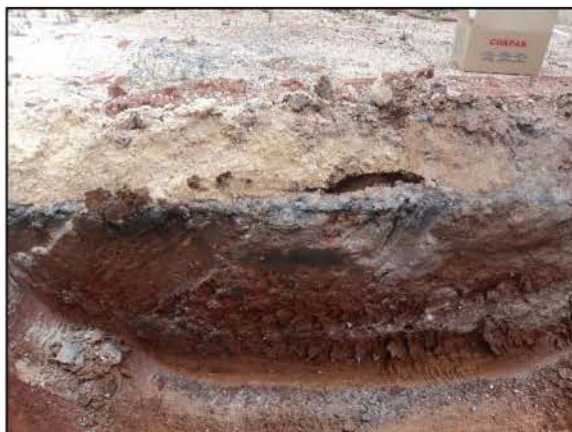
- Ashy fill material, see Figure 8 and Photograph 1.

Photograph 1 – Example of ashy fill material

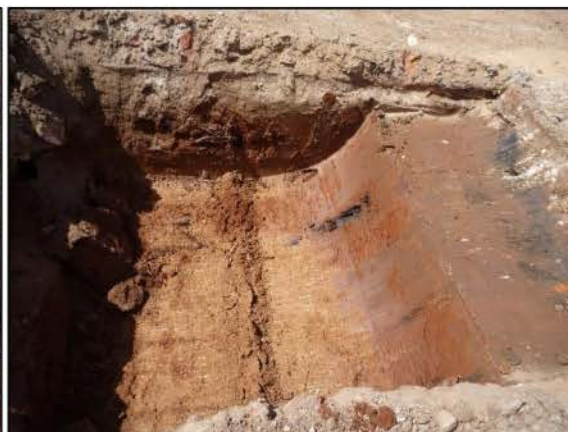
Photograph 2 – Example of ashy fill lens ('Area F')

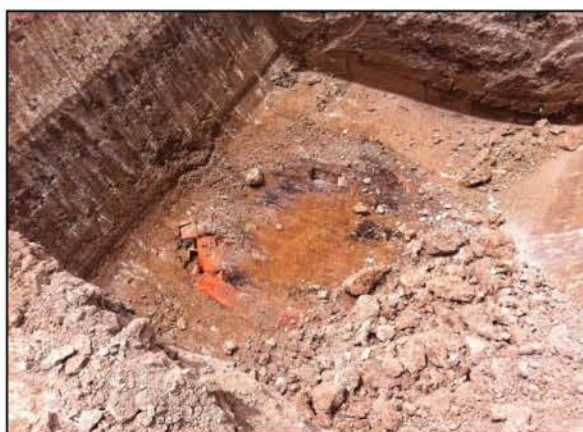
- A suspected former brick-lined well (Reference: P18BW) in the footprint of the former Maintenance Workshop, see Figures 9 and 10; and Photograph 2.

Photograph 2 – Pit 18 brick-lined well
