ENVIRONMENT PROTECTION AUTHORITY

Ash Storage Area dust event (1st & 2nd January 2017)

24th February 2017

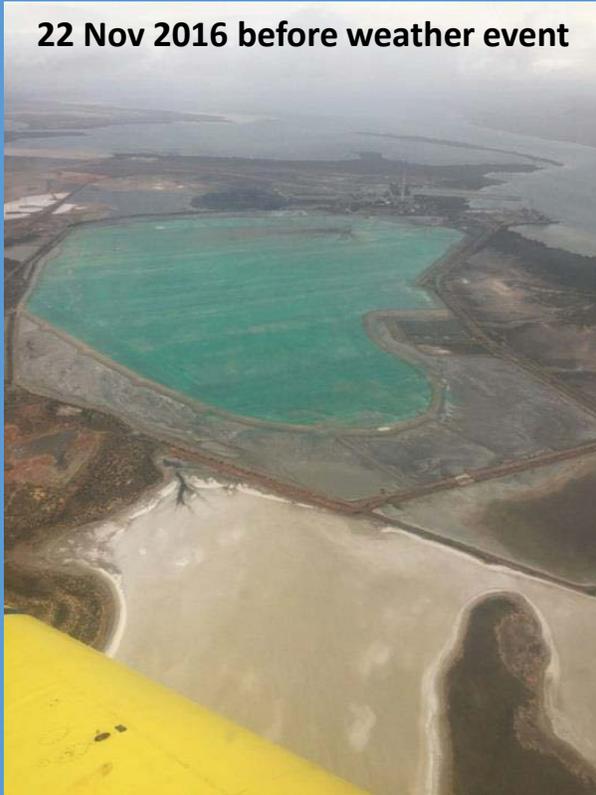
22 Nov 2016 before weather event

- Inspections by land and by air following the weather event were unclear as to what proportion of the dust suppressant seal had been impacted. This is due to limited access to the area by foot, and dust being deposited on top of the seal, obscuring an intact layer of sealant underneath.

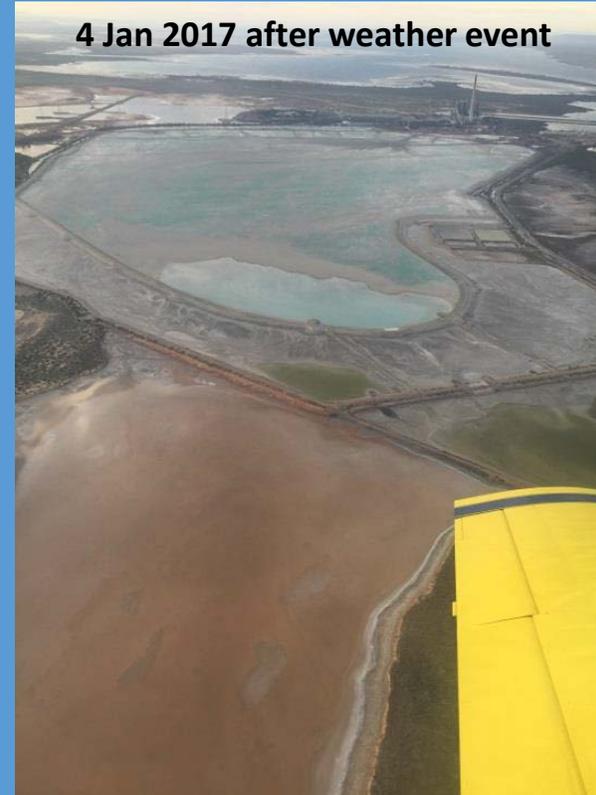
4 Jan 2017 after weather event

Primary Cause:- On advice from _____ the primary cause appears to be the coating has been breached by sub surface movement in some areas (due to the composition of the underlying ash surface and soil saturation). Once the Vital Bon-Matt coating was breached it was further damaged by water erosion of the sub surface underneath and high winds then lifting the coating from the surface.

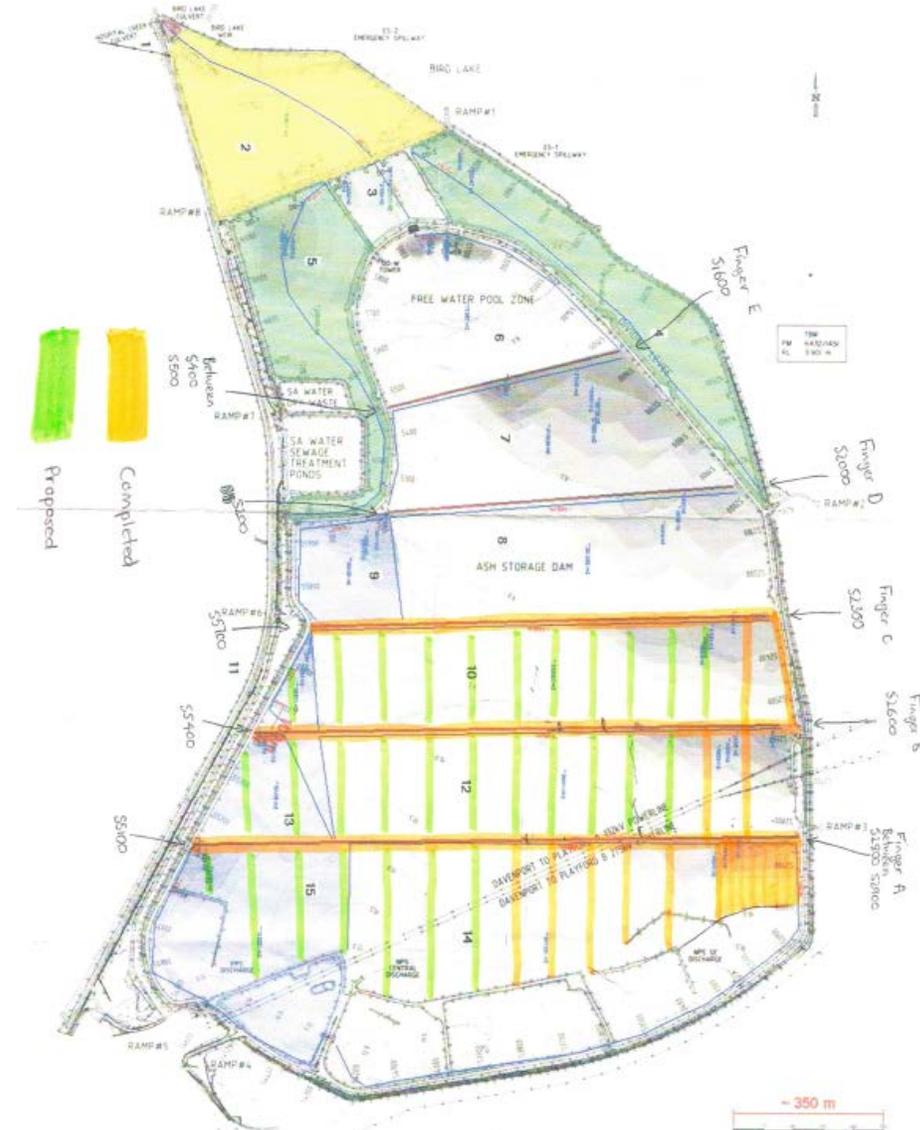
The most significant areas of damage, and subsequent areas of dust generation, were adjacent the eastern and western levee bank. Due to the dam surface contours, rainfall is shed from the central area to the outer edges.

The adjacent figure shows the East/West and North/South access fingers that have been constructed to date (orange highlight) and the proposed additional fingers (green highlight). It is likely that additional North-South fingers will be required between Fingers C and D and Fingers D and E, however the design philosophy will be progressively reviewed during construction.

A key control strategy to prevent water movement across the surface of the dam is to construct east-west access fingers, that will act as levee banks. On completion these fingers will remain and form macro catchment zones for the dam. During construction, additional north-south connecting levees will also be constructed to create smaller cells. These cells have two purposes: 1) to aid trafficability and enable soil to be emplaced and spread along their length, and 2) to act as sub-catchments. Should another significant rain event occur, the sub-catchments will assist to restrict and contain rainfall, and prevent surface and sub-surface erosion of the seal.

<p>10. Assess modifications to topsoil fingers design to provide protection of suppressant during earthworks phase (consideration of additional short fingers at the western and eastern edges of the dam – refer Slide 14).</p>	<p>FP Program Mgr & McMahon Services Site Manager</p>	<p>31/1/17</p>	<p>Revised strategy agreed and works underway – refer Slide 14.</p>
