CONSTRUCTION ENVIRONMENTAL MANAGEMENT PLAN

**'AUDIT AREA 1'
PORTION OF FORMER HILLS INDUSTRIES SITE
CORNER OF SOUTH ROAD & ACKLAND STREET
EDWARDSTOWN
SOUTH AUSTRALIA**

Date: September 2015
Reference No: 3698
Report Version: 3698/AA1/CEMP/01

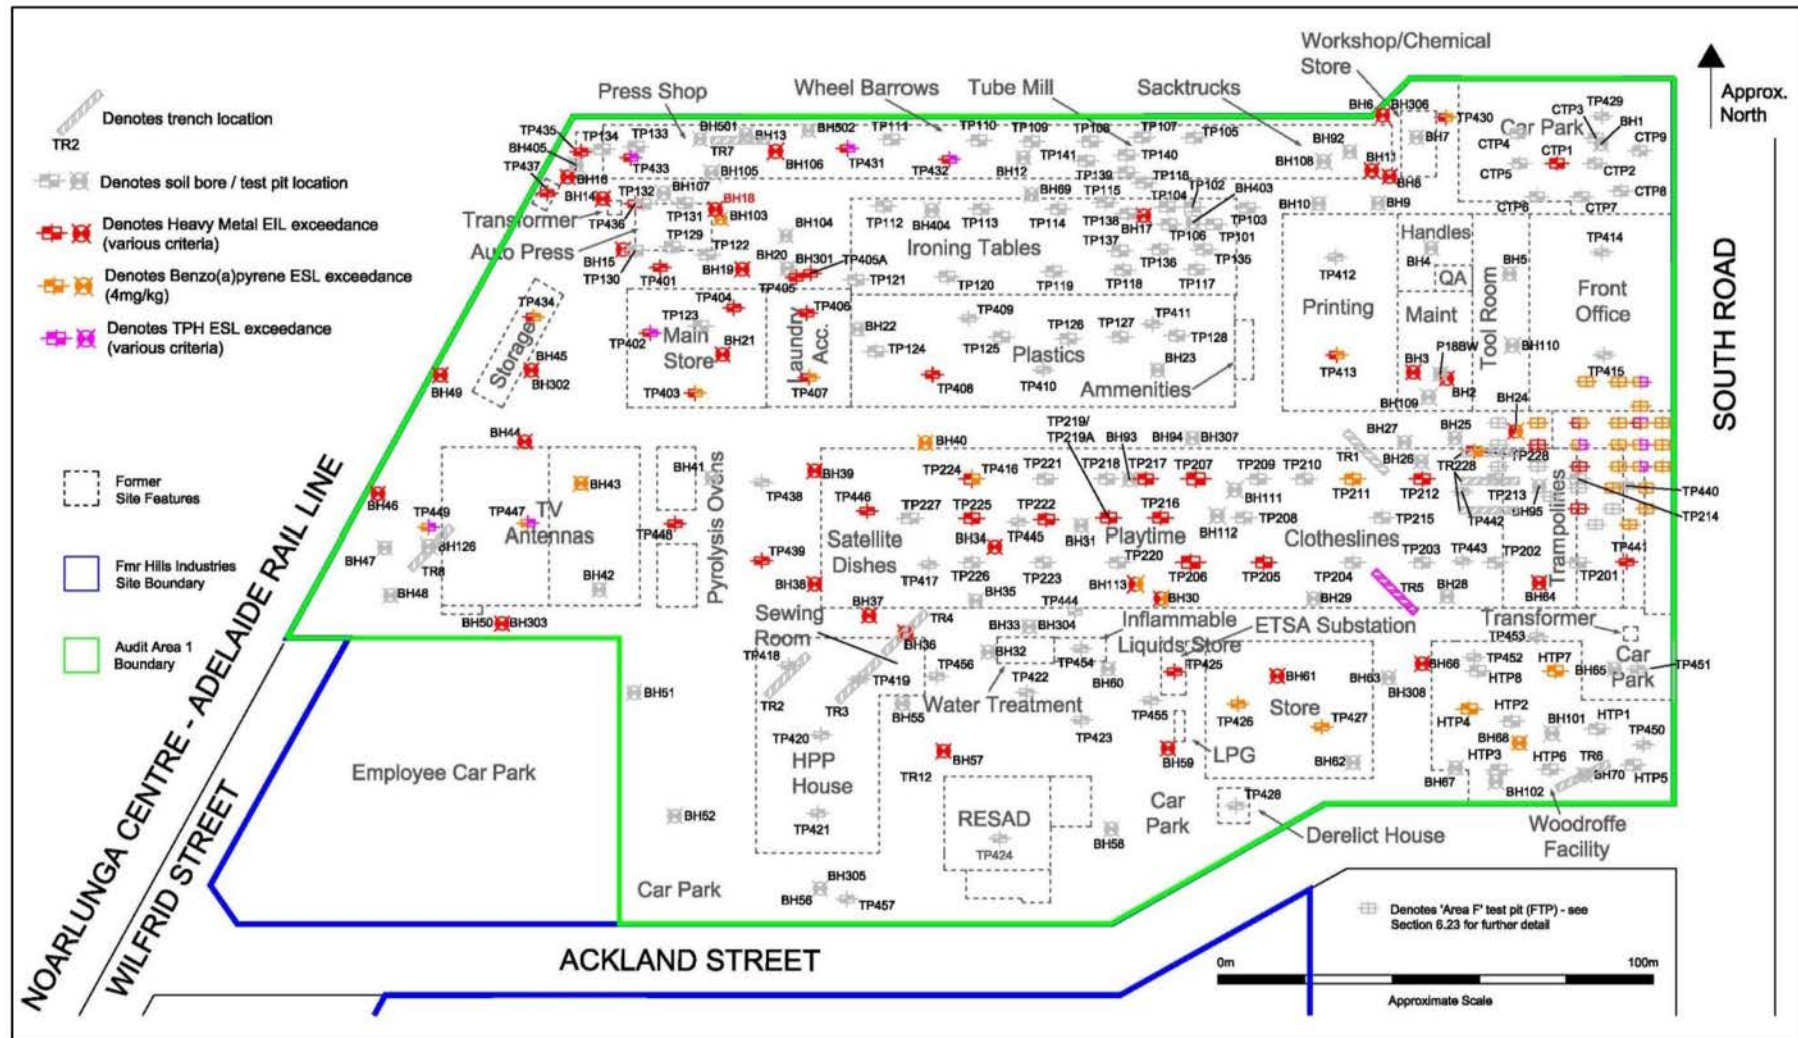
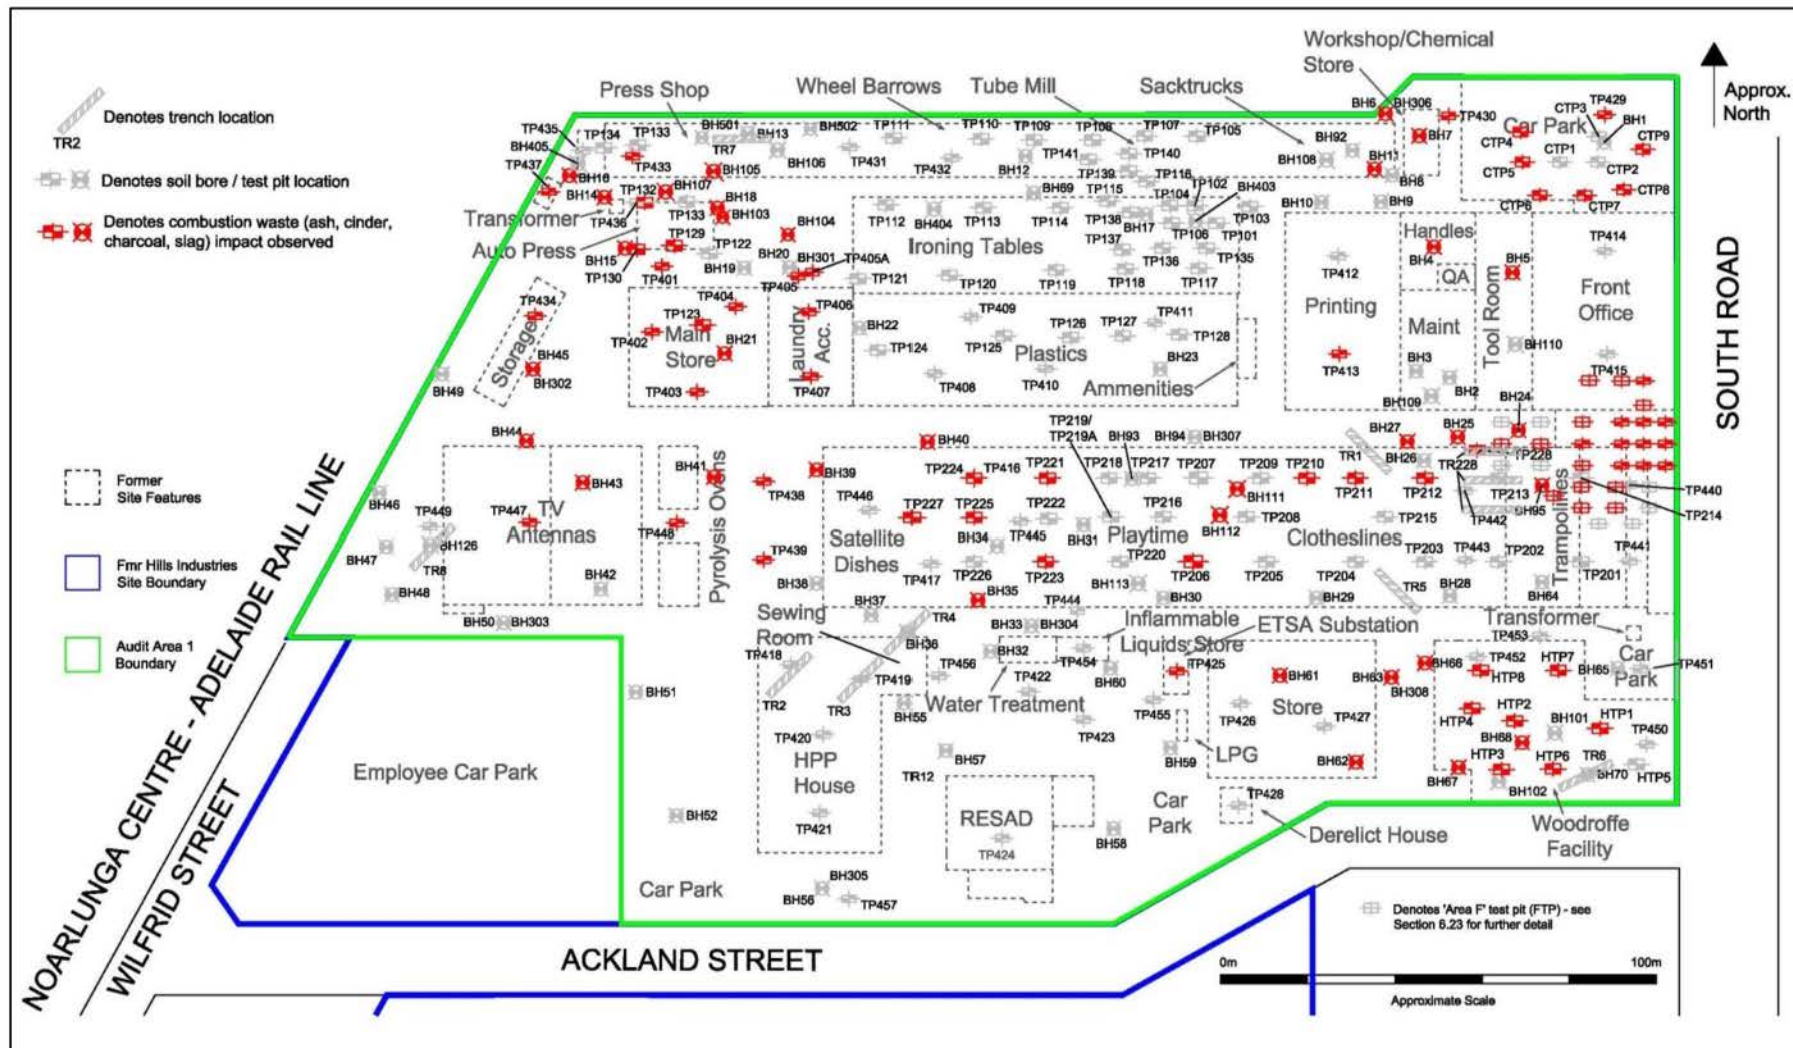
Figure 8 – Approximate Distribution of Combustion Waste Impacts (typically within fill material in upper 0.5m)

Combustion waste (typically ashy fill material) is scattered across the site. The approximate distribution of this material is presented in Figure 8. It is noted that this material has been adequately assessed and is considered suitable to remain on the site for the proposed development. Remaining impacts, including isolated pockets of ashy material on site for which HIL/HSL exceedences exist are summarised in Table 3 and presented in Figures 9 and 10.

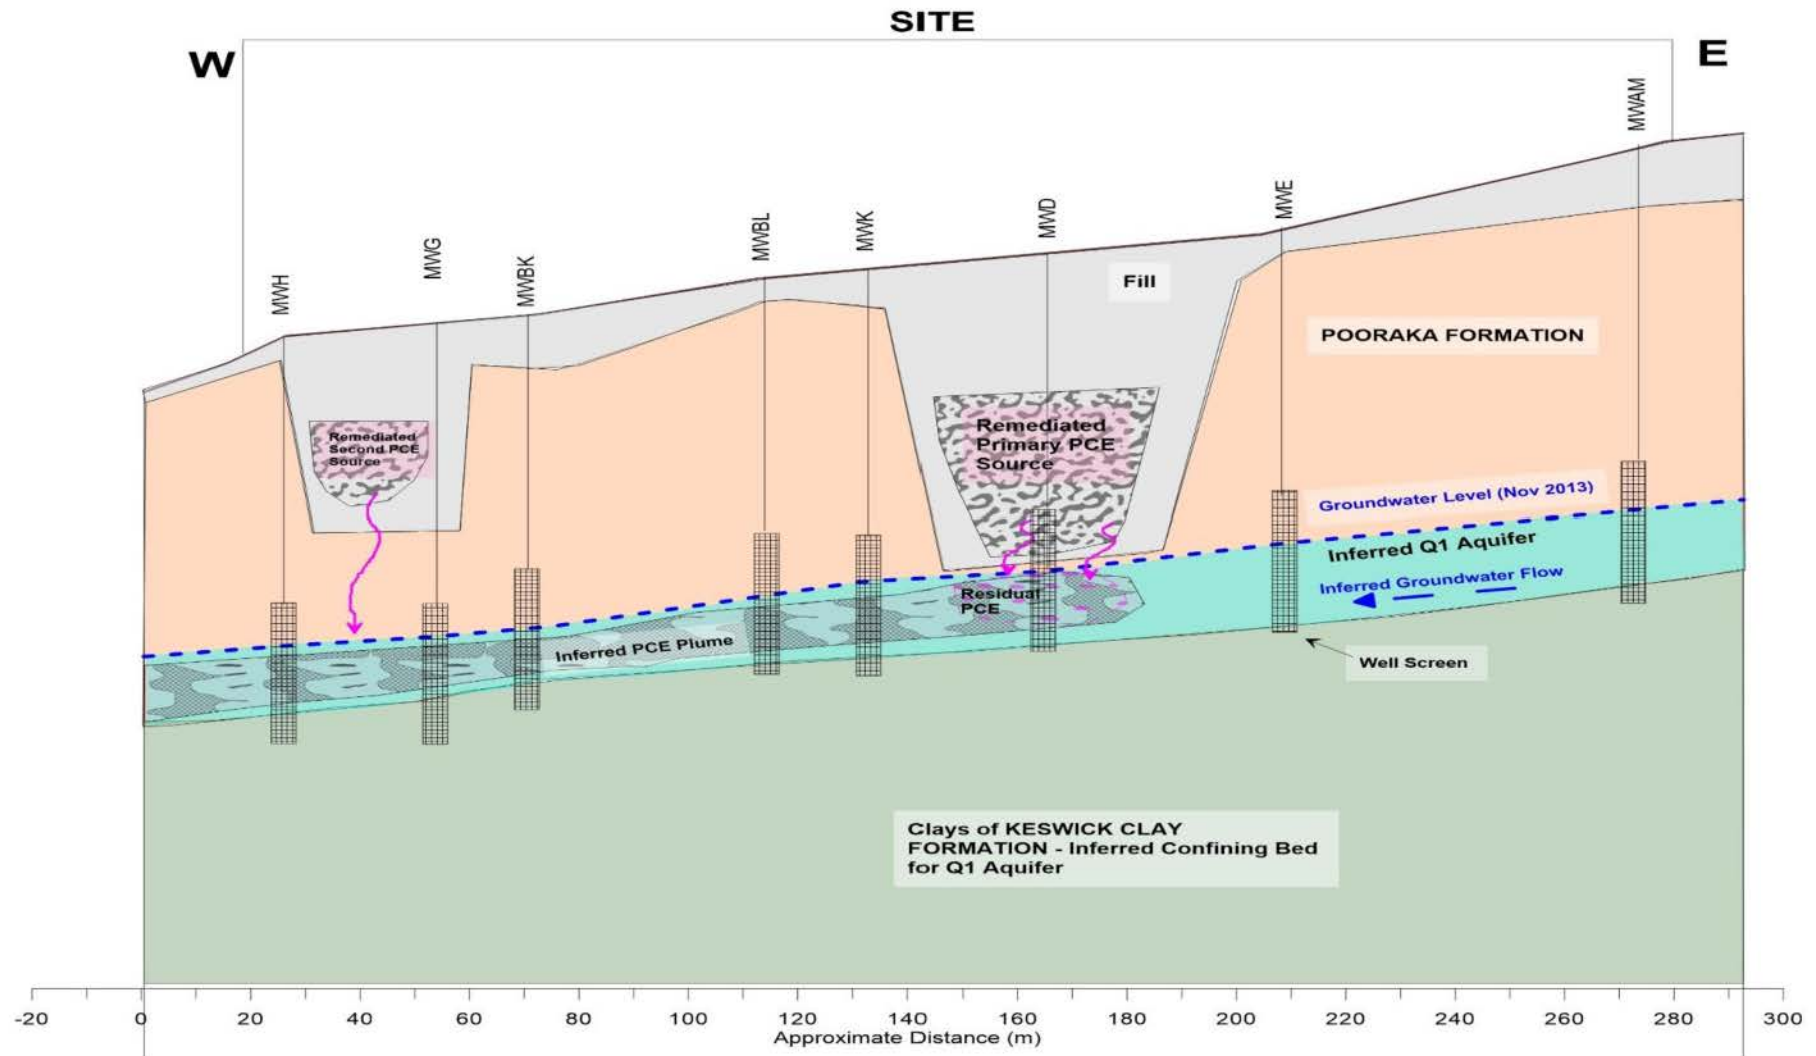
Figure 12 – East-West Conceptual Hydrogeological Cross Section

The location of the groundwater solvent impacts are presented in Figure 11, a hydrogeological cross-section of the solvent impacted area (along the northern boundary of the site) is presented in Figure 12.

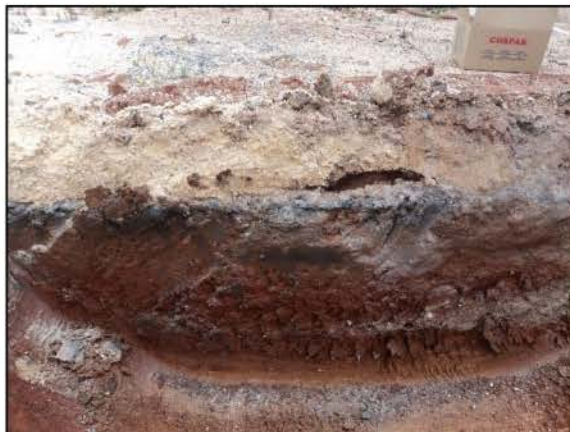
- Ashy fill material, see Figure 8 and Photograph 1.

Photograph 1 – Example of ashy fill material

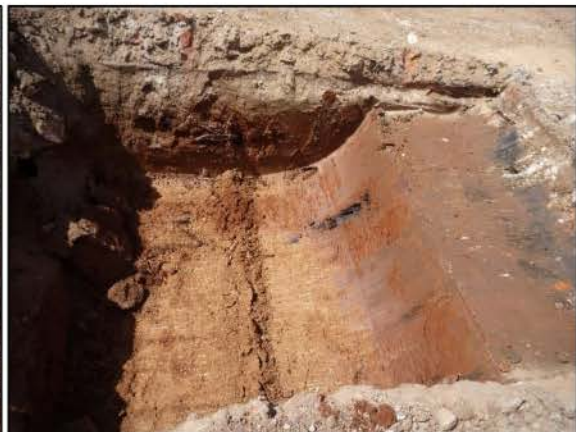
Photograph 2 – Example of ashy fill lens ('Area F')

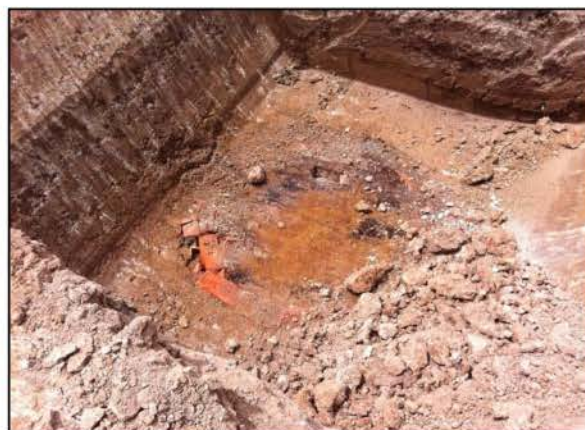
- A suspected former brick-lined well (Reference: P18BW) in the footprint of the former Maintenance Workshop, see Figures 9 and 10; and Photograph 2.

Photograph 2 – Pit 18 brick-lined well
