CURRENCY CREEK & FINNISS RIVER WATER QUALITY REPORT

Report 5, to 12 August 2009

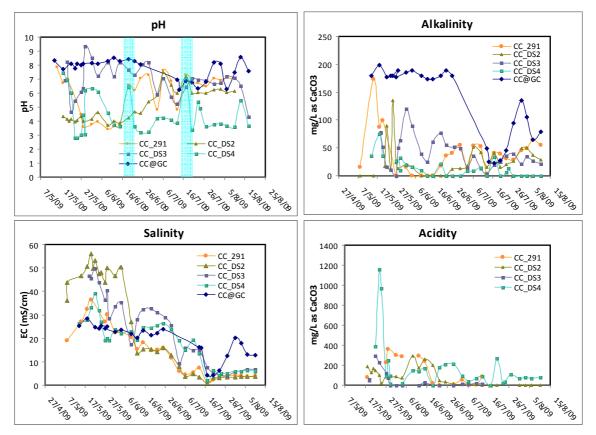
Figure 2 - Currency Creek Water Quality

- Site CC291 has generally shown an increasing trend in alkalinity since the most recent aerial limestone application. Alkalinity at this site currently (10th Aug) stands at 55 mg/L (as CaCO₃). This alkalinity level is still low and indicates the water body remains susceptible to further acidification.

- Sites CCDS2 and CCDS3 within Currency Creek show some signs of improvement following recent aerial limestone application. However, these sites have since recorded low alkalinities of 22 and 29 mg/L (10th Aug), respectively, and appear to be declining. These alkalinity levels indicate the water body is very susceptible to further acidification.

- Alkalinity continues to be absent at site CCDS4 despite the additional aerial limestone application in mid July. This is likely due to further input of acid from the sediment to the water following wind seiching and highlights the difficulty in managing acidity once it has been generated.

- CC@GC had shown improvement post limestone application but alkalinity has since fallen from a high of 135 mg/L (31st July) to 79 mg/L (10th Aug).

- CC291, CCDS2 and CCDS3 have no observed acidity as a consequence of aerial limestone dosing and increased dilution flow.
- CCDS4 acidity levels remain relatively stable. The last four times this site has been monitored the acidity has ranged within 64 and 81 mg/L (as CaCO₃). Currently acidity level stands at 81 mg/L (10th Aug).

- The pH (3.6 on 10th Aug) at CCDS4 remains well below the ANZECC guideline levels for protection of aquatic organisms (pH 6.5 to 9.0). Figure 2 shows that the pH at the site appears to have levelled out between 3 and 4 after previously showing some initial signs of improvement post aerial limestone application (e.g. pH of 7 on 17th July).
- pH has also decreased well below the guidelines recently at CCDS3 and the pH of 6.1 at CCDS2 is also just below the ANZECC guidelines.
- pH at CC@GC (pH of 7.5) and CC291 (pH of 7.0) remains above the ANZECC guidelines.

- Salinity levels at all sites within the Currency Creek region (excluding CC@GC) have stabilised and range between 3.67 and 6.7 mS/cm (3670-6700 EC).
- Salinity levels at CC@GC are influenced by both catchment inflows and mixing with Goolwa Channel water (higher salinity influence). The salinity level at this site has been variable in recent weeks and currently stands at 12.9 mS/cm (10th Aug).

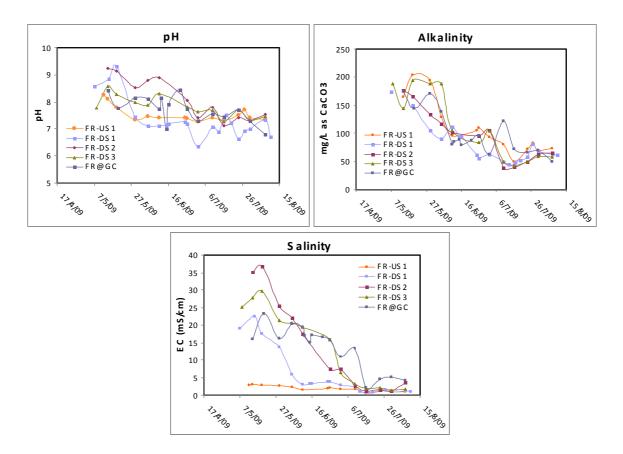
Figure 4 - Finniss River Water Quality

- Alkalinity at the Finniss River sites FRUS1, FRDS2 and FRDS3 remains relatively stable between 58 and 73 mg/L (7th Aug).
- Alkalinity at the Goolwa channel site (FR@GC) has declined and currently stands at 49 mg/L (7th Aug). Site FRDS1 has also declined with current alkalinity standing at 61 mg/L (10th Aug).

• pH levels at all Finniss River sites remain within the ANZECC guidelines for aquatic ecosystems. However, sites FR@GC and FRDS1 have exhibited recent declines in pH.

• Salinity levels at all Finniss River sites have stabilised between 0.9 and 4.16 mS/cm (900-4160 EC).

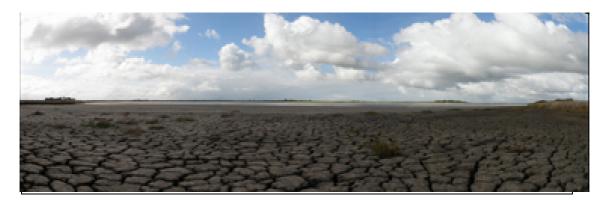
On the 4th of August, surface, pore and crack water quality were analysed along two transects in a wetland on the western bank of the lower Finniss River (see Figures 1 and 1A for location). This wetland had a large area of exposed and cracked acid sulfate soils (see Photos 1 and 2). The monitoring results (Table 2) show low pH and high acidities in surface, crack and pore waters, highlighting the risk posed by acid sulfate soils in the lower Finniss River region.

Photo 1 - Finniss River wetland exposed sediments

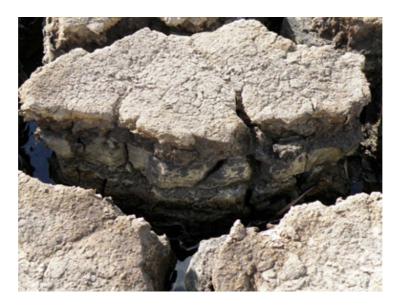
Photo 2 - Pale yellow mottles (acid sulfate soil minerals - jarosite/natrojarosite) with acidic water in cracks
