Adelaide Brighton Cement - Acoustic Consultancy Ground Vibration Monitoring Survey

Report Date: Tuesday, 12 July 16
Reference: A15623RP3, Revision C

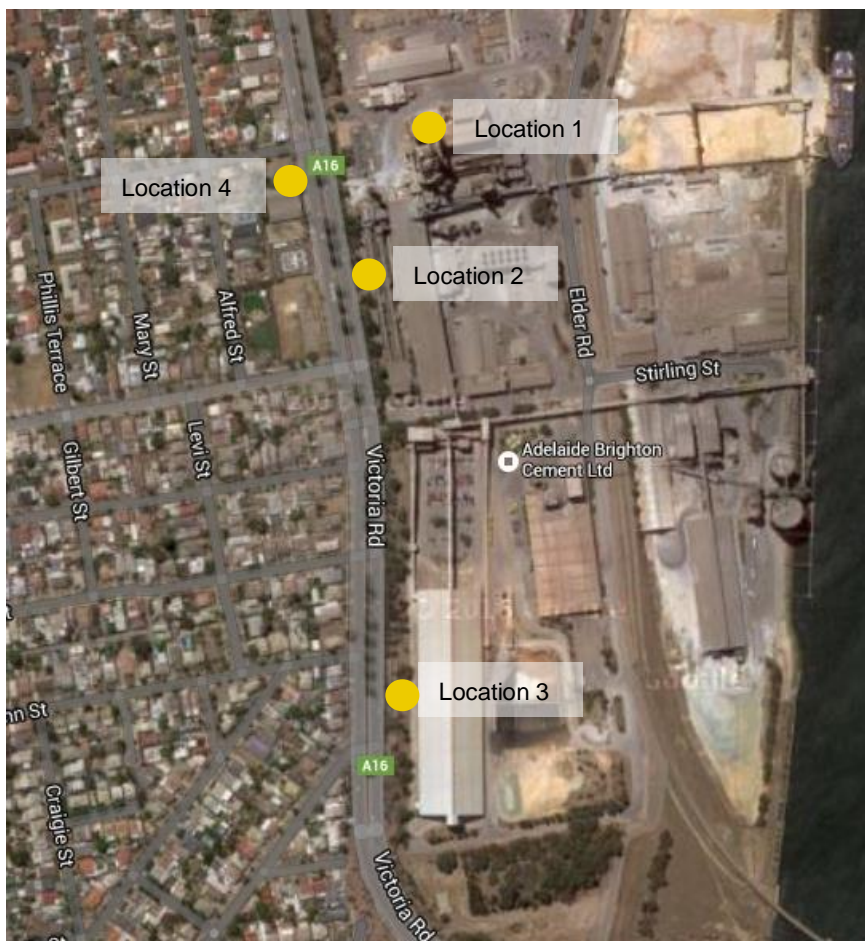
Figure 1: ABC Birkenhead and Measurement Points

- Location 1 – Tower 4A Base
- Location 2 – ABC Boundary 1 – Community park
- Location 3 – ABC Boundary 2 – Reclaimer shed
- Location 4 – ABC Social Club.

Figure 1 shows the physical locations of the measurement points.

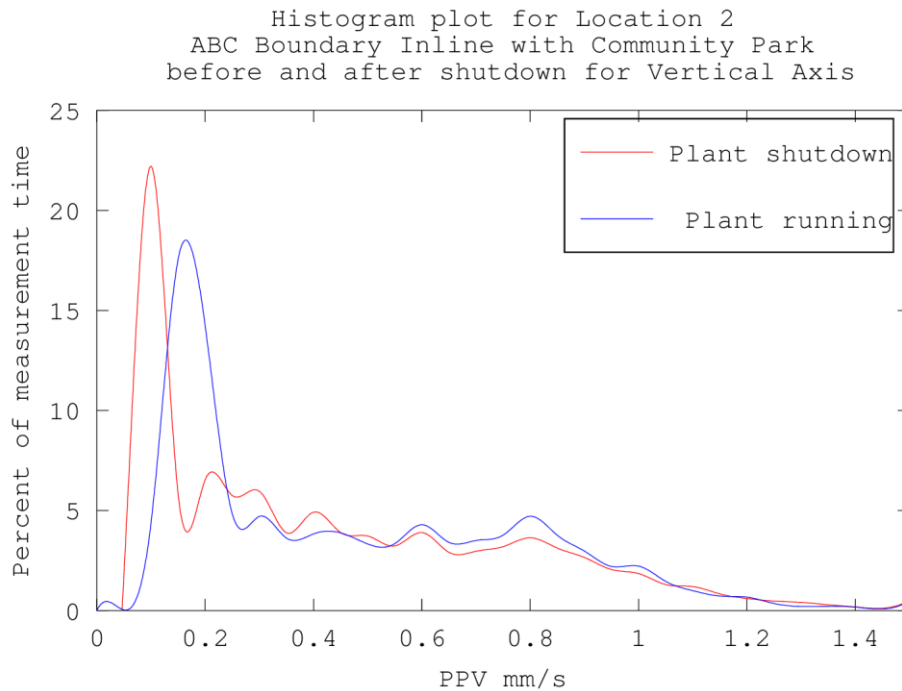
Figure 2: Location 2 vibration level histogram during and after plant shutdown

Where there were data for both the plant operating and whilst shut down, a histogram of the measured data during each period has been generated. Figures 2, 3 and 4 show histograms of the measured peak particle velocity (PPV) in the vertical axis for three measurement locations before and after the shutdown period. We have shown the vertical axis as we consider that this is the most significant in this case.

The histogram plots show that there is a general increase in the background peak particle velocity vibration level when the plant is turned on compared to whilst it was shut down. The measurements taken at the ABC Social club (shown in Figure 3) were also taken back-to-back, where the sensor was not moved or measurements stopped between the plant being shut-down and fully operational.

The majority/mode of the measured peak particle velocities measured at the boundary and the social club were in the order of 0.15 mm/s and 0.2 mm/s respectively, which are considered to be very low in regards to ground-borne vibrations. We note however that for a large proportion of the time, these vibration levels were measured during quiet night time periods. Typically, on weekdays during the day-time, vibration levels were higher than these background levels, which are likely due to increased traffic movements along Victoria Road, or other activities. These increased levels are both present when the plant was offline as well as online, indicating that it is likely not due to ABC operations. See Figure 5, which outlines this occurrence on a typical weekday during and after the shutdown. The results show that whether the plant is shut down or running, vibration levels during the day are typically much higher than the baseline levels and independent of plant activity. This indicates that the measured background vibration levels, which are likely caused by the ABC plant, are much lower than other transient vibration events such as vehicle traffic on Victoria Road, train movement and other activities. This means that activities independent of the ABC plant have the potential to be of greater impact on nearby residences than the plant itself.

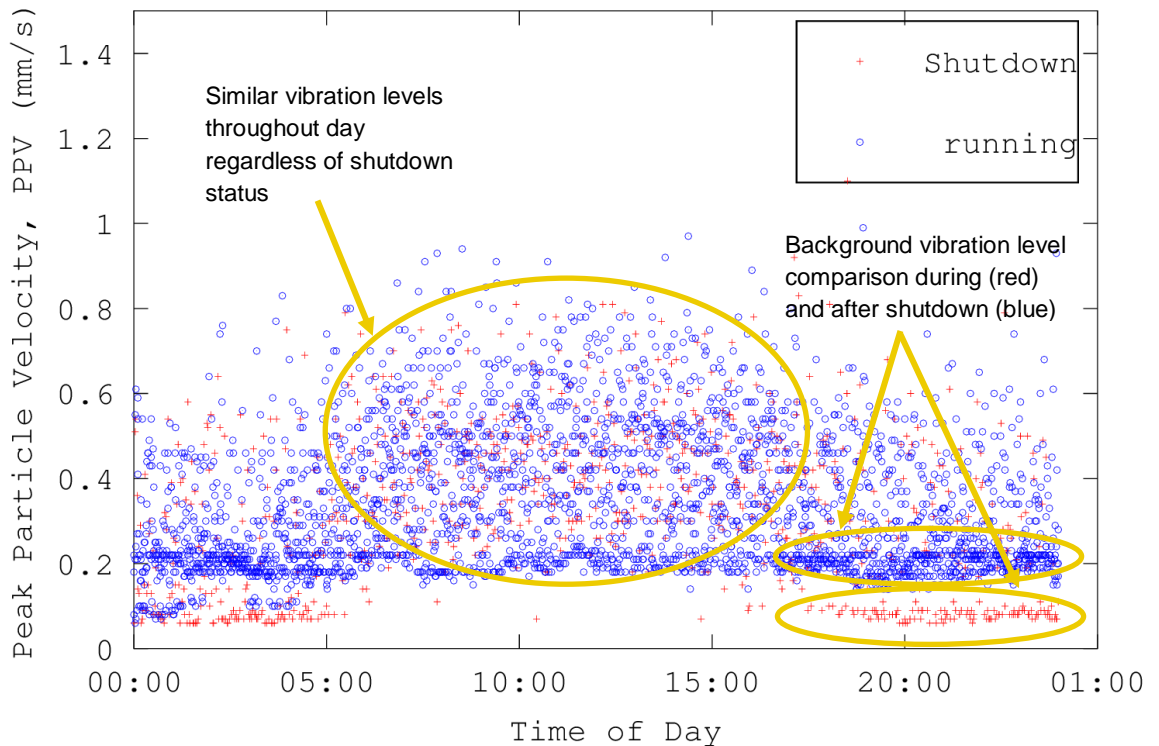
Figure 5: Vibration levels throughout typical week day at Location 4 during and after shutdown

plot for Friday at Location 4 - ABC Social Club
 before and after shutdown for Vertical Axis

We would expect that vibrations from the ground into residential foundations/properties would generally experience some coupling loss, therefore the measured vibration on the ground directly is likely to be lower than when measured within a residential building. Currently, the vibration levels measured are on the threshold of the human comfort criterion given by AS2670.2. However, our conversion of the RMS criterion to a PPV criterion level is conservative. Furthermore, we have also adopted the most stringent frequency specific criterion, given that spectral measurements have not been undertaken at this stage. Therefore from our conservative assessment approach, combined with the expected coupling losses between the ground and building foundations (and also between furniture and building floors), we expect the vibration levels from the ABC plant to be below the AS2670.2 guidelines.

Further detailed investigation is therefore warranted within a selection of nearby residential properties to confirm the measured vibration levels and foundation coupling loss.

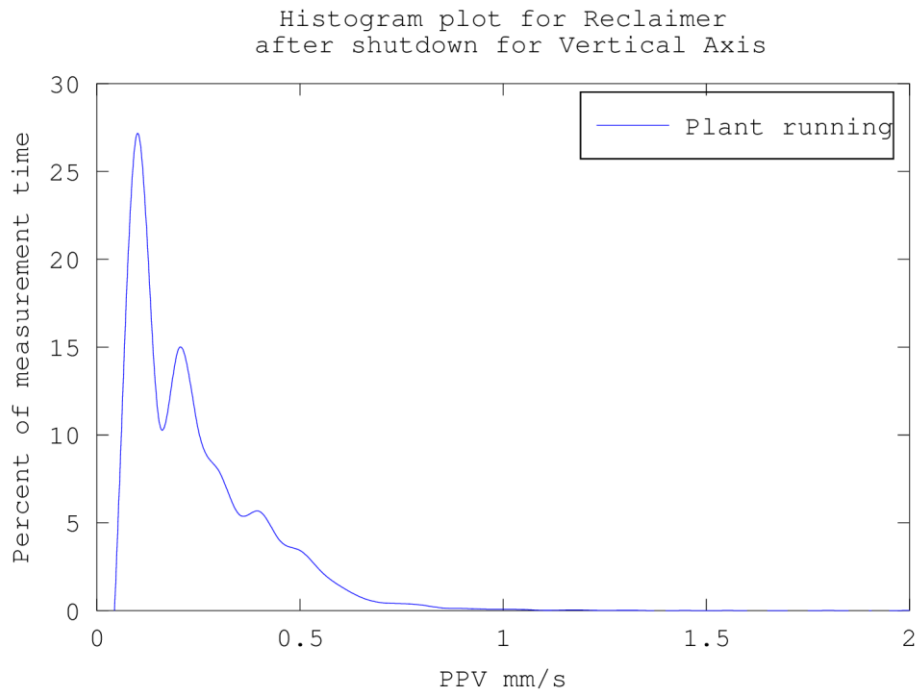
Figure 6: Reclaimer (Location 6) boundary vibration level histogram during and after plant shutdown

Figure 6, below shows the peak particle velocity histogram for the measurements taken at the reclaimer. We note that measurements couldn't be taken at the reclaimer during the shutdown period and therefore no direct comparison can be made to determine if the measured vibrations are operational or not. However, the majority of the measured vibration levels are at the noise floor of the measurement instrument (0.1 mm/s) and therefore show that there is minimal vibration levels present from the plant at this location.
