YEARLY AMBIENT AIR MONITORING PROGRAMME FOR BIRKENHEAD WORKS

COMPLIANCE DATE: 31/10/16 – Yearly Report, 2016

EPA Licence 1126

Licensed site: Adelaide Brighton Cement, Birkenhead Works

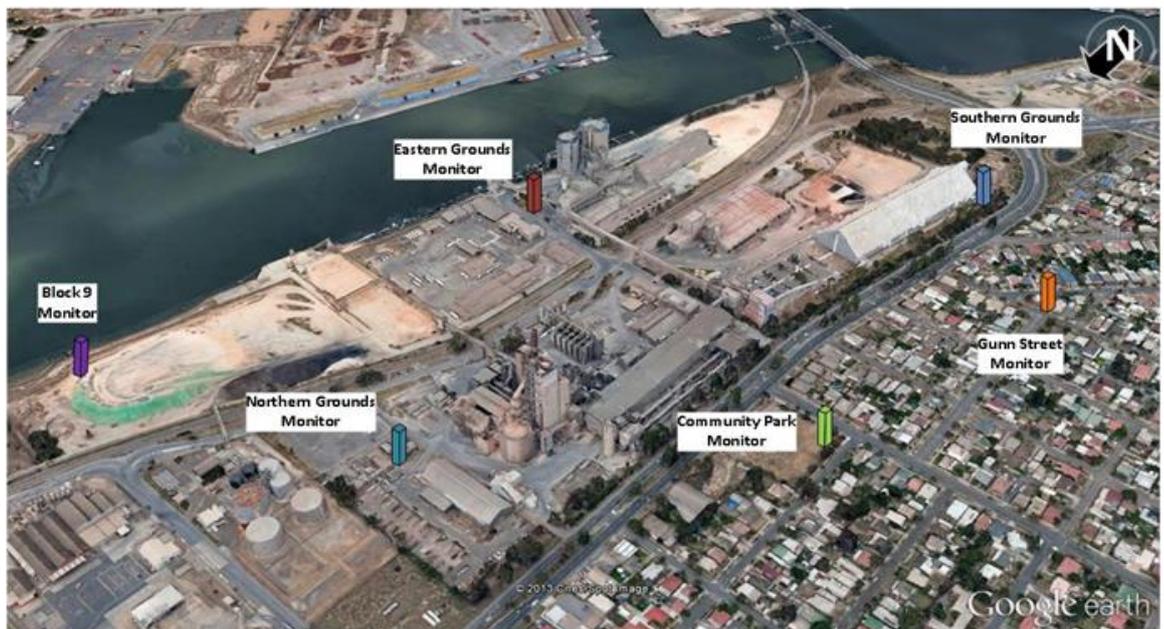
- *Map showing sampling locations, major infrastructure, sensitive environmental receptors, and north arrow*

Sampling locations are indicated by colour coded dots on the above map.

NB: Four sampling points are located on the Birkenhead Works site; the other sampling points are in the community (corner of Gunn/ Well streets and Community Park).

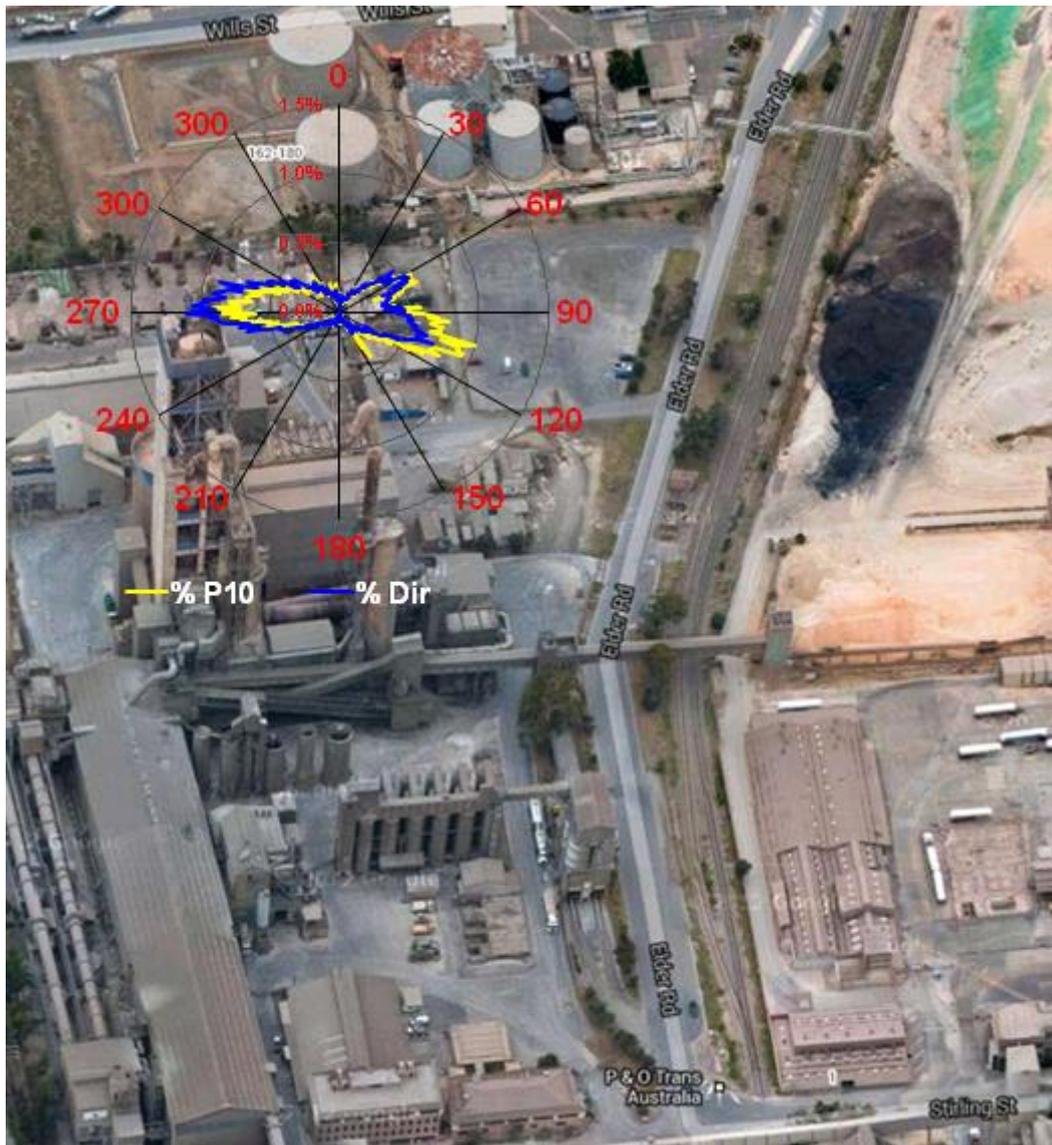
Northern Grounds Monitor

Westerly winds were the most dominant throughout October 2015 – October 2016. The higher proportion of PM10 to wind direction from the southeast suggest that there may be a contribution to PM10 loads from that direction. Possible sources could include stockpiles, truck and traffic movements. The Accolade was at dry dock during part of the second quarter resulting in increased traffic movement of limestone from stockpiles. This process was managed by the constant application of water and a dust suppressant agent using a dedicated water cart.

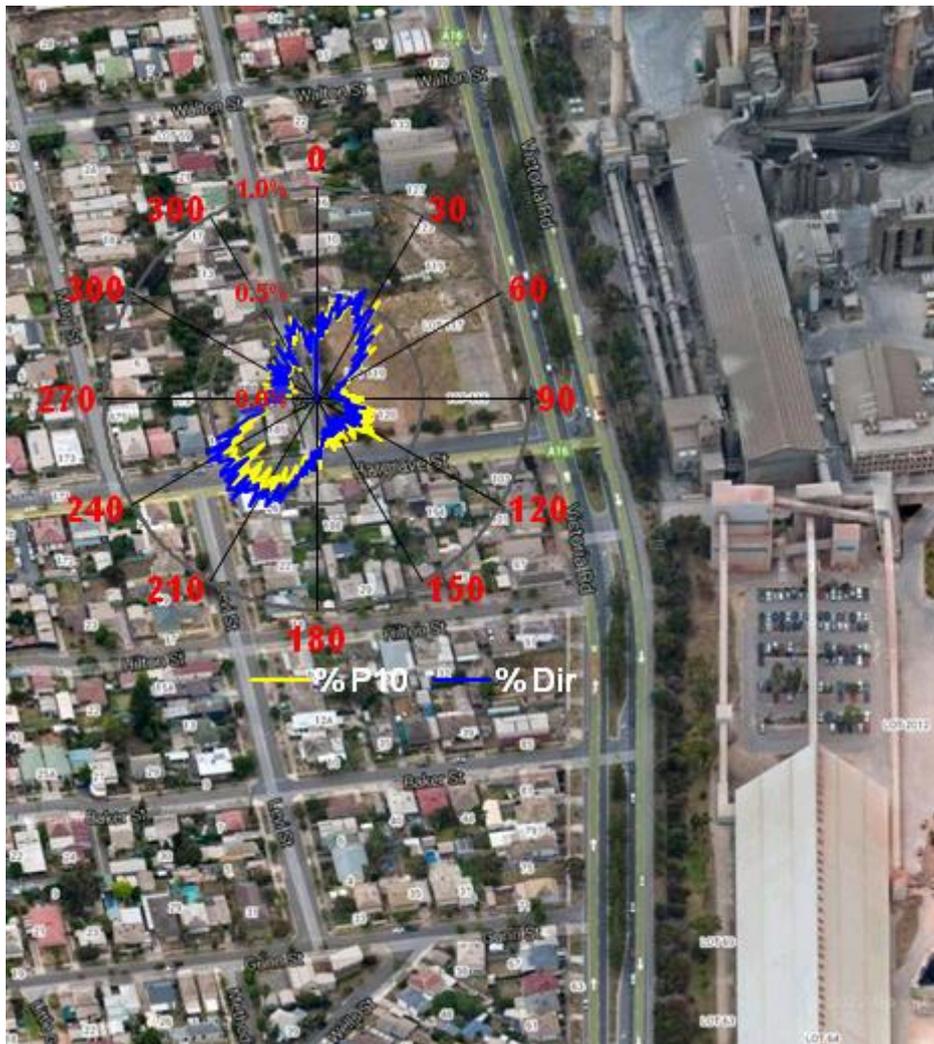
Community Park Monitor

Southwesterly and northeasterly winds were most common throughout October 2015 – October 2016. Higher proportions of PM10 levels in comparison to wind direction originate from an easterly direction. Possible contributors may include activities around the limestone conveying system/activities, traffic movement at Victoria Road/Hargrave Street, council/construction works near Hargrave Street directly adjacent to the monitor.

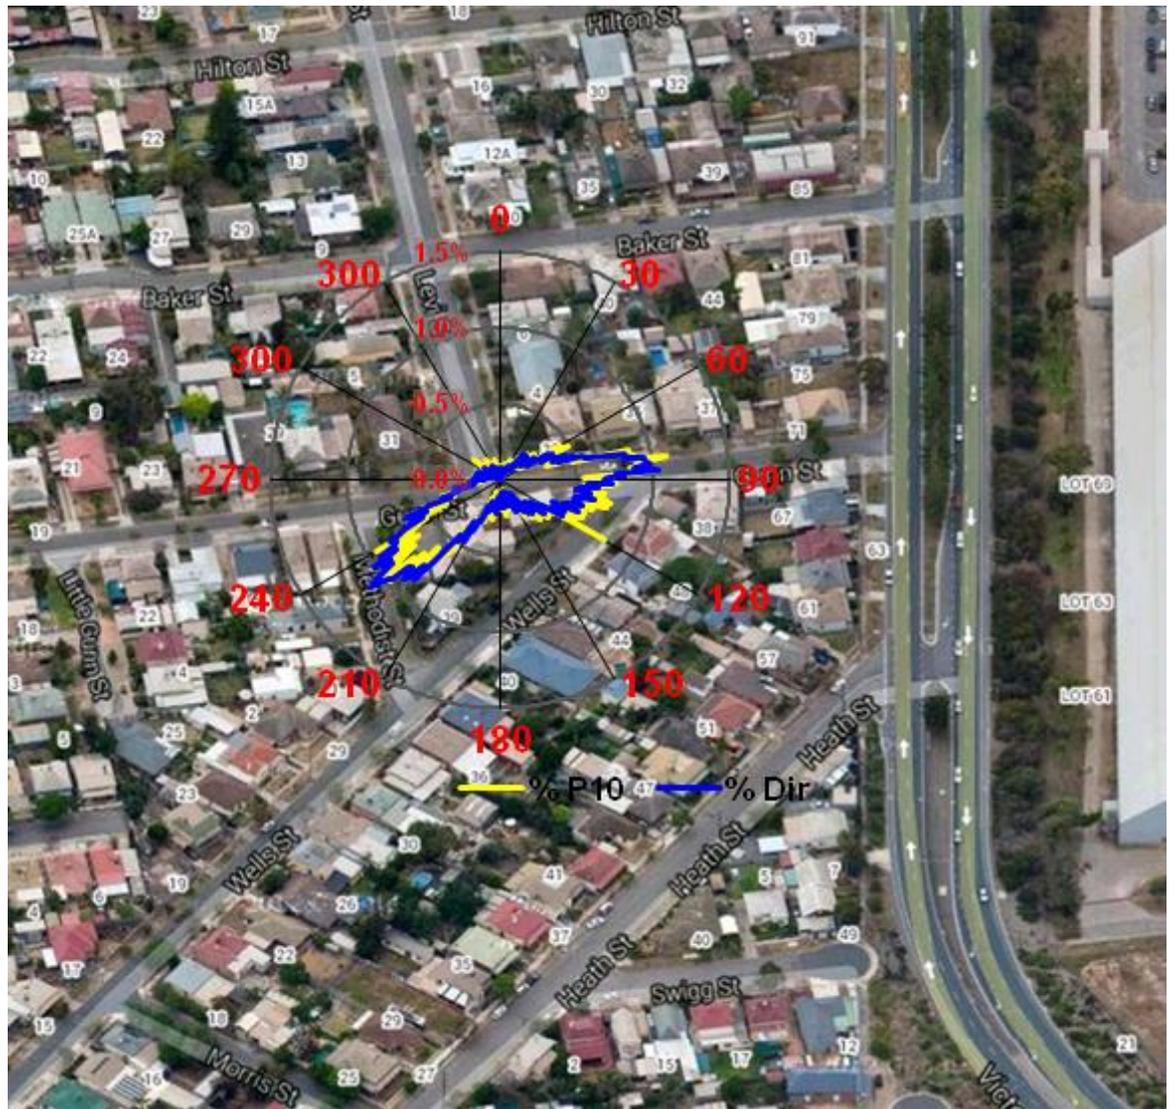
Gunn Street Monitor

Southwesterly and easterly winds were most common throughout October 2015 – October 2016. The PM10 trend on the diagram implies PM10 dust originating from the southeast. The dust could be related to localised events including traffic in the area. The average PM10 levels from this location are low.

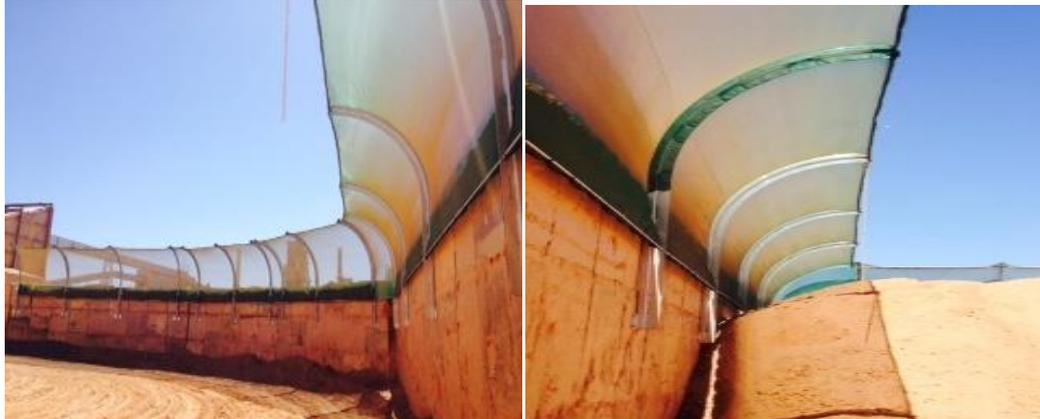
- Installation of foam mist spray system (EIP project) on the MM tipping loading hopper was installed and commissioned in late December 14
- **Fabric/Mesh canopies** were installed at the fringe Materials Management system on top of the concrete bunker walls in March 2015. This will reduce the tendency for dust to become airborne when loading/unloading material as it acts as a wind break. This is an EIP project.

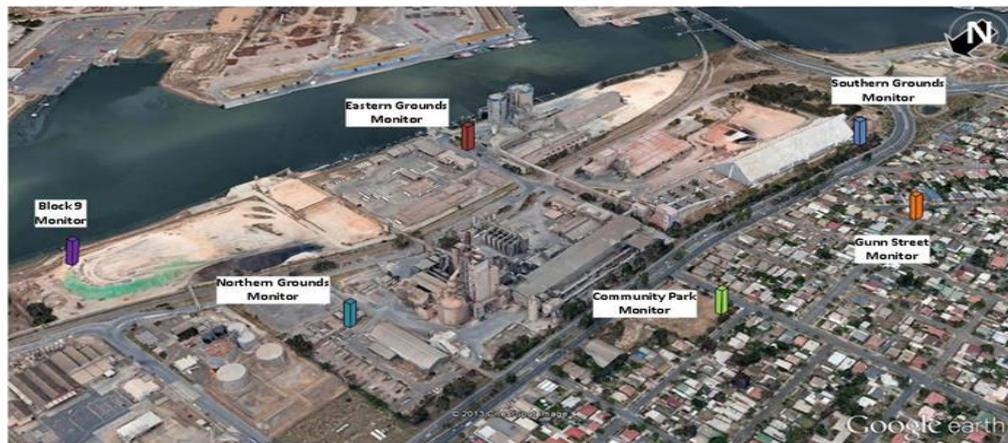
- **Standardisation of Ambient air monitoring network**

- Four of the older generation ambient air monitors were replaced during the second quarter with current generation systems as used on Community Park and Block 9 area (2013).

- The older generation models were Osiris monitors (Northern Grounds and corner of Gunn Street) and DustTrak 8520 (Southern and Eastern grounds).
- The older generation monitors were over 10 years old and suffered from reliability and integrity issues

- All monitors are now the DustTrak TSI DRX model
- A spare DustTrak TSI DRX unit was purchased to ensure full utilisation of the network during servicing, maintenance, breakdowns etc...

- The new DustTrak TSI DRX monitors use current technology and consist of a dust analyser that can sample all of the required forms of reportable fugitive dust (PM2.5, PM10 and TSP). The system uses an ultrasonic wind sensor

which is more precise and reliable than the anemometers used on the Osiris dust monitors. These anemometers also require virtually no maintenance as they have no moving parts.
