**Flinders Power Partnership**  
**Detailed Site Investigation – Version 2**  
Augusta Power Stations  
28 February 2017

# Detailed Site Investigation – Version 2

Prepared for  
Flinders Power Partnership

754-ENAUKESW01445AD-R01 Version 2

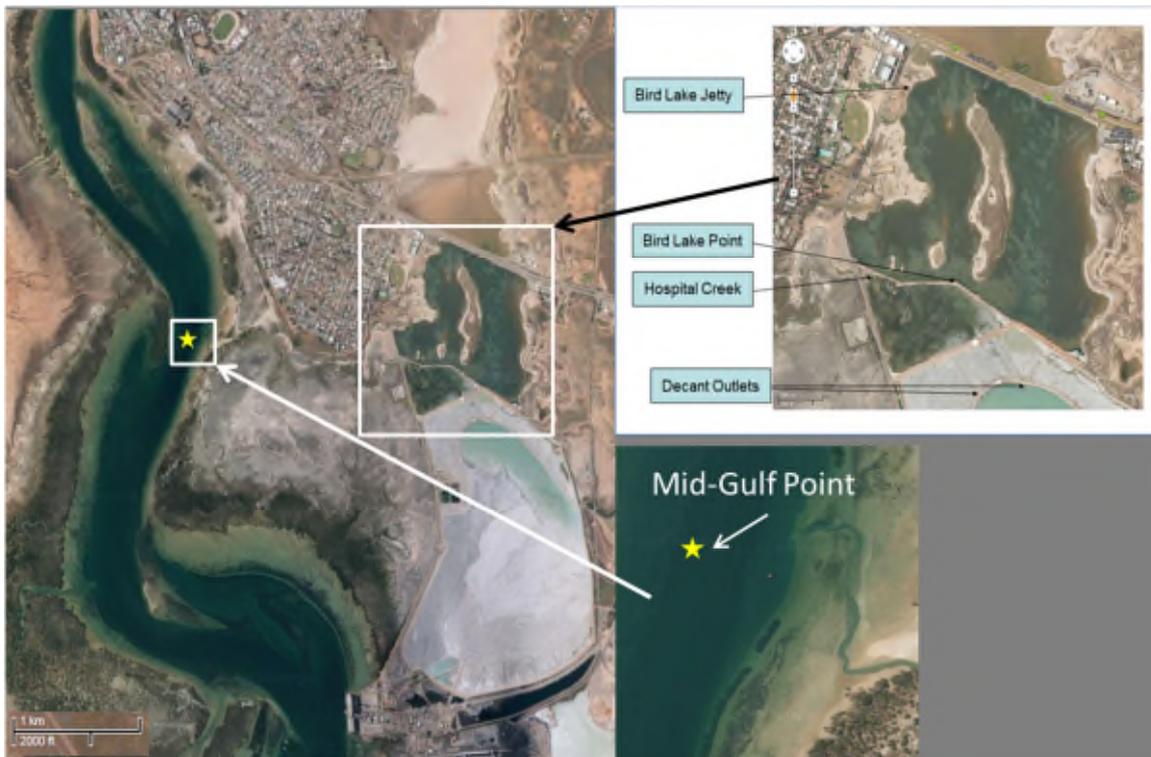
Figure 2.1: Surface water quality collection points (FPP)

Coffey has been provided with water quality data collected between May 2007 and August 2015 from Hospital Creek, Bird Lake Jetty, Mid Gulf Point and at a background location called Transect 7. Water collected at each event was tested for trace elements and nutrients, results are presented in Table 24 and locations are presented below.

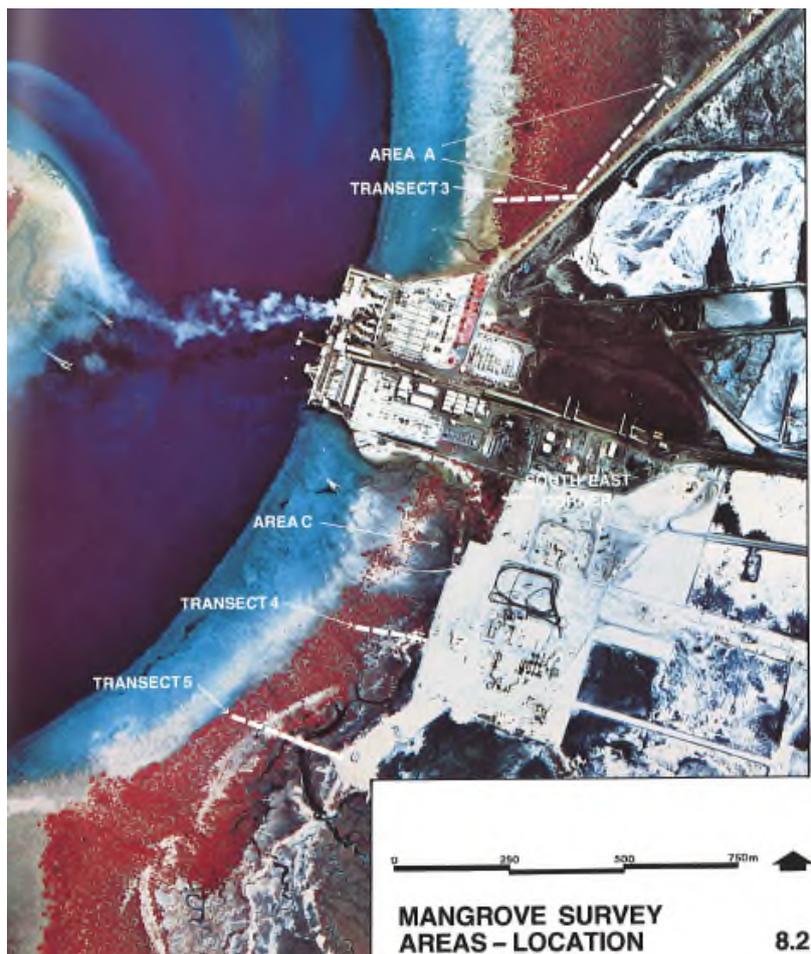
Figure 2.3: Mangrove areas surveyed (Kinhill Stearn, 1985)

Prior to 1961, it is recorded that the mangroves to the north (Area A) and south (Area C) of the Playford Stations had a number of die backs. It was determined that this was caused by sulphur dioxide emissions from the Playford chimneys (six short 40m high chimneys), these chimneys were replaced in 1961 by one 80m chimney (Kinhill Stearn, 1985). Aerial photographs reviewed between 1972 and 1984 showed a recovery and stabilisation of the mangrove community in these areas (Kinhill Stearn, 1986).

Further dieback to the mangroves north of the Playford (Area A) was observed in 1985 and it was determined that this was due to a 'slug' of highly saline groundwater migrating through these mangroves from the ash pond. It was recommended to direct water flows into the eastern side of the ash pond during summer to avoid future die back from saline water as well as installing a drain system along the Playford Station access road on the western side of the ash pond (Kinhill Stearn, 1986). It is understood both of these measures were implemented at the site.

It was also noted that through the construction of the Northern Station including the cooling water channels, some areas of the mangroves, particularly Transect 4 and 5 and the southern area of Area C as shown in Figure 2.3 above were markedly changed by mechanical disruption (Kinhill Stearn, 1986) and as such, the mangrove community within this area has been highly modified.

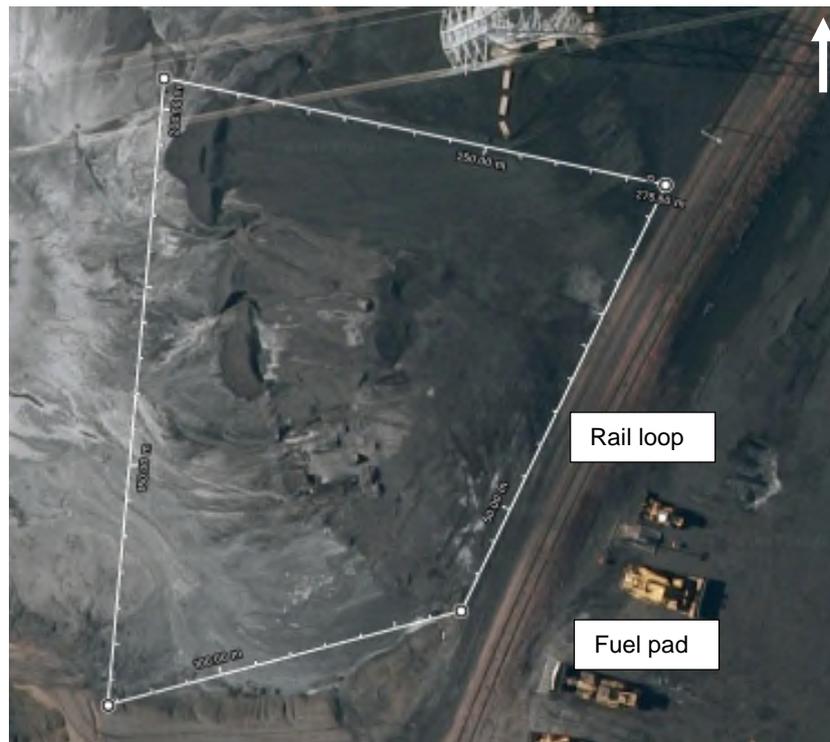
Figure 2.4: Unburnt coal remaining (FPP)

Unburnt coal that is remaining at the site comprises of coal rejects that could not be burned in the power generation process, unburnt coal removed from the coal conveyor including the bins and bunkers over time as well as the coal cleaned out of the coal conveyor bins during the site demolition works. The unburnt coal is deposited in the area as shown in Figure 2.4 below, east of the fuel pad and rail loop (Area 15) with an approximate volume, as of December 2016, estimated to be 5,200m<sup>3</sup> (1.2m deep). There is approximately 200m<sup>3</sup> of coal remaining within the coal conveyor bins to be added to this area. This area is noted to be included within the future management plan for the site and is currently intended to be revegetated.

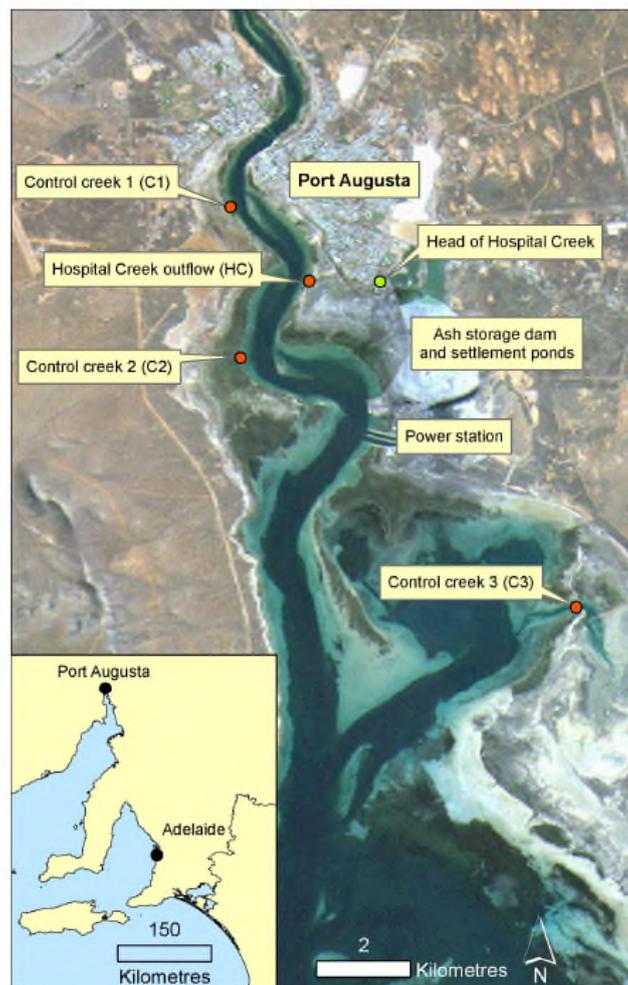
Figure 2.5: Mangrove sediment background locations (SARDI 2010)

In the discharge assessment conducted by SARDI in 2010, sediment samples were collected from three control sites as well as at the Hospital Creek discharge point. These samples were tested for heavy metals as well as other property characteristics and the data collected from the three control sites is considered likely to be representative of background concentrations for the mangrove sediments in the area. The areas sediments were collected from are indicated on the plan below:

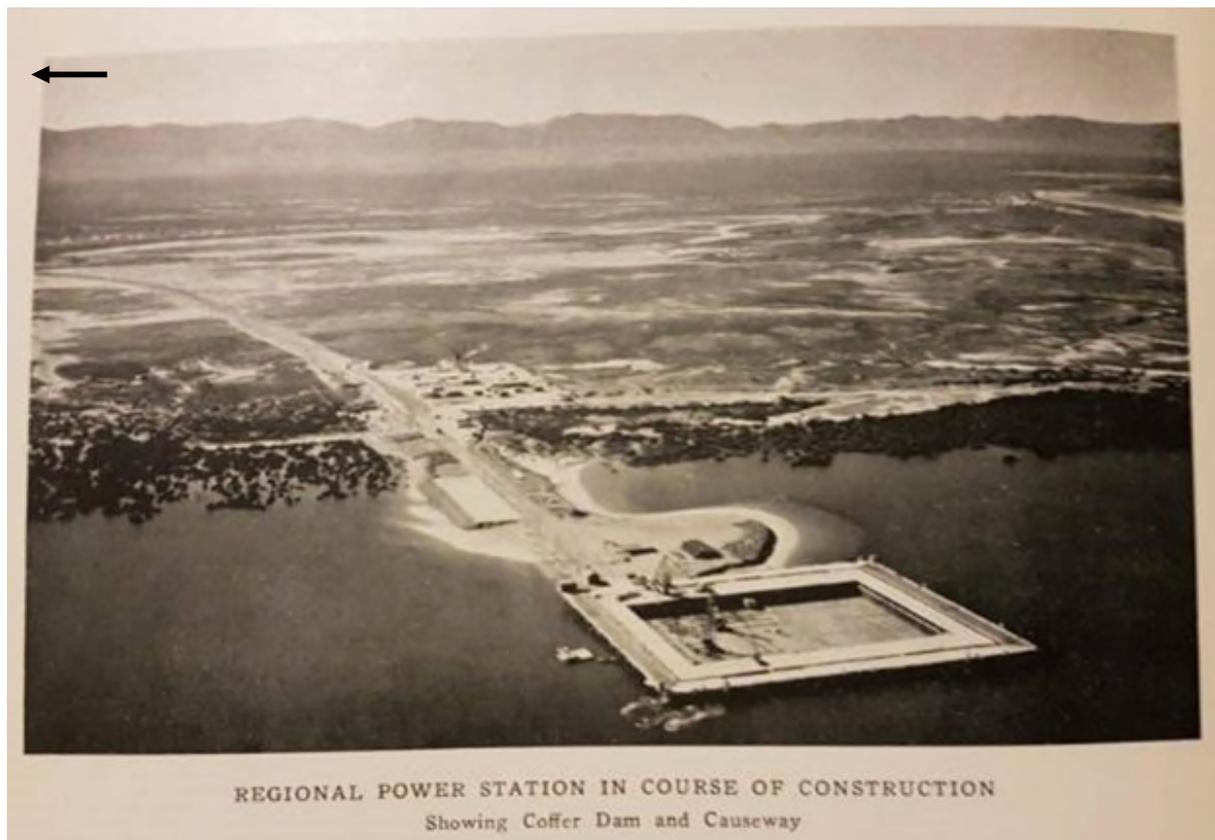
Figure 5.1: Playford A Station foundation construction, circa 1950's (FPP)

A historical photograph during the construction of Playford A Station is provided below that shows the natural layout of the site:

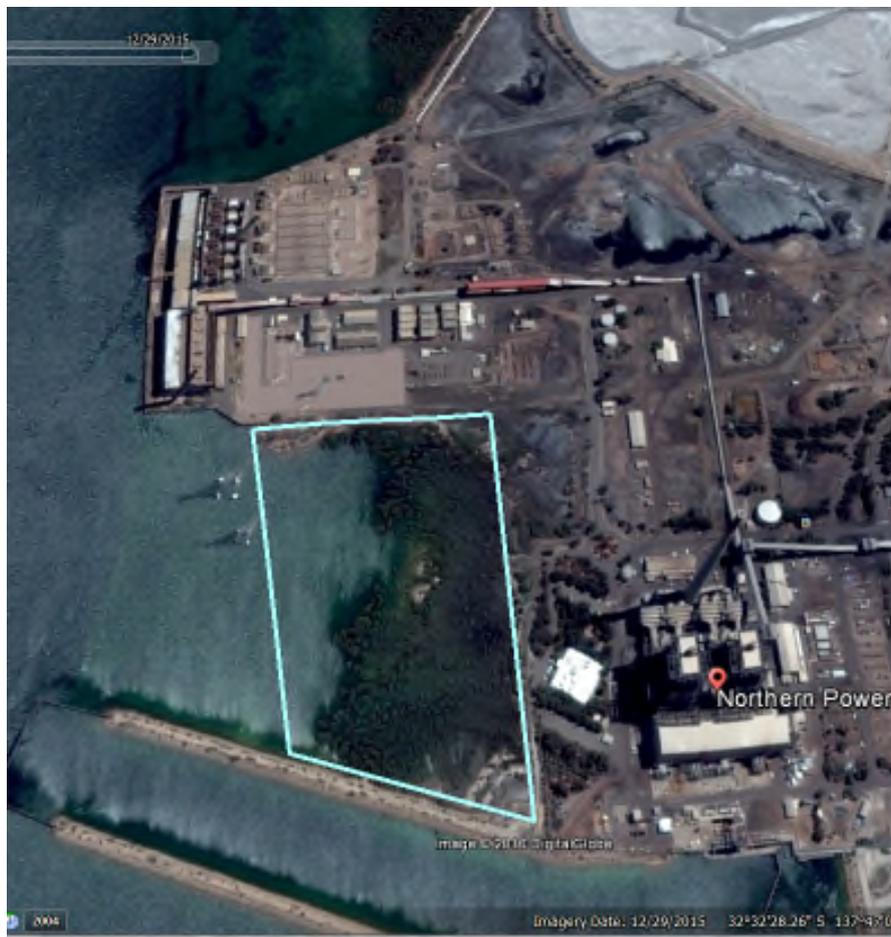
Figure 9.1: Mangrove swamp - area of investigation

The data collected has been used to undertake this Ecological Risk Assessment (ERA) to evaluate any potential ecological impacts of the discharge from the SPEL drains has had on the mangrove ecosystem located to the south of the Playford area between the Playford Stations and Northern Station. The mangrove ecosystem area under investigation ('the mangrove') is shown in Figure 9.1 below and presented in the overall site plan (Figure 8D).

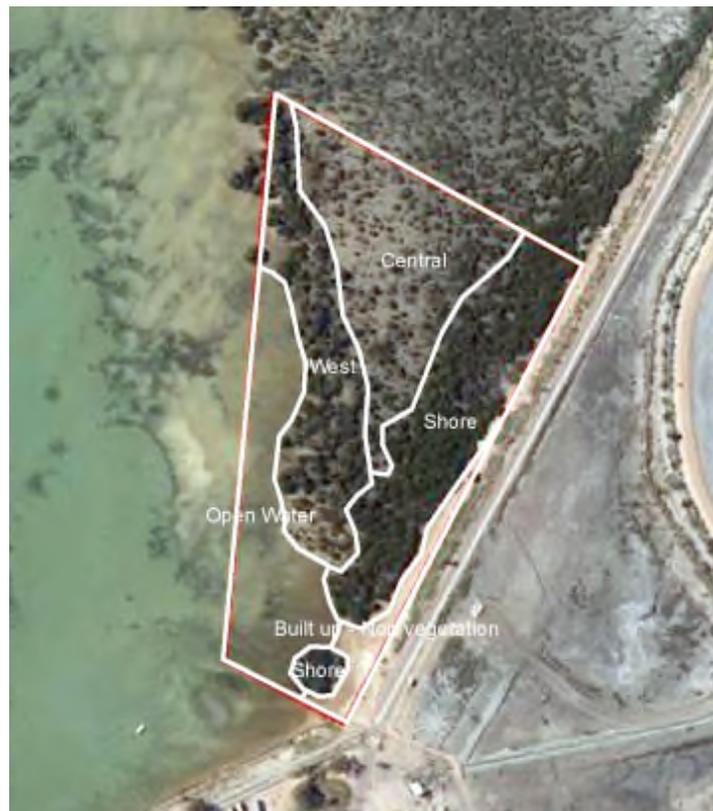
Figure 9.3: Vegetation condition mapping for the mangrove control site based on 2009 imagery (Ecological Associates, 2016)

The northern control site as shown in Figure 9.3 above, mangrove vegetation is in good condition, with the presence of barnacles and dense pneumatophores, and does not appear to show signs of environmental impact. The mangrove tree condition was generally considered to be moderate to very good. The canopy cover ranged from 75% shade in the Shore Zone to 20% in other areas where the tree density was less but the trees were generally in good health. Tree height was more than 2m in most trees however tree density across the zones was considered low, attributable to presence of largely mature trees.

It is noted this area of mangroves has suffered die backs on numerous occasions due to the sulphur dioxide emissions from the Playford chimneys in the 1950's as well as a 'slug' of highly saline groundwater migrating through these mangroves from the ash pond in the 1980's (Kinhill Stearn, 1986).

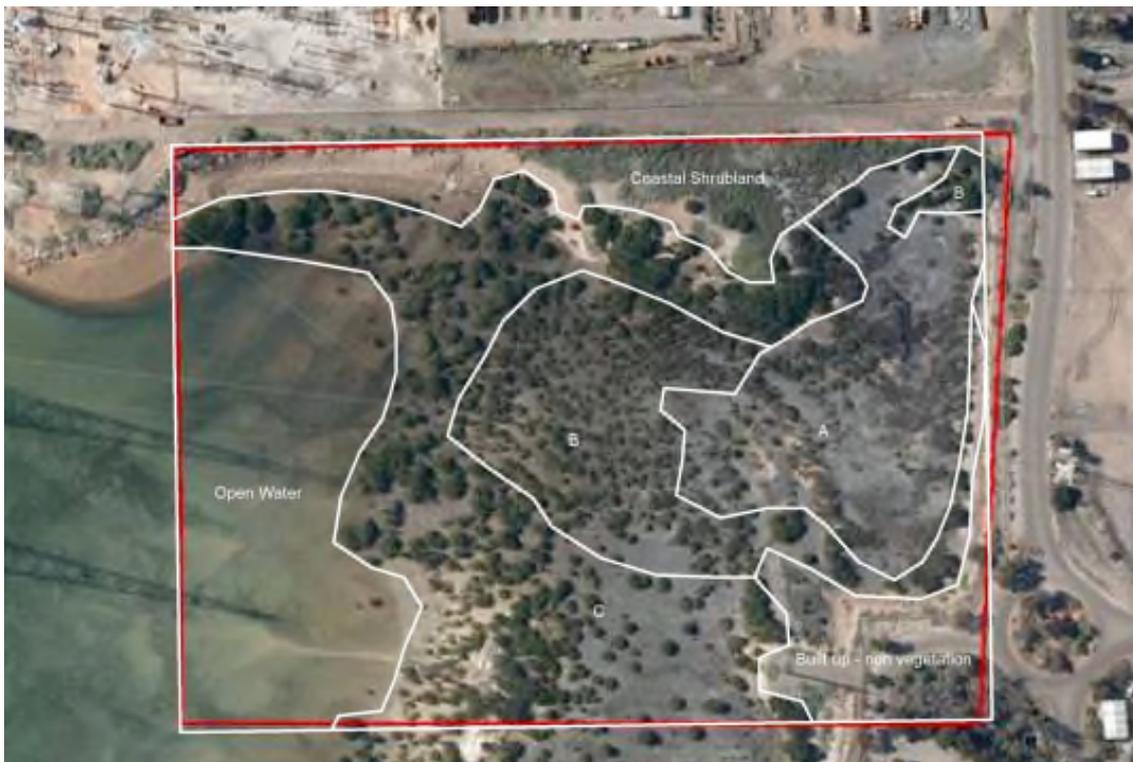
Figure 9.4. Vegetation condition mapping for the mangroves based on 2009 imagery (Ecological Associates, 2016)

The mangrove under ERA as shown in Figure 9.4 above, was observed to be in poorer condition. For the purposes of this assessment the investigation area has been divided into three zones on the basis of vegetation mapping. Refer to Figure 9.4 for the location and extent of the designated zones. Tree condition in Zone C, located in the deepest waters, were in good condition however Zone B trees in the central area of the mangroves were mainly moderate or good condition with a significant portion in poor condition. Trees in Zone A were mostly dead. Zone A generally includes the discharge area related to SPEL 1 and the eastern portion of the mangrove. Canopy coverage ranged from 20-30% in Zones B and C due to low tree density and <1% in Zone A. Tree height in Zone A was mostly <1m and included dead seedlings and stumps of dead immature trees. Zone B also contained a large number of trees < 1m, including many juvenile trees. The majority of trees in Zone C were 2-3m tall. Tree density in Zone C was low however Zone A and B were considered high due to the high numbers of seedlings and immature trees in Zone B.

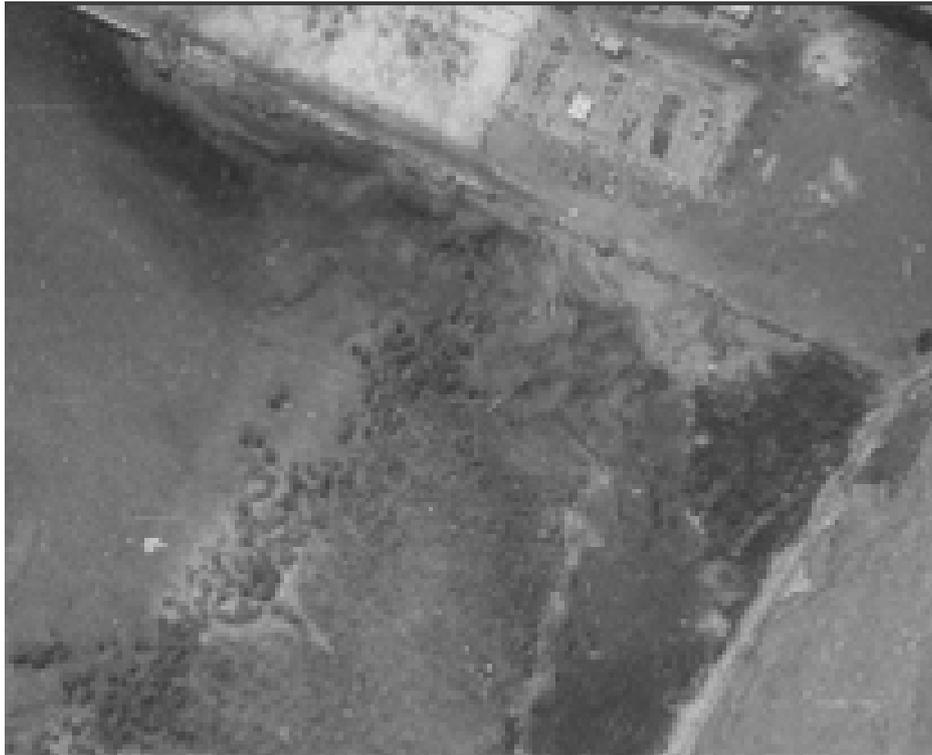
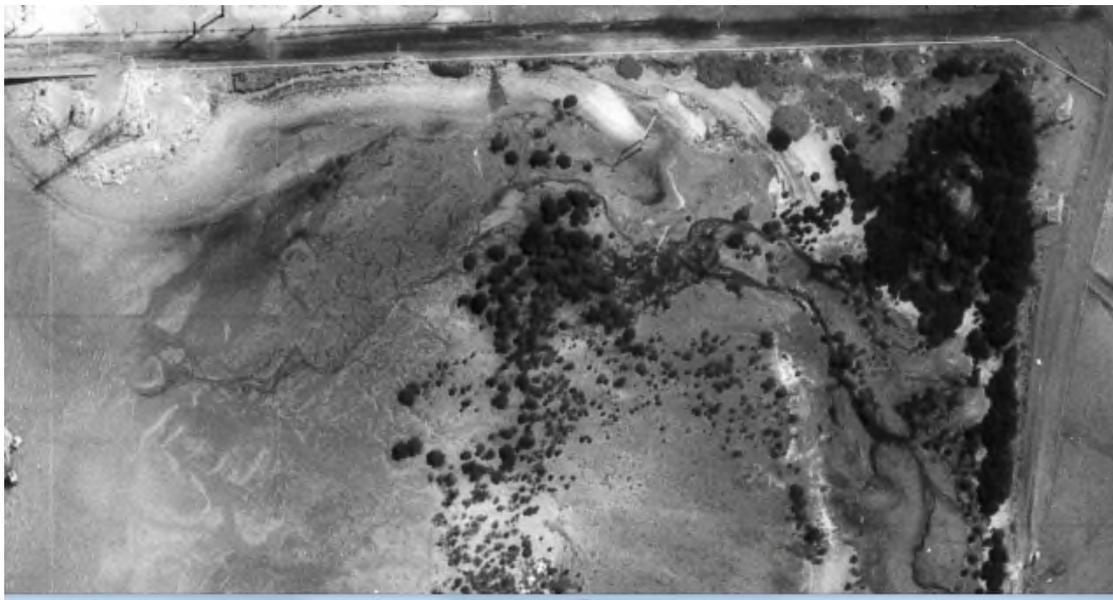
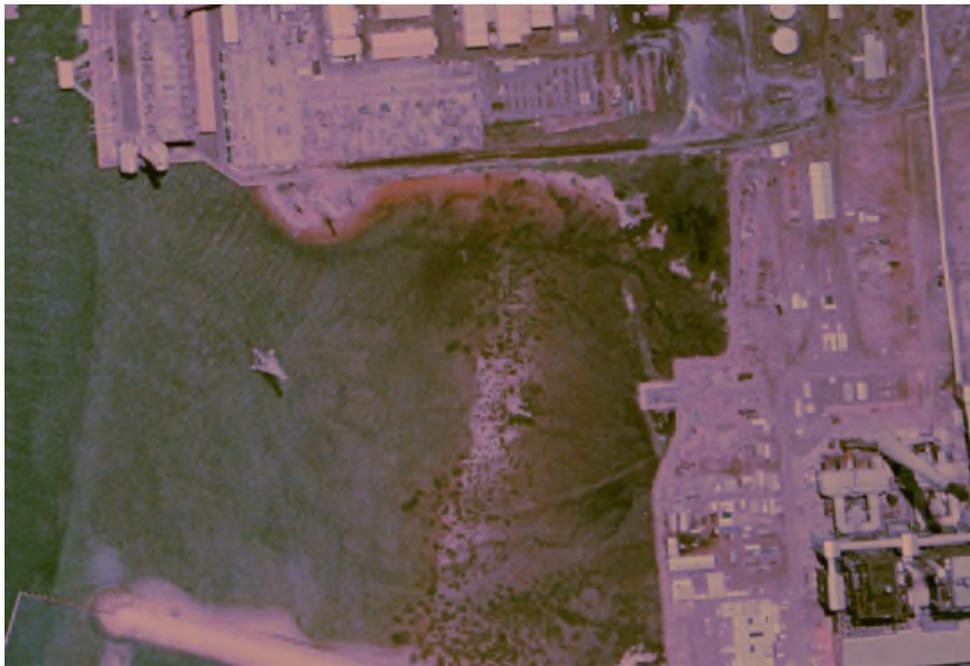
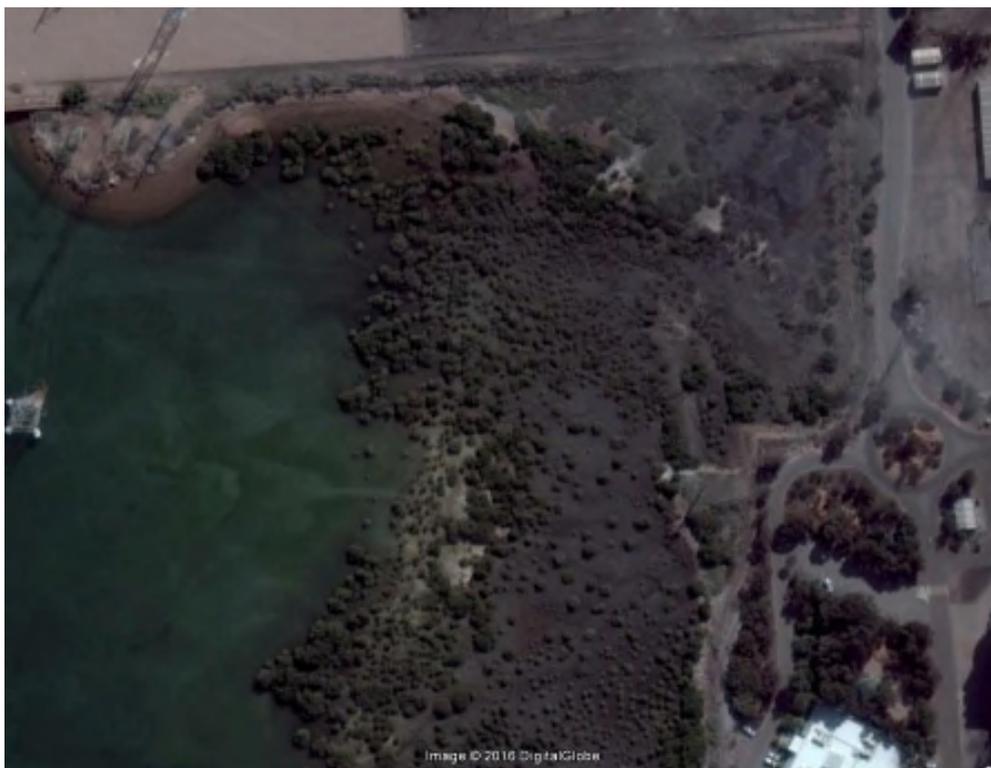
While the flora and fauna assessment indicated that degradation of this area appears to have occurred between 2002 and 2009, historical aerial photography between the 1950's and 2016 does not support this and indicates the area has recovered from the 1950's dieback, and stabilised following the Northern Station construction disruption. This area has also had a number of replanting events.
