QUARTERLY AMBIENT MONITORING PROGRAMME FOR BIRKENHEAD WORKS

COMPLIANCE DATE: 31/07/17 - Quarter 2, 2017

EPA Licence 1126

Licensed site: Adelaide Brighton Cement, Birkenhead Works
 62 Elder Road, Birkenhead, SA 5015

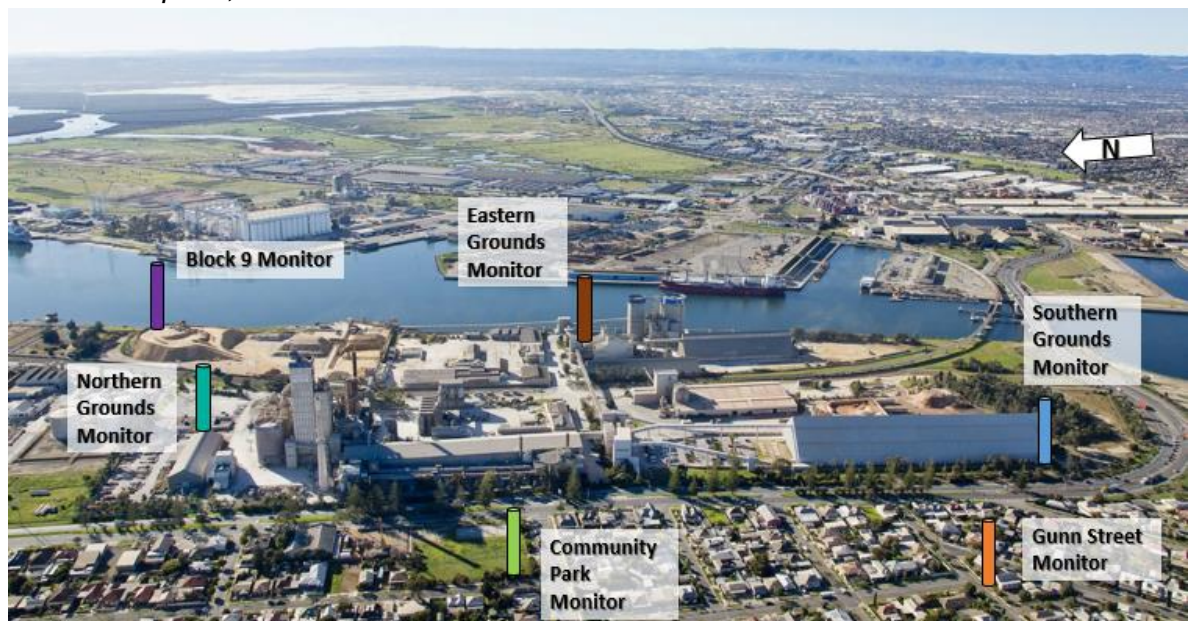
Sampling locations are indicated by colour coded dots on the above map.

NB: Four sampling points are located on the Birkenhead Works site; the other sampling points are in the community (corner of Gunn/ Well streets and Community Park).

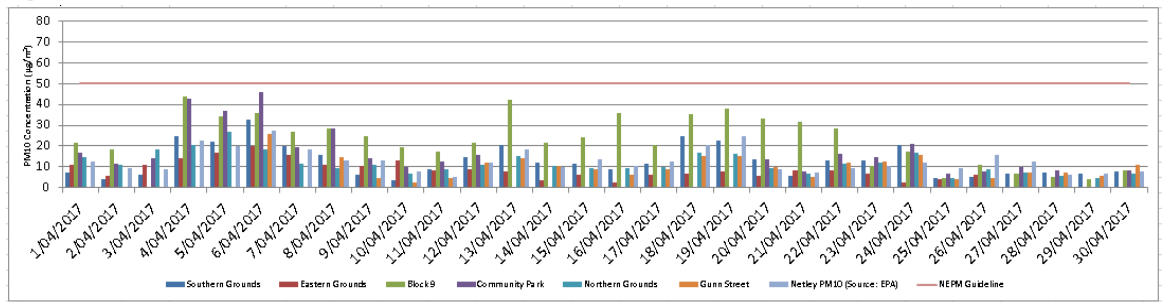
April 2017

All monitors generally displayed similar PM10 trends throughout the month with nothing exceeding the daily average of 50 ug/m³. Block 9 monitor is trended higher for an 11-day period towards the middle of the month. This could be related to localised stockpiling activities, Port River ship loading/unloading and adjacent Port River industrial operations.

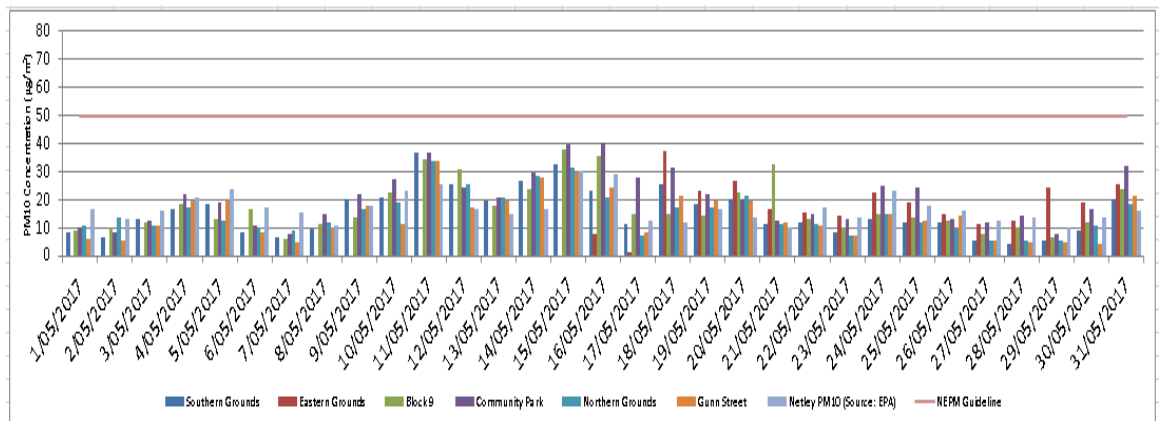
May 2017

All monitors displayed similar PM10 trends throughout the month with nothing exceeding the daily average of 50 ug/m³.

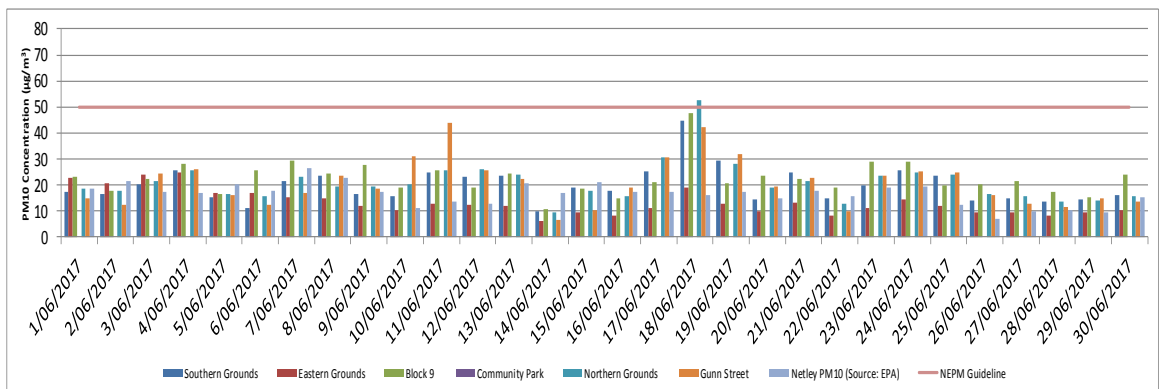
June 2017

All monitors displayed similar PM10 trends throughout the month with one exceedance on the 18th on the northern ground monitor of the daily average of 50 ug/m³

On the 18th June all site ABC monitors showed elevated levels. No site activities could be identified that would have contributed to this and would suggest an external source in the air-shed.

The Community park monitor data was removed for the month due to the low availability of data caused by a battery problem.

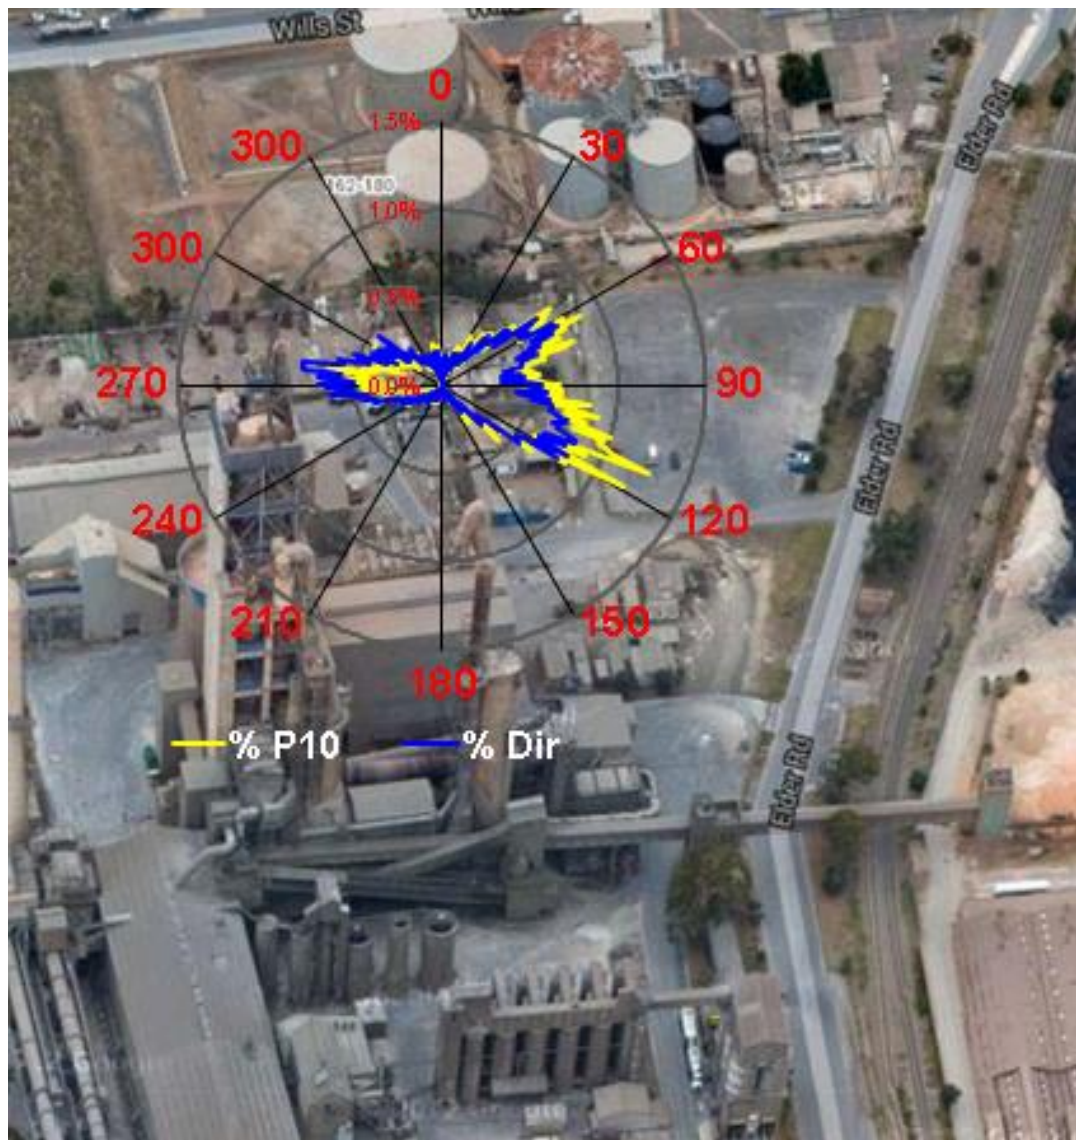
Northern Grounds Monitor

The wind-rose implies that dominant winds are westerly and easterly. Higher proportions of PM10 levels relative to wind directions appear to be coming from most notably the southeast. Possible sources could be related to localised stockpiling activities, Port River ship loading/unloading and adjacent Port River industrial operations.

Please Note: Yellow plots show the percentage of PM10 whereas blue plots show the percentage of winds travelling from a specific direction. It is important to note that the percentages listed in these graphs are relative values and not absolute so they must not be compared quantitatively to other parameters.

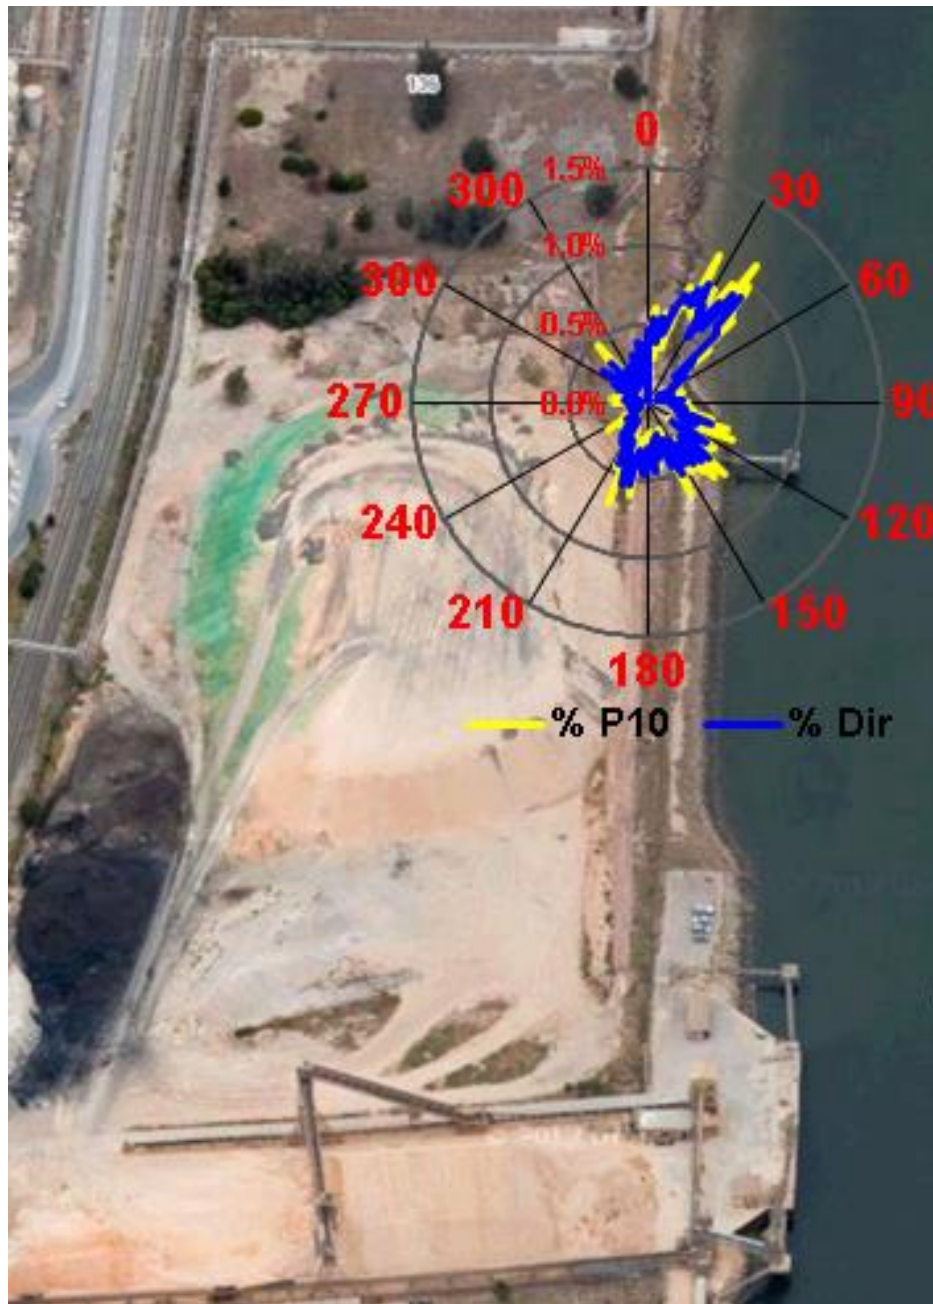
Block 9 Monitor

The wind rose implies winds are predominately from the northeast and southeast. The wind rose of PM10 suggests fugitive dust originates from a southeast and northeast direction. This could be related to localised stockpiling activities, Port River ship loading/unloading and adjacent Port River industrial operations.

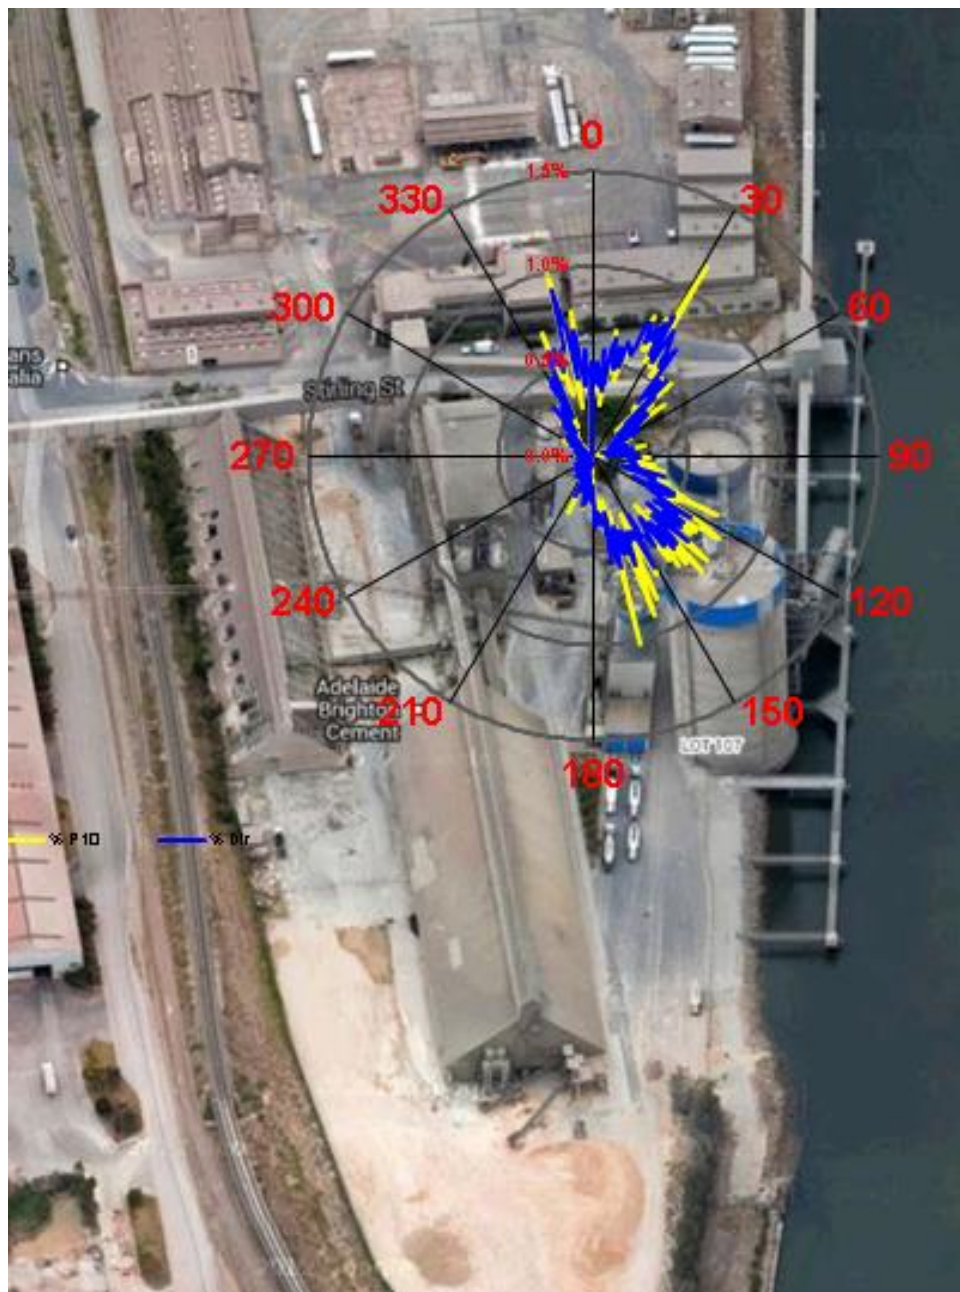
Eastern Grounds Monitor

The wind rose implies that prevailing winds originated from a north and south of the adjacent truck wash.

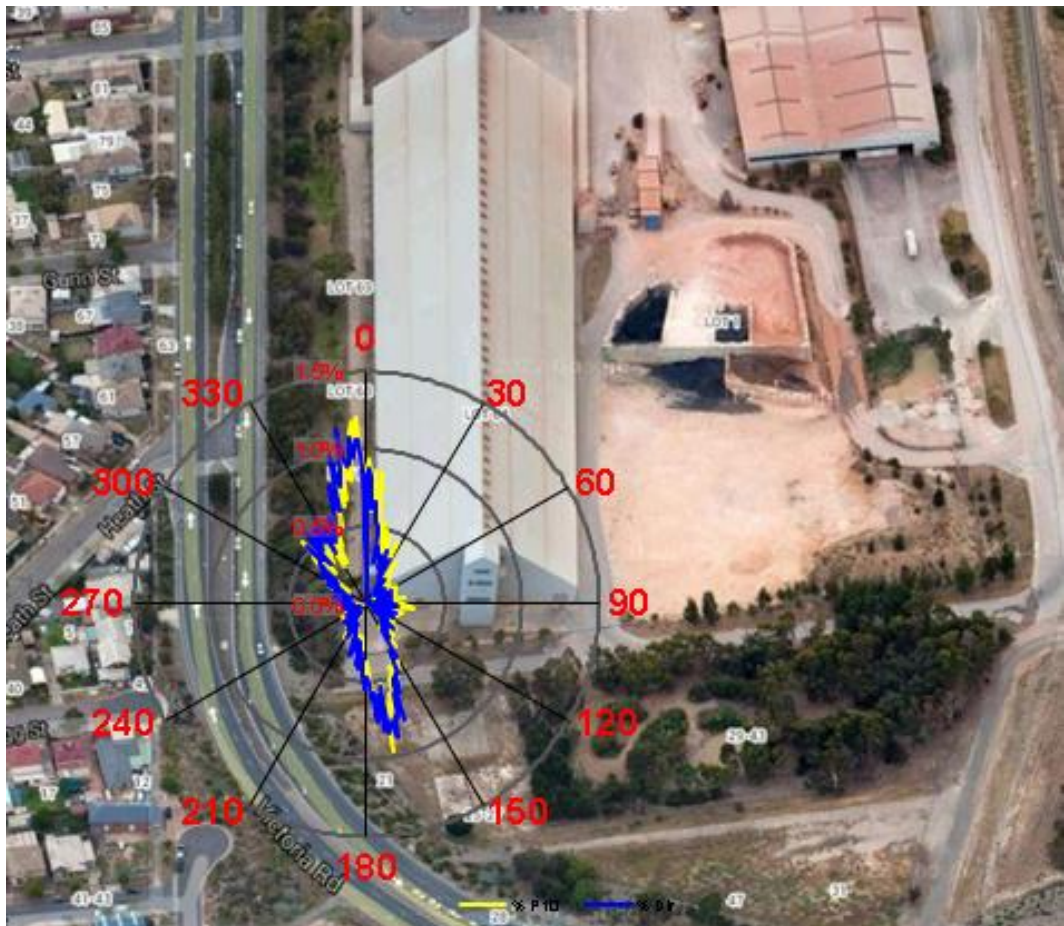
Southern Grounds Monitor

The wind rose implies that prevailing winds originated from a north and south.

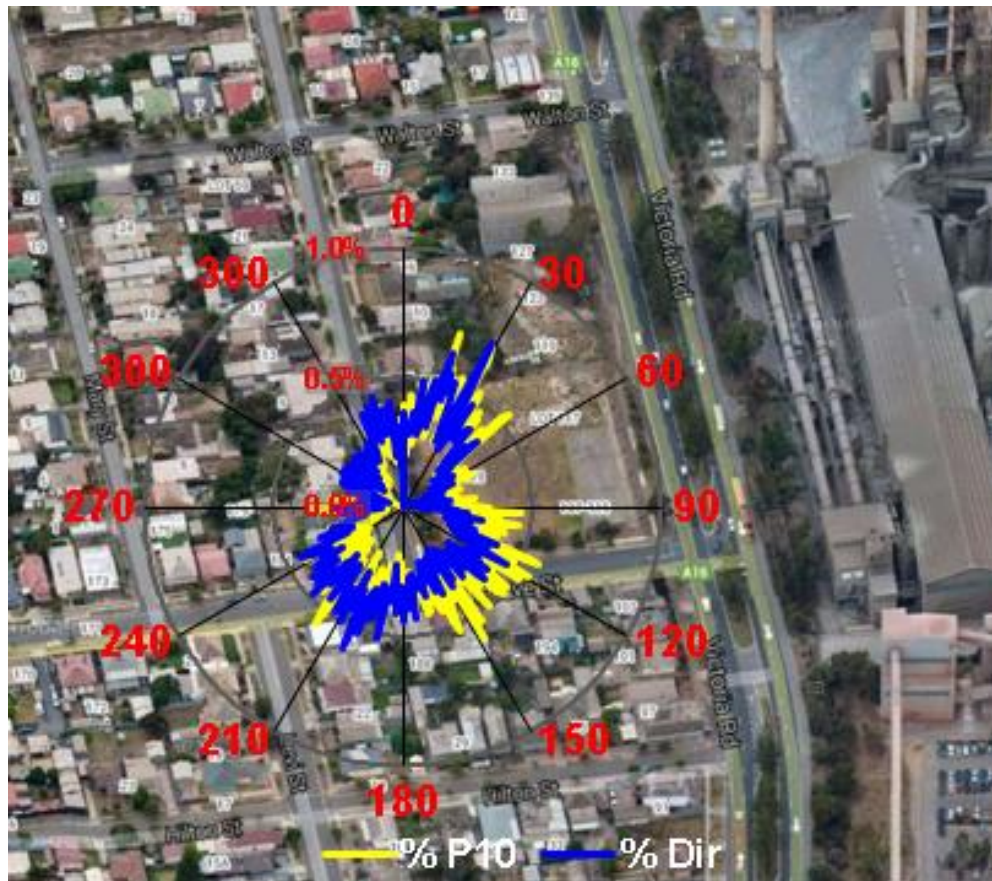
Community Park Monitor

The wind rose implies winds prevailing from all directions. Higher proportions of PM10 levels in comparison to wind direction originate from an easterly direction.

Possible contributors may include activities around the limestone conveying system/activities, traffic movement at Victoria Road/Hargrave Street, council/construction works near Hargrave Street directly adjacent to the monitor.

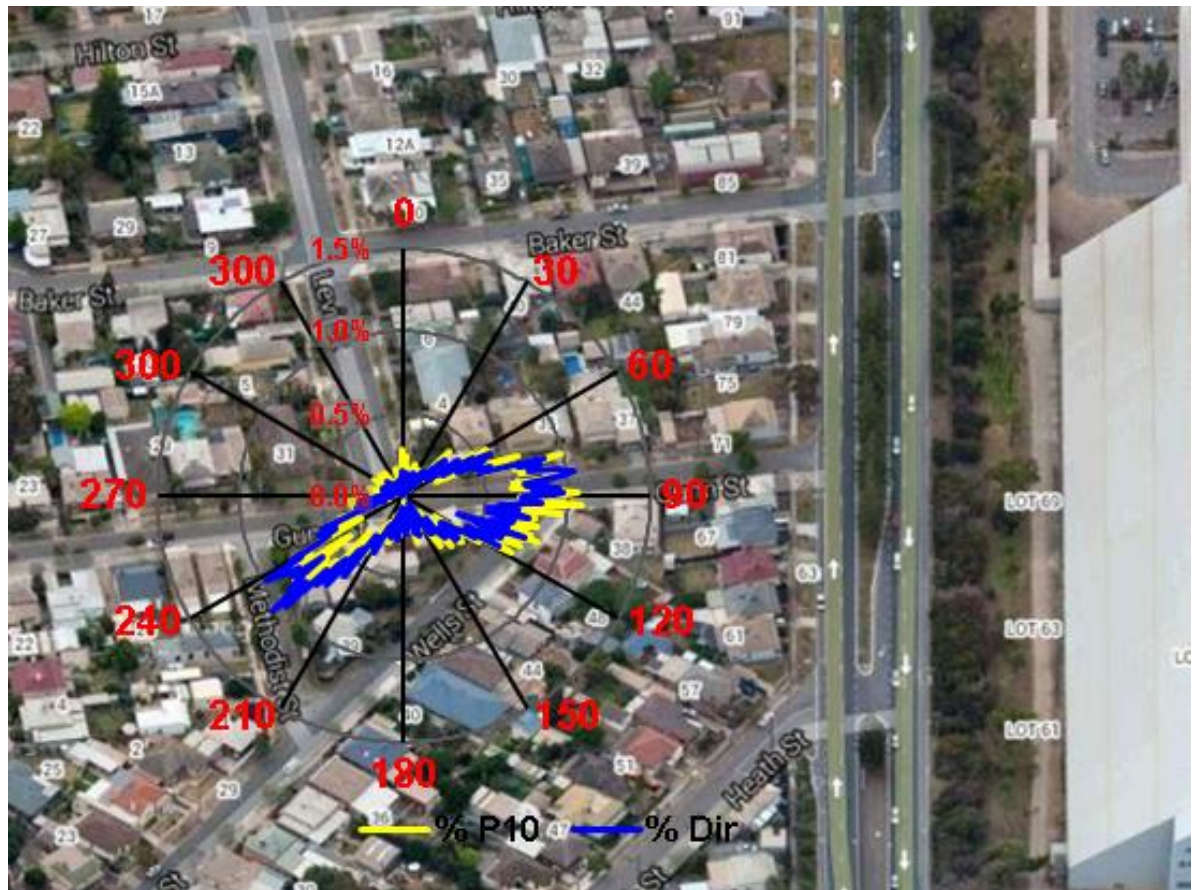
Gunn Street Monitor

The wind rose implies prevailing winds were southwesterly and easterly. The PM10 trend on the diagram implies PM10 dust originating from a predominantly eastern direction. The PM10 loads could be related to localised events including traffic in the area. However, as shown earlier in the 24 hour average graphs, the average PM10 levels from this location are low.

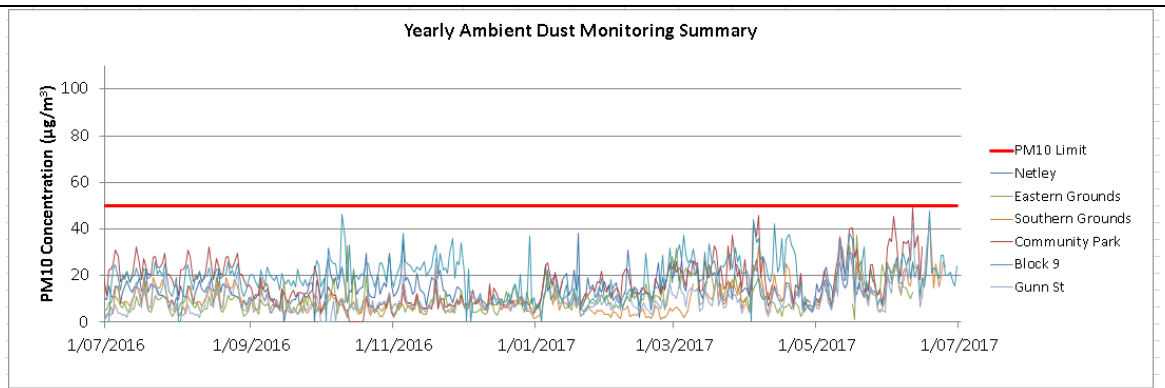
Overall progress of ambient PM10 tracking was graphed to observe what happened to the plant over the past year.

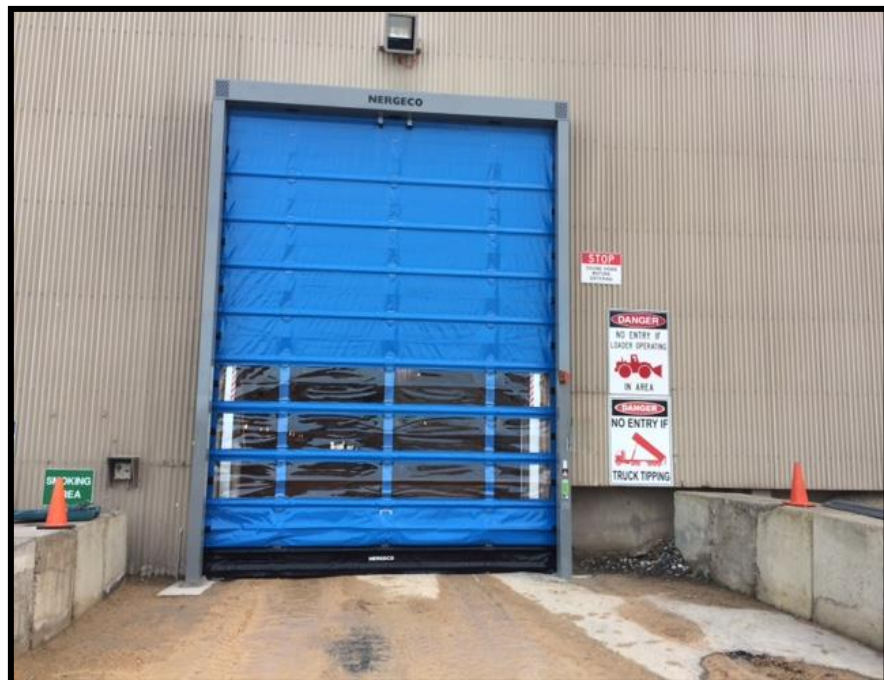
- Installation of a large rapid raise door was installed on the southern side of the Wallaroo raw material storage shed. This type of door closes automatically and quickly to minimise fugitive dust excursions.

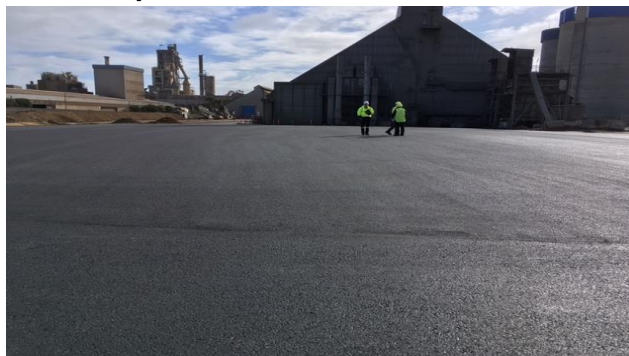
- All heavy traffic areas at the southern end of the plant adjacent the Cement Mill 1 Gantry have been sealed. All traffic movements will now travel on the sealed surfaces, subsequently reducing fugitive particulate emissions. The sealed surfaces will also allow for the area to be regularly road swept, which will further reduce and contain particulate emissions
