**Environmental Fact Sheet
Bridgestone Australia**

Edwardstown Plant, S.A.

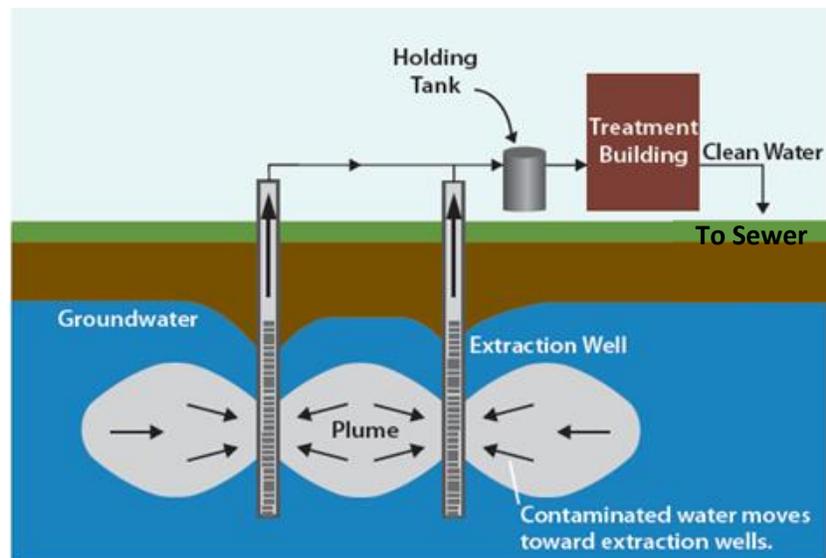
Example of a Pump and Treat System with Two Extraction Wells.

Much of the leaked materials were recovered using a pump and treat process. In this process, contaminated groundwater is pumped up out of the ground for treatment and disposal. However, this activity while removing most, can never remove all of the lost chemicals.
