# Lower Lakes and Tributaries

## Water Quality Report

Ambient and Response Monitoring

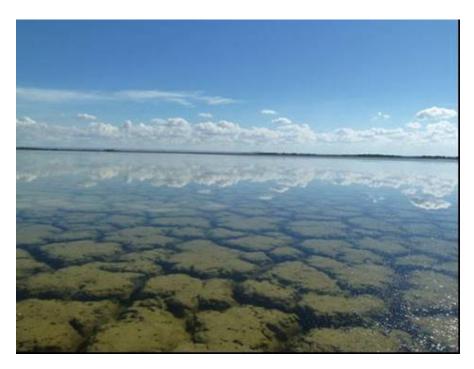
Figure 26 – Acidified surface water (pH 2-3) overlying cracked clay soils
