**The pollutant trace sampling, source
detection and remediation program
STATUS REPORT 2002**

Mount Lofty Ranges Watershed Protection Office

Status Report 2002

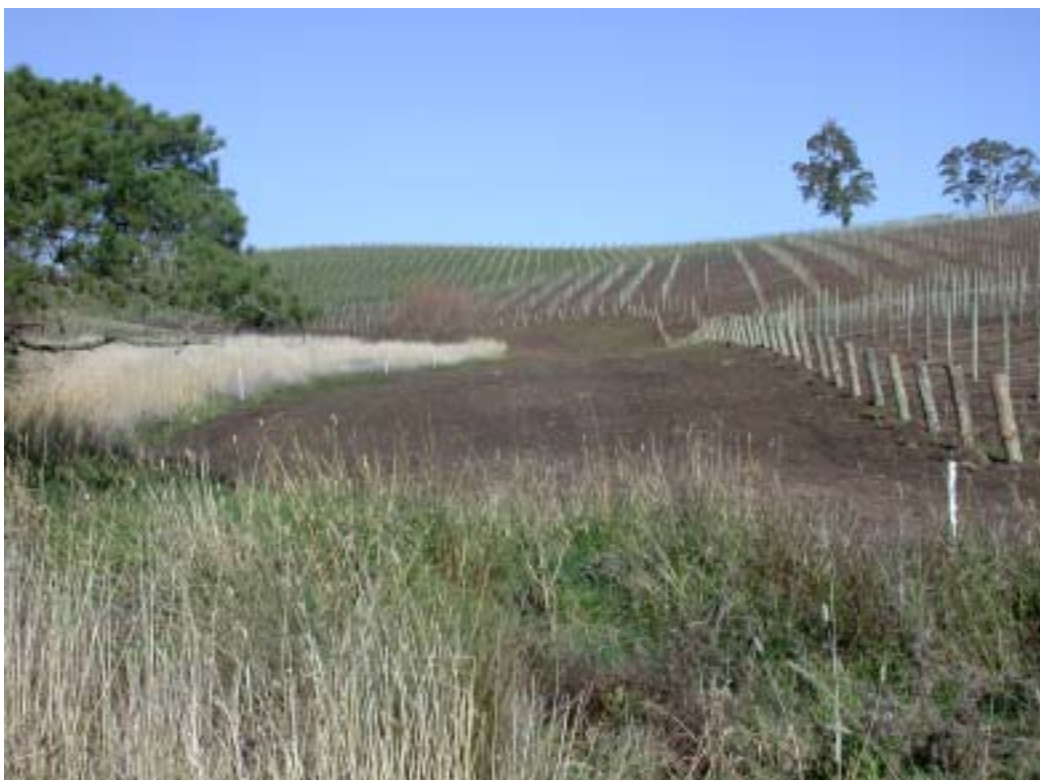
Plate 1 Vineyard on Coleman Road

The turbidity issue was traced to a newly established vineyard on Coleman Road, Gumeracha. Plate 1 shows the vineyard thought to be the source of sediment entering the creek and elevating the turbidity of the water. Note the bare soil, the slope and the proximity to the drainage line. Plate 2 shows rill erosion occurring between the rows of vines. This is the likely source of sediment causing high turbidity levels found in the creek. Plate 3 clearly shows that soil from the vineyard has moved with the rainfall event to the creek. This photo was taken at the base of the slope between the vineyard and the stream.

The WPO raised the issue of vineyard establishment with the Adelaide Hills Wine Region group on 9 July 2002. The group agreed that this was a problem for the industry and that the code of practice for establishment should be revised and used by contractors when establishing vines.

On the same day the WPO sent a letter to the Northern Hills Soil Conservation Board raising the matter of inappropriate activities leading to the high turbidity found in the stream. A Board representative visited the site on Monday 15 July 2002 and, on 23 July 2002, the Board replied thus:

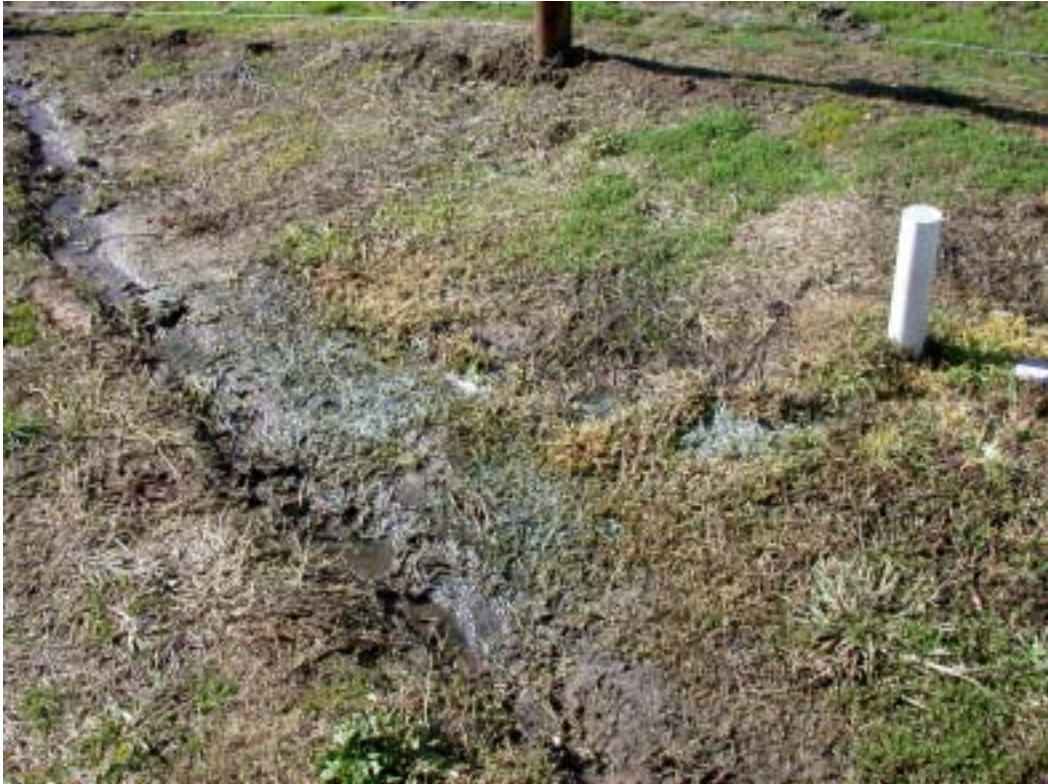
Plate 4 Overland wastewater flow from septic tank on Coleman Road

The pathogen problem was traced to a house on Coleman Road. A spoon drain had been dug to drain the surface water from the property. The spoon drain was situated directly across the inlet to the property's septic tank. The inlet was broken and raw sewage was flowing down the spoon drain (see Plate 4) to a roadside drain before entering the creek.

The Adelaide Hills Council environmental health officer was advised of the issue and subsequently investigated it. The officer has advised that a new aerobic water treatment system has been installed on the property replacing the failing septic tank.

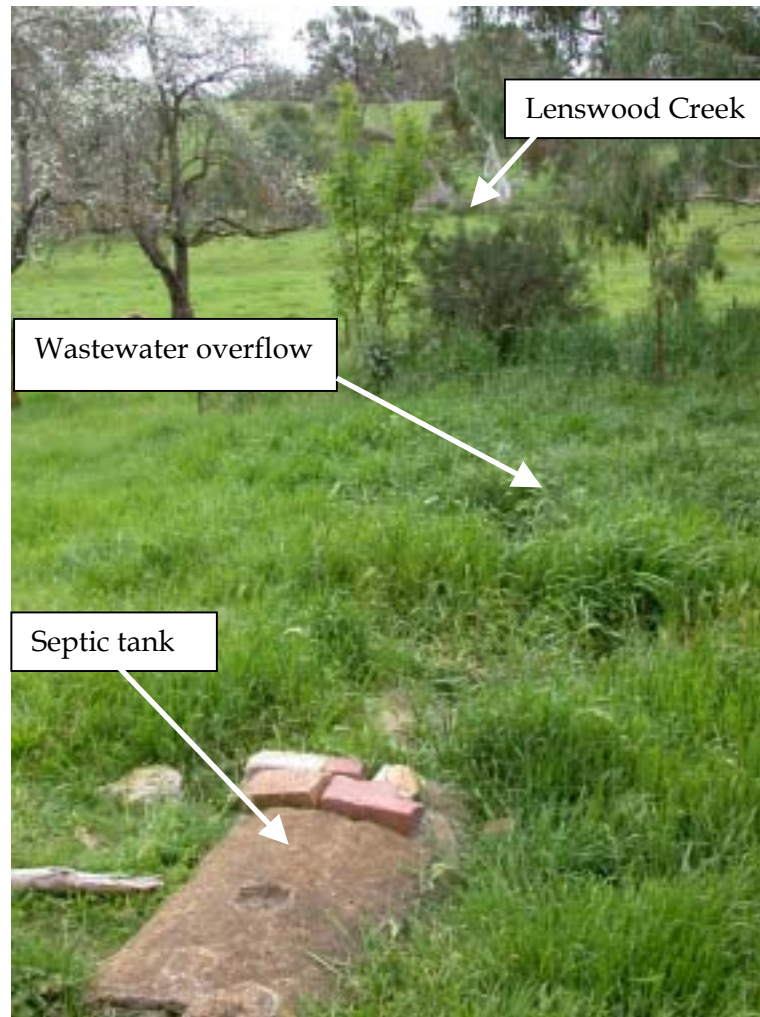
Plate 5 Failing septic tank in the Lenswood Creek sub-catchment

During the investigation 18 properties were visited. Of these, five were reported as having significant failures that would be likely to contribute wastewater to Lenswood Creek. A further four required further investigation and some possible improvement. Plates 5 and 6 show examples of inadequate systems that display significant failures at two sites. Both are significantly undersized, do not have soakage fields and overflow directly to the surface; such wastewater can easily enter the nearby Lenswood Creek. Plate 7 shows wastewater on the ground surface from the overflow of a failing septic tank in Lenswood Creek.

The Adelaide Hills Council environmental health officer was advised of the issue and subsequently investigated it. The officer has advised that of the five significant failures:

- one property owner is now upgrading their system
- two property owners did not respond to council letters and Adelaide Hills Council has now served a notice to the landowners to upgrade their systems
- an application to put in a new system was given to another of the properties
- the fifth property owner believes their system is functioning effectively and Adelaide Hills Council will inspect the system again and discuss the landowner's concerns.

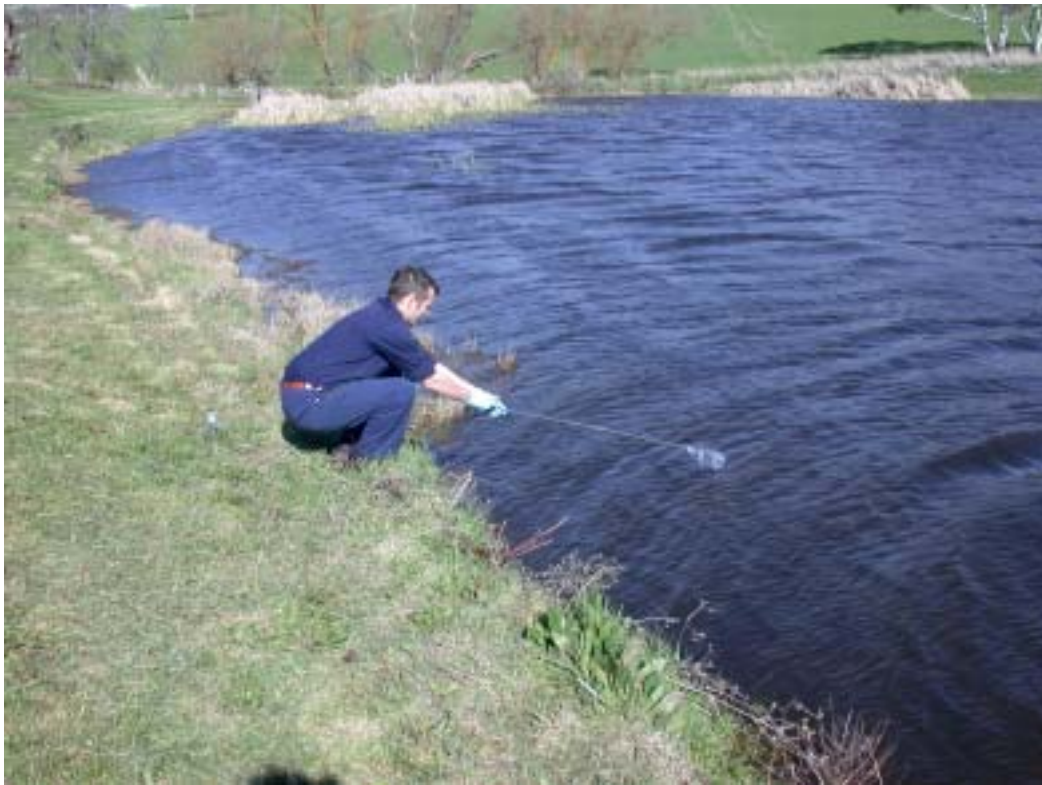
Plate 8 Taking water samples in Balhannah Creek

On 5 September 2002, trace sampling was undertaken in the Balhannah Creek sub-catchment. Figure 7 shows the trace sampling sites and Table 14 shows the surface water results of trace sampling. Plate 8 shows a sample being taken from an in-stream dam on Balhannah Creek.

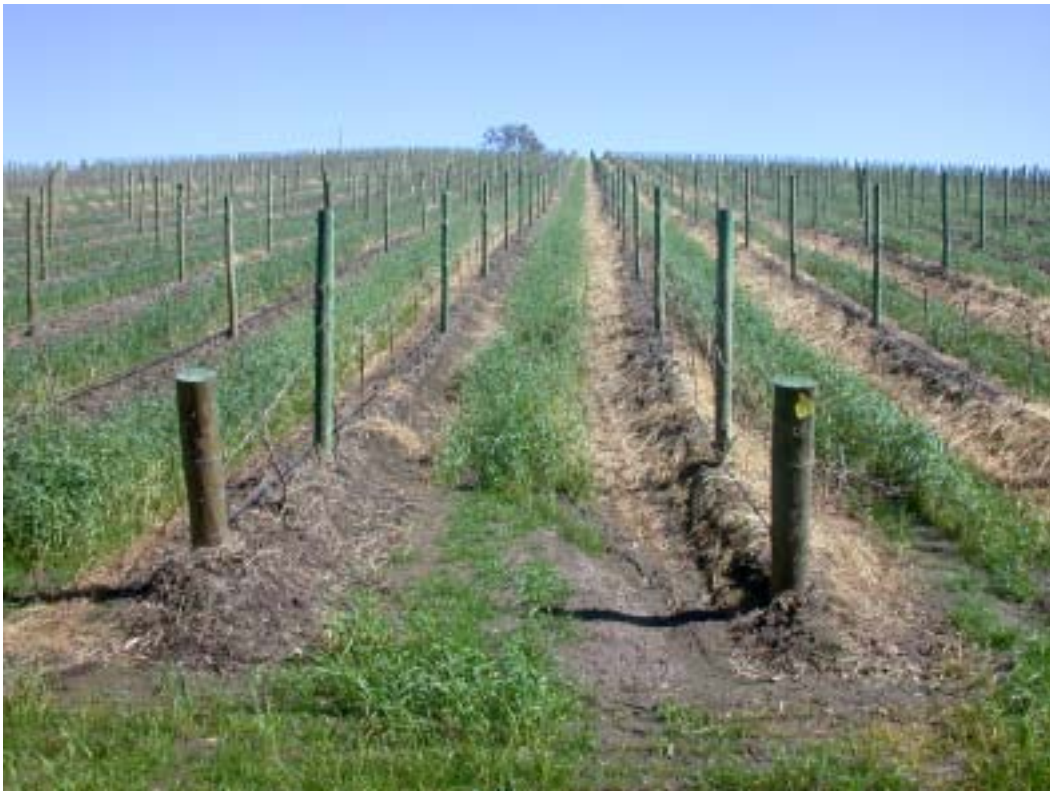
Plate 9 Vineyard in the Balhannah Creek sub-catchment

Surface soil sampling results for Balhannah Creek are shown in Table 15. Plate 9 is a typical Adelaide Hills vineyard. This photo shows that the base of the vines have been treated with a pesticide to limit the growth of unwanted vegetation. Soil samples were taken at this site.

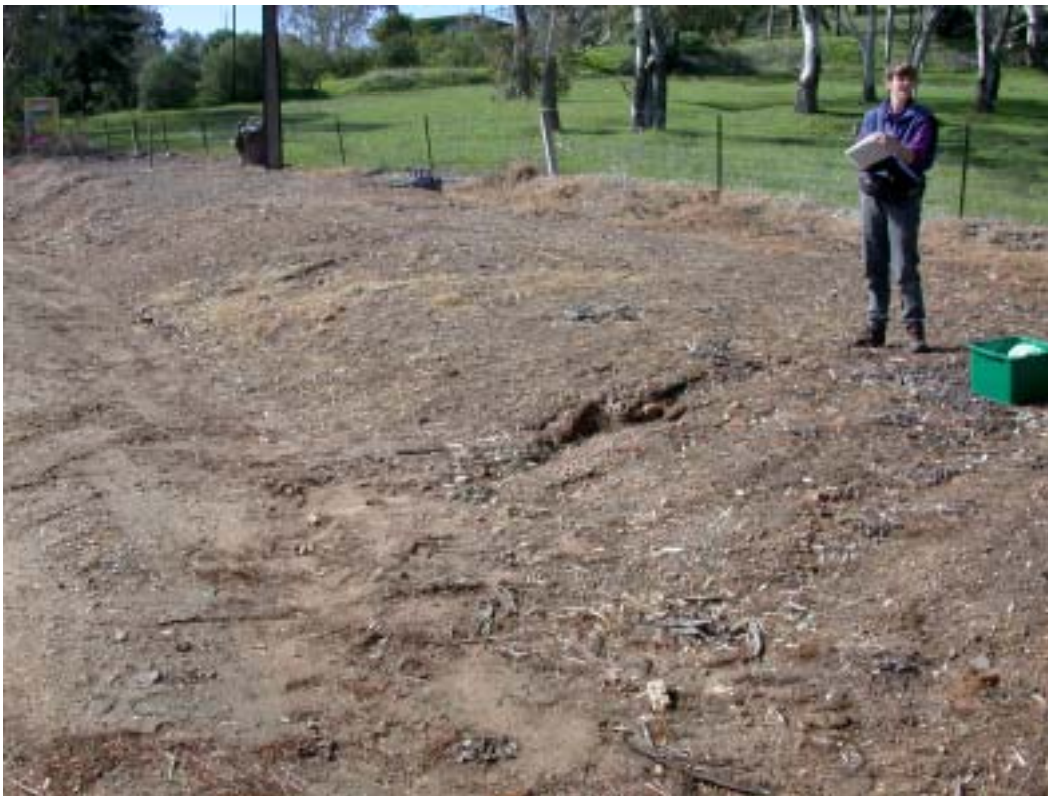
Plate 10 Roadside drain at Williamstown (Victoria Creek sub-catchment)

On 5 September 2002, trace sampling was performed in the Victoria Creek sub-catchment at the sites shown in Figure 8. Soil sampling results are shown in Table 16. Plate 10 depicts a section of roadside drain in the Victoria Creek sub-catchment at Williamstown that had been sprayed with Simazine. Note the contrast between vegetation in the paddock and on the roadside.
