# QUARTERLY AMBIENT MONITORING PROGRAMME FOR BIRKENHEAD WORKS

COMPLIANCE DATE: 31/01/17 - Quarter 4, 2016

EPA Licence 1126

**Licensed site:** Adelaide Brighton Cement, Birkenhead Works  
 62 Elder Road, Birkenhead, SA 5015

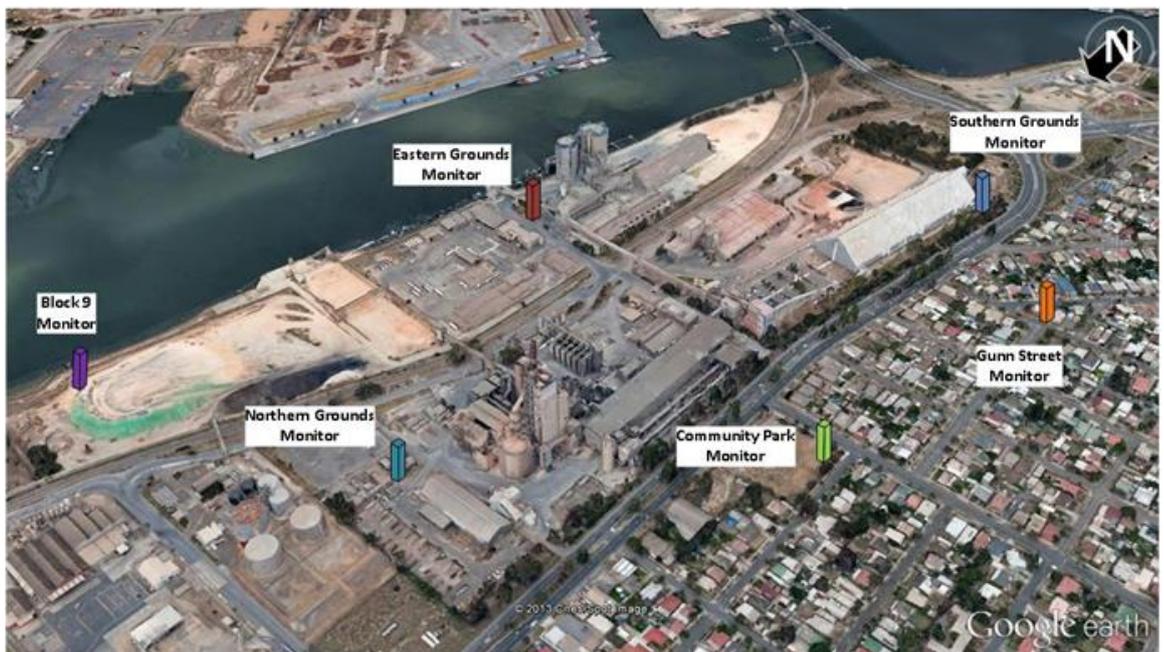
Sampling locations are indicated by colour coded dots on the above map.

**NB:** Four sampling points are located on the Birkenhead Works site; the other sampling points are in the community (corner of Gunn/ Well streets and Community Park).

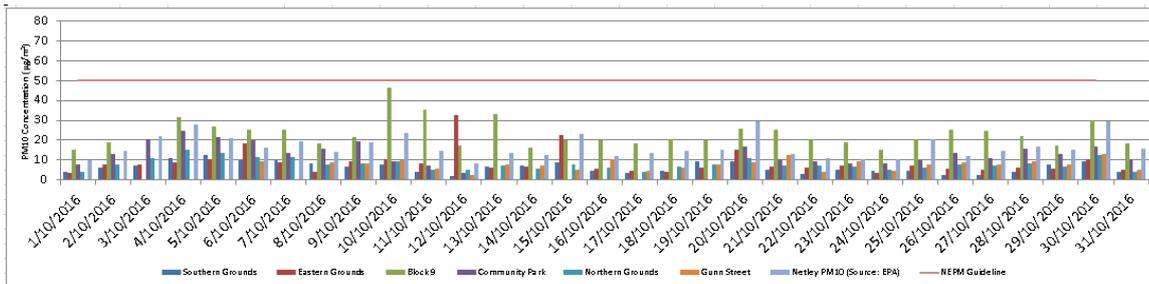
### October 2016

All monitors displayed similar PM10 trends throughout the month with no exceedances of the daily average of 50 ug/m<sup>3</sup>. The Block 9 Monitor, located adjacent to limestone reserve stockpile and the port river, displayed comparatively higher levels of PM10.

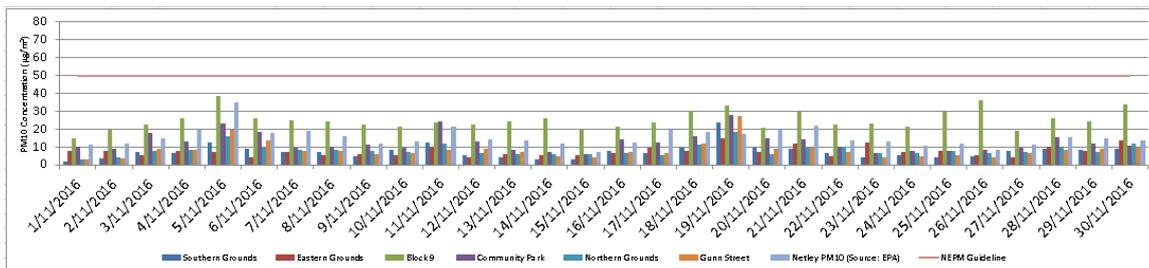
### November 2016

All monitors displayed similar PM10 trends throughout the month with nothing exceeding the daily average of 50 ug/m<sup>3</sup>. The Block 9 Monitor displayed comparatively higher levels of PM10.

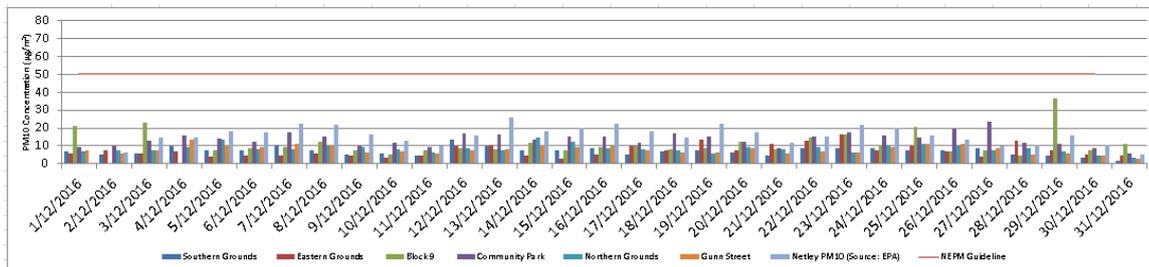
### December 2016

All monitors displayed similar PM10 trends throughout the month with nothing exceeding the daily average of 50 ug/m<sup>3</sup>.

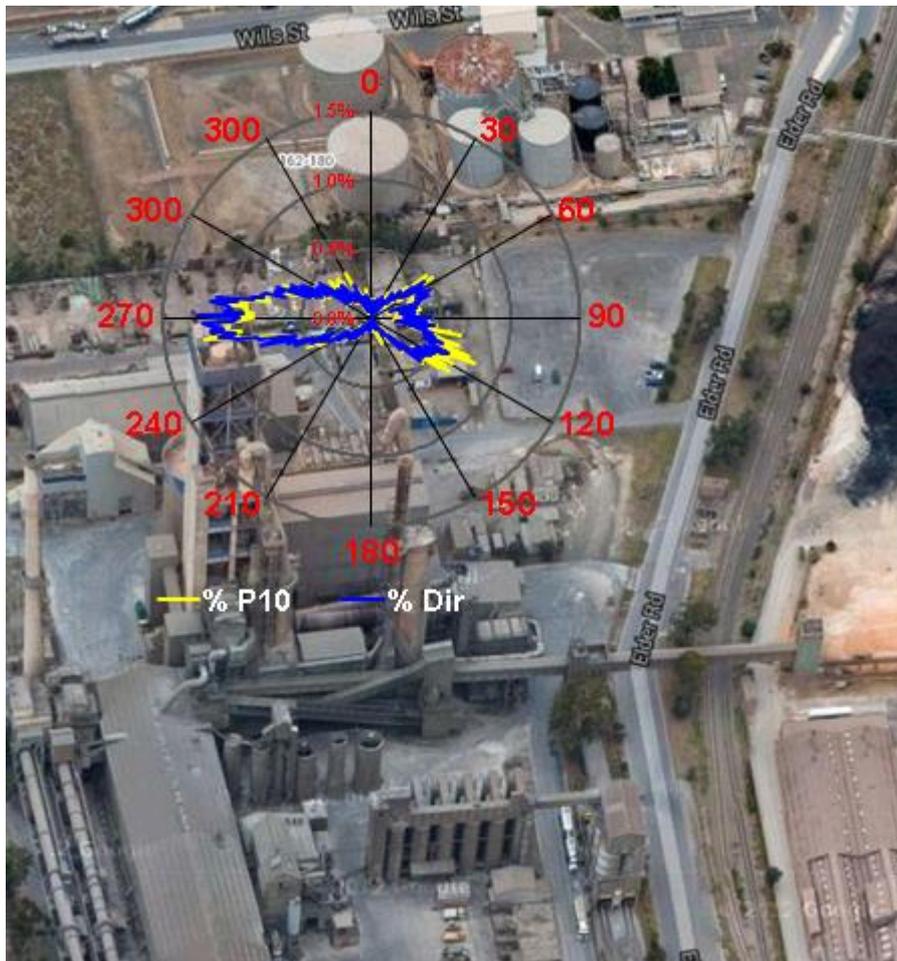
## Northern Grounds Monitor

The wind-rose implies that dominant winds are westerly and easterly. Higher proportions of PM10 levels relative to wind directions appear to be coming from the southeast. Possible sources could include stockpiles, truck and traffic movements. This process is managed by the constant application of water and a dust suppressant agent using a dedicated water cart.

Note: Limestone is pre wetted as it is transferred to Block 9, stockpiles are sealed and dust reducing polymers are applied to unsealed surfaces.

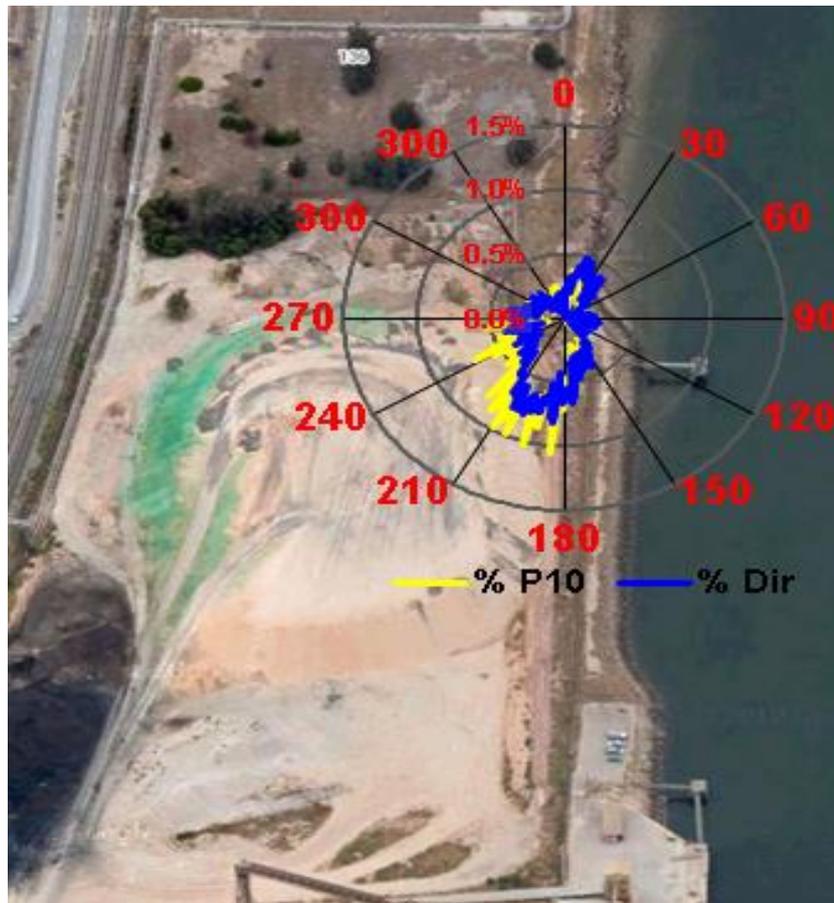
## Block 9 Monitor

The wind rose implies winds are predominately from the south and north.

The wind rose of PM10 suggests fugitive dust originates from a southwest direction towards Port River. Possible contributors may include heavy traffic and material movement in that area.

Actions taken to minimise dust in this area, including: pre-wetting material at Block 9 before its transferred to main stockpile, regular addition of a dust suppressant sealant and sprays (both at Klein Point and Birkenhead), regular wetting with water and polymer sealing of unsealed road and stockpile surfaces.

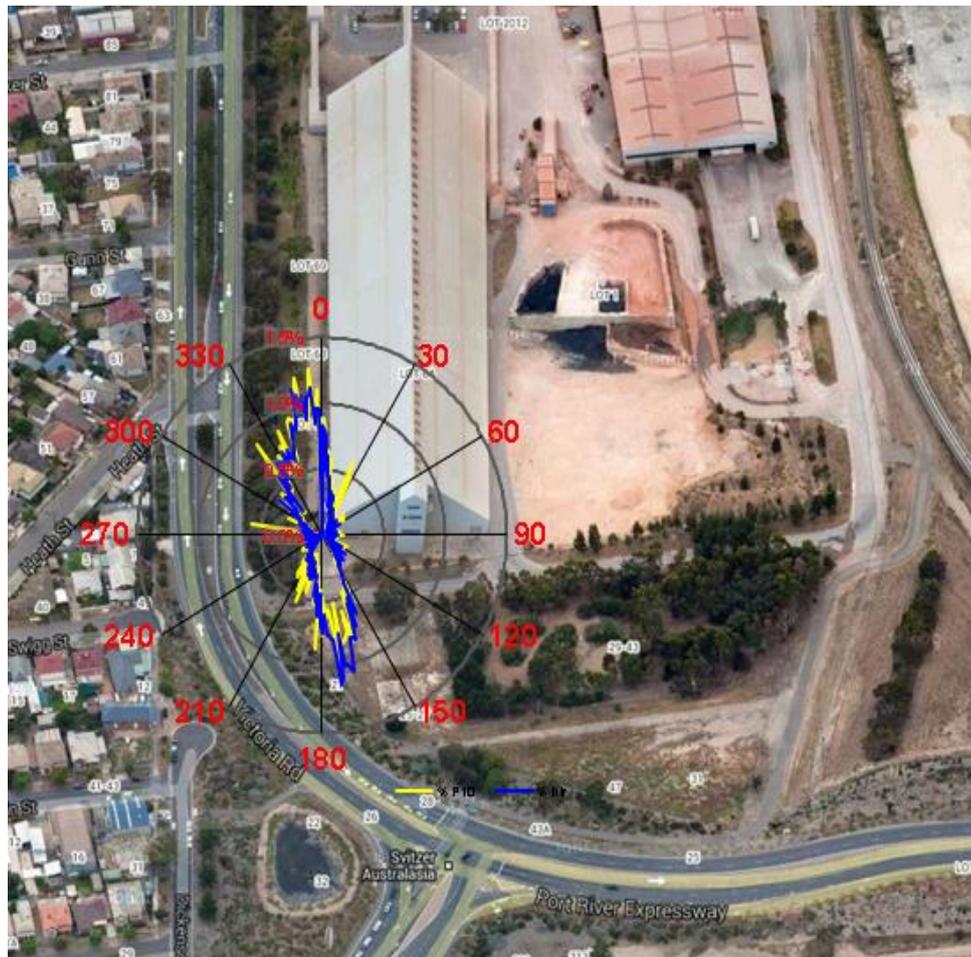
## Southern Grounds Monitor

The wind rose implies that prevailing winds originated from a north and south. There were no significant events observed on this monitor in this quarter.

Improvements in the area include: the installation of the bunker canopy system covering the Materials Management (MM) stockpile area and the foam dust suppression system on the unloading hopper, both environmental improvement programme initiatives.

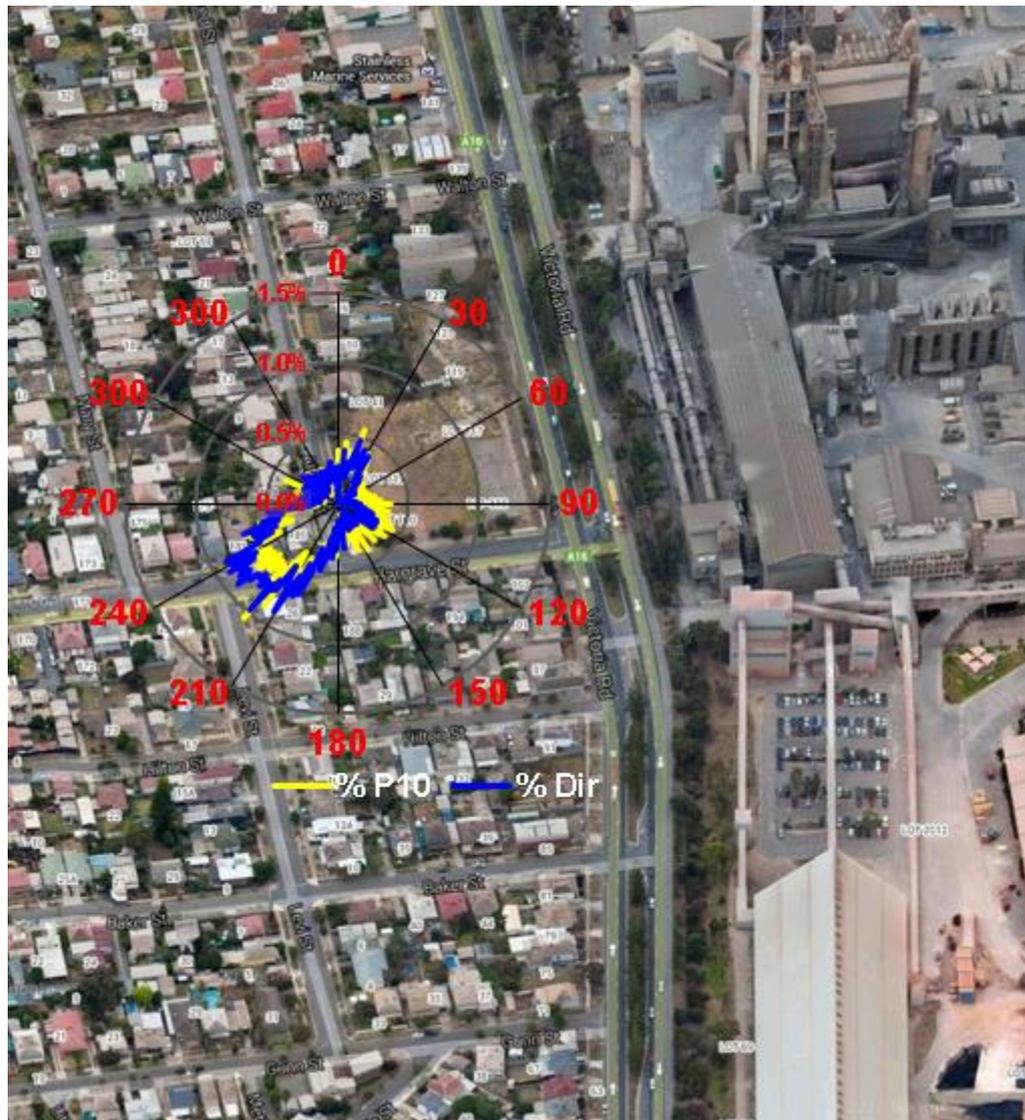
## Community Park Monitor

The wind rose implies winds prevailing from all directions but predominantly from the southwest. Higher proportions of PM<sub>10</sub> levels in comparison to wind direction originate from an easterly direction.

Possible contributors may include activities around the limestone conveying system/activities, traffic movement at Victoria road/Hargrave Street, council/construction works near Hargrave Street directly adjacent to the monitor and large civil and infrastructure works on Victoria road directly adjacent monitor.

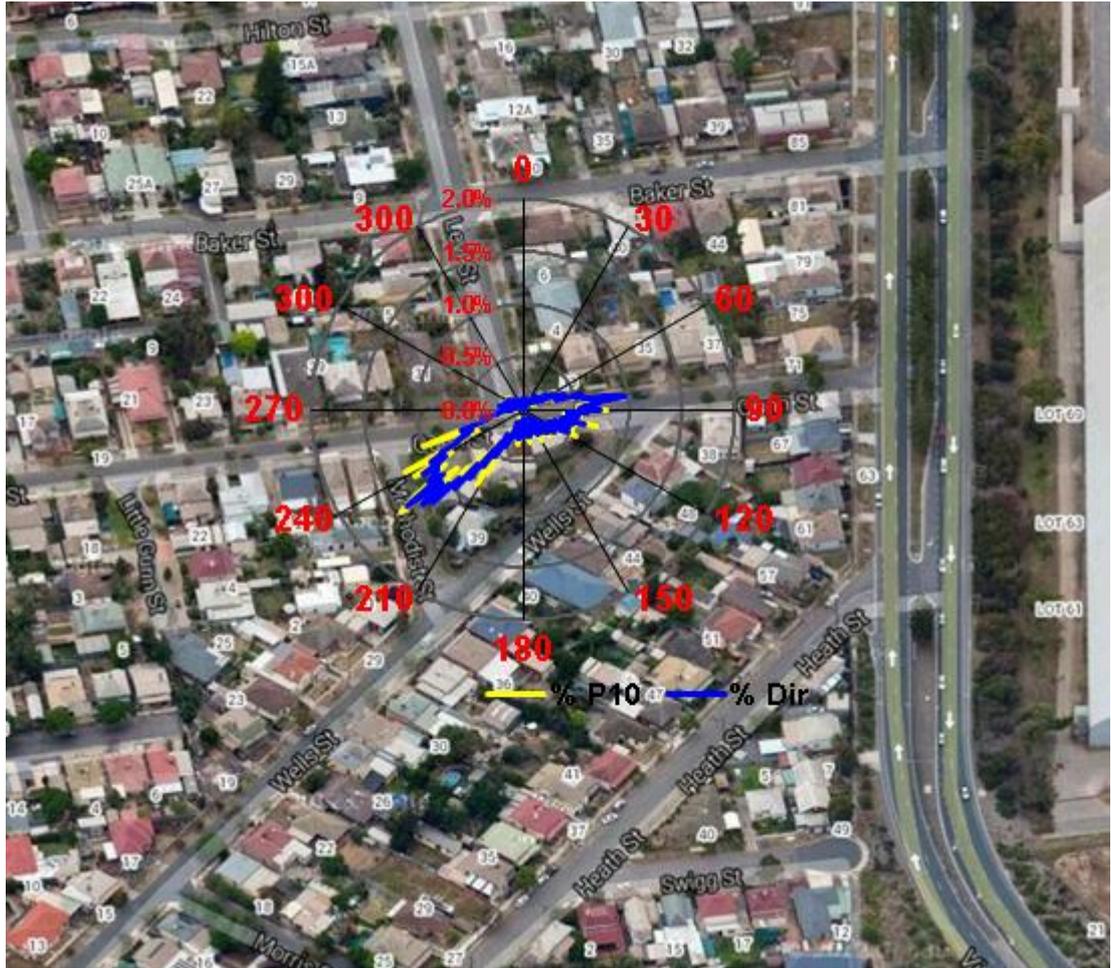
## Gunn Street Monitor

The wind rose implies prevailing winds were southwesterly and easterly. The PM10 trend on the diagram implies PM10 dust originating from predominantly an western direction. Considering the PM10 originates from a number of directions, the loads could be related to localised events including traffic in the area. However, as shown earlier in the 24 hour average graphs, the average PM10 levels from this location are low.

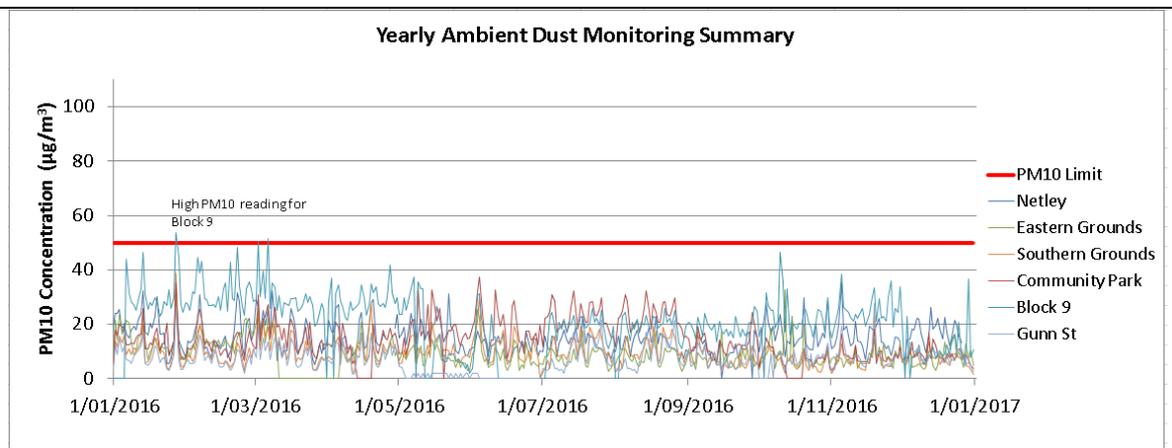
Overall progress of ambient PM10 tracking of all site and EPA Netley monitor was graphed to observe levels and trends over the past year.
