QUARTERLY AMBIENT MONITORING PROGRAMME FOR BIRKENHEAD WORKS

COMPLIANCE DATE: 30/04/17 - Quarter 1, 2017

EPA Licence 1126

Licensed site: Adelaide Brighton Cement, Birkenhead Works
 62 Elder Road, Birkenhead, SA 5015

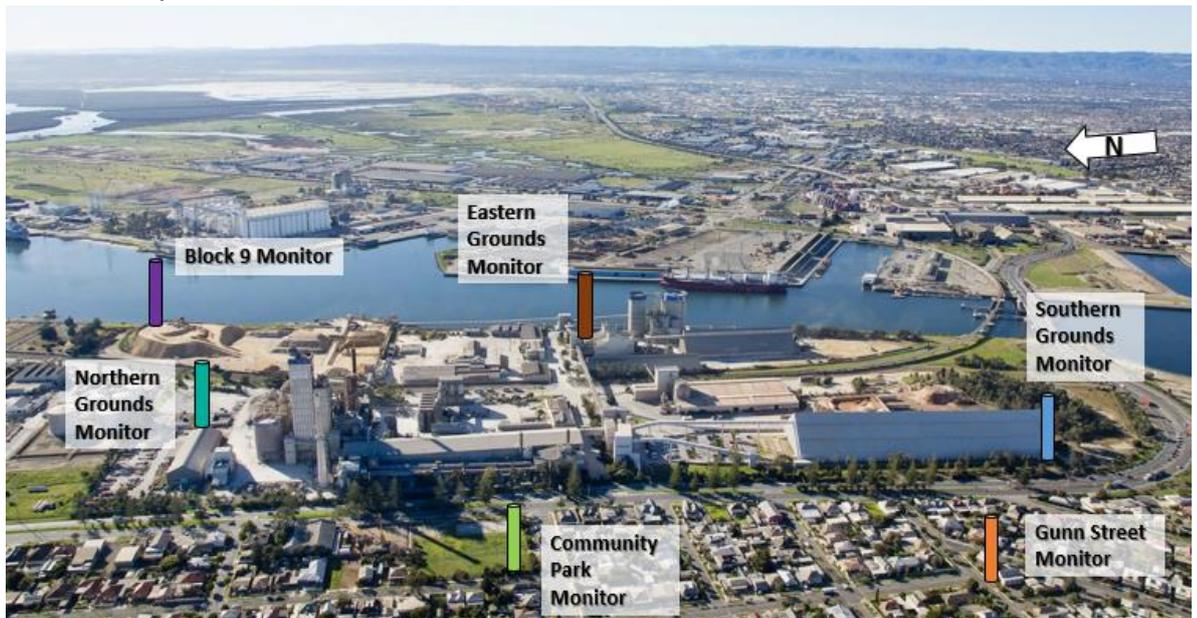
- *Map showing sampling locations, major infrastructure, sensitive environmental receptors, and north arrow*

Sampling locations are indicated by colour coded dots on the above map.

NB: Four sampling points are located on the Birkenhead Works site; the other sampling points are in the community (corner of Gunn/ Well streets and Community Park).

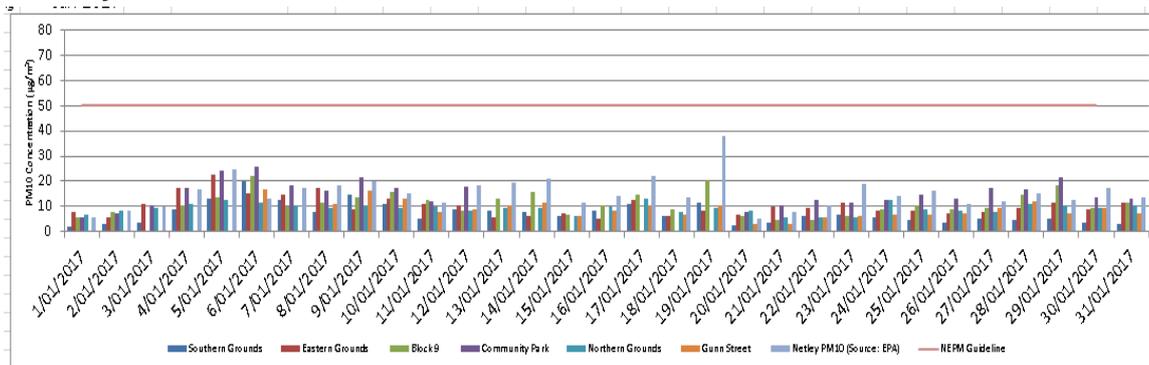
January 2017

All monitors displayed similar PM10 trends throughout the month with nothing exceeding the daily average of 50 ug/m³.

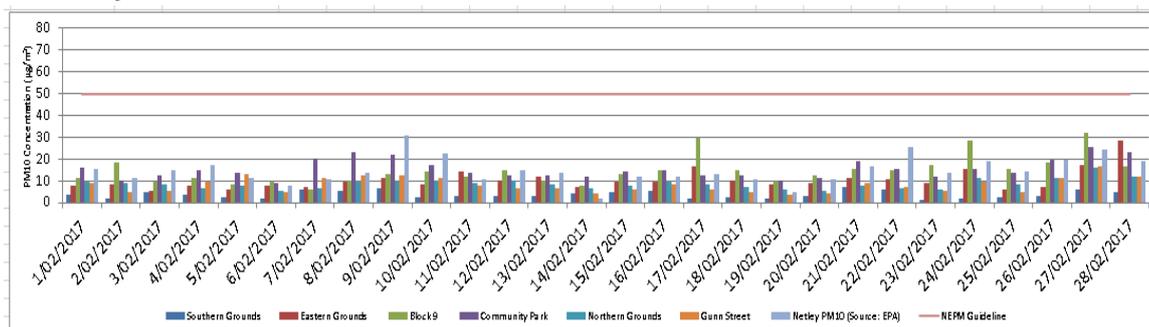
February 2017

All monitors displayed similar PM10 trends throughout the month with nothing exceeding the daily average of 50 ug/m³.

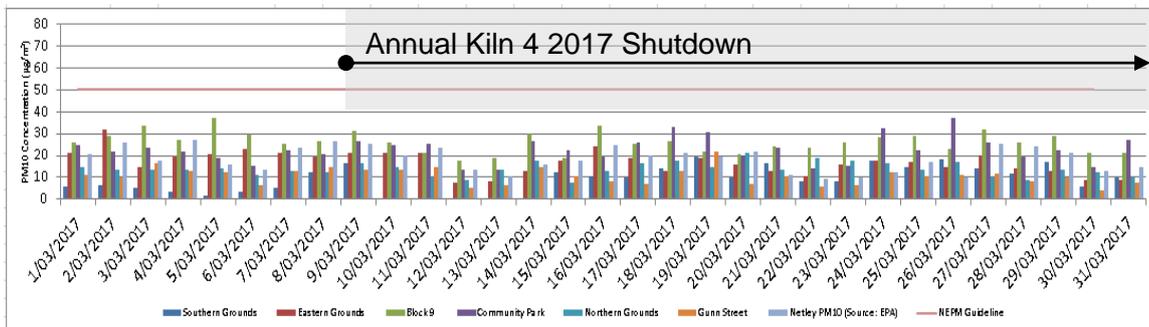
March 2017

All monitors displayed similar PM10 trends throughout the month with nothing exceeding the daily average of 50 ug/m³.

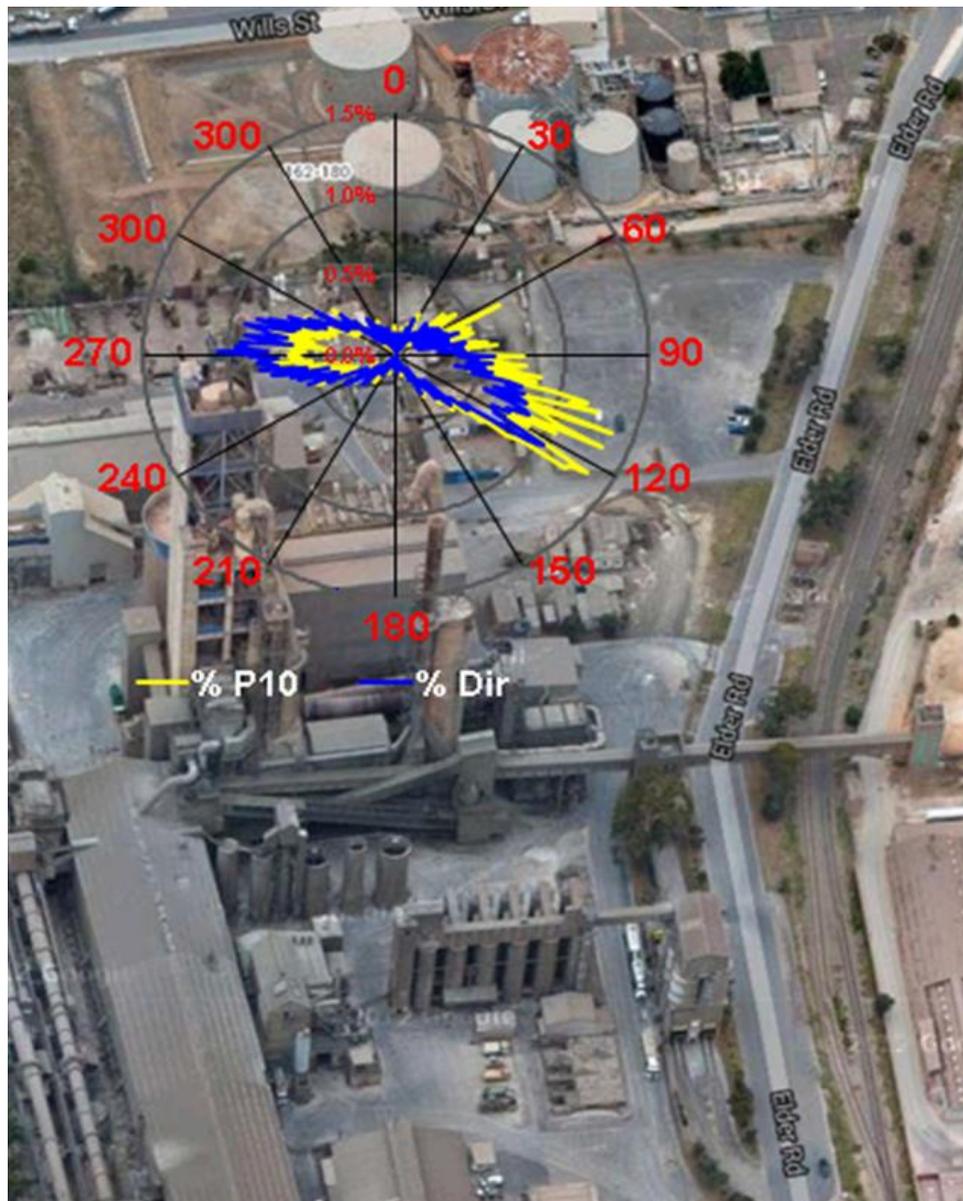
Northern Grounds Monitor

The wind-rose implies that dominant winds are westerly and easterly. Higher proportions of PM10 levels relative to wind directions appear to be coming from most notably the southeast. Possible sources could include stockpiles, truck and traffic movements. This process is managed by the constant application of water and a dust suppressant agent using a dedicated water cart.

Note: Limestone is pre wetted as it is transferred to Block 9, stockpiles are sealed and dust reducing polymers are applied to unsealed surfaces.

Please Note: Yellow plots show the percentage of PM10 whereas blue plots show the percentage of winds travelling from a specific direction. It is important to note that the percentages listed in these graphs are relative values and not absolute so they must not be compared quantitatively to other parameters.

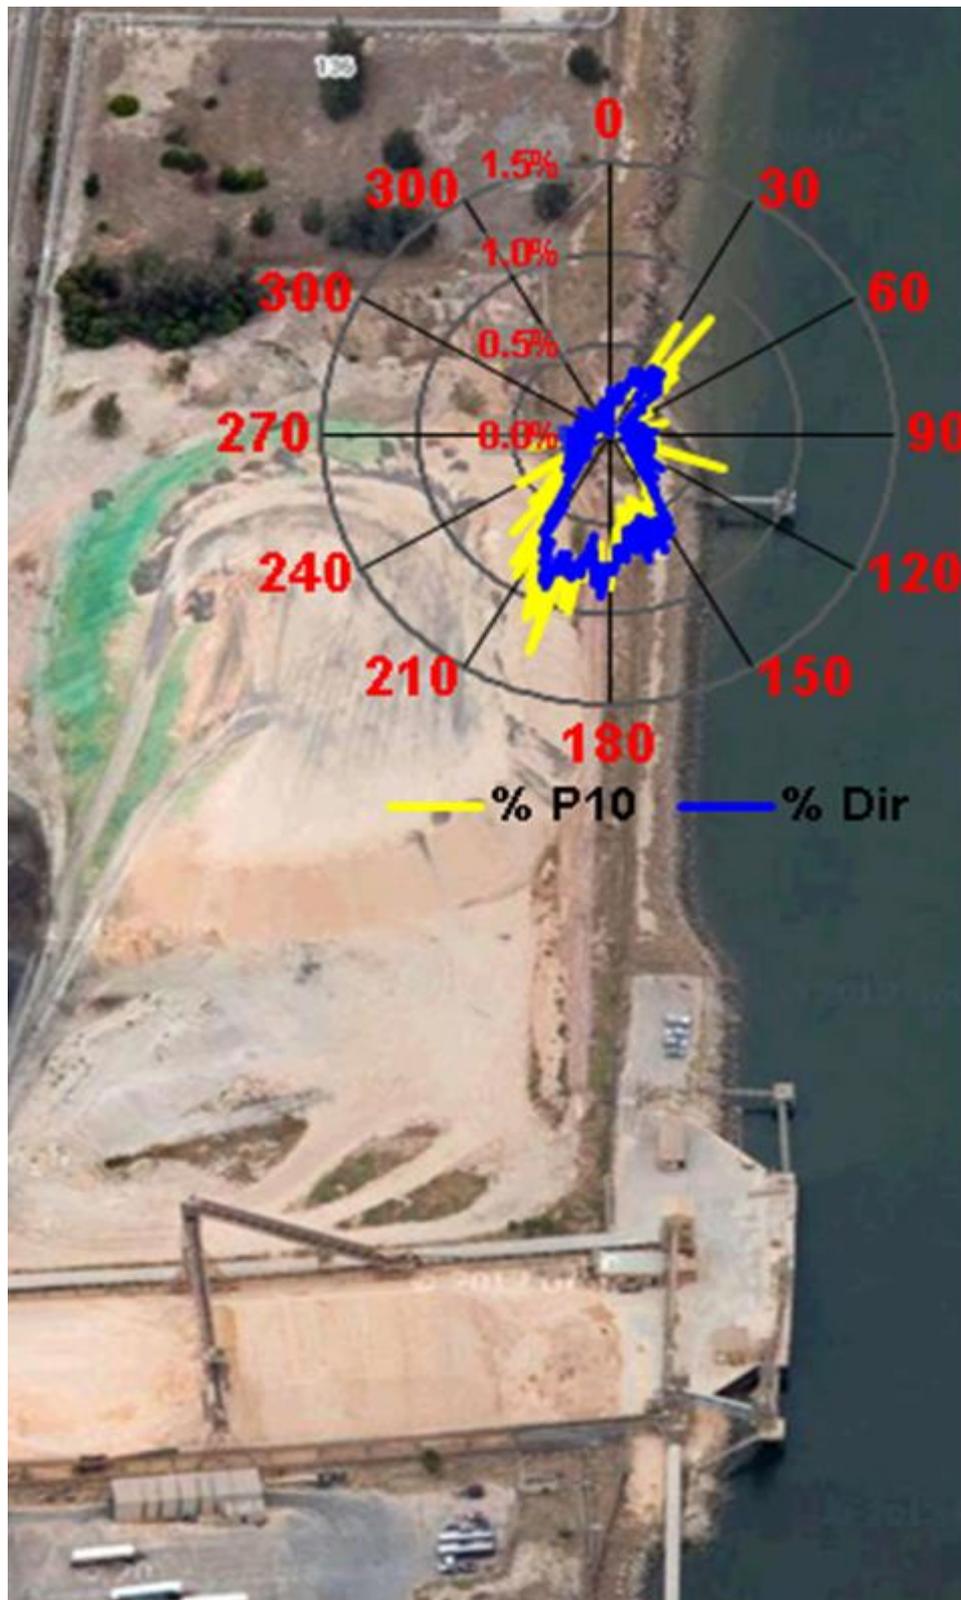
Block 9 Monitor

The wind rose implies winds are predominately from the south and north.

The wind rose of PM10 suggests fugitive dust originates from a southwest direction with spikes coming from the northeast and southeast.

Actions taken to minimise dust in this area, including: pre-wetting material at Block 9 before its transferred to main stockpile, regular addition of a dust suppressant sealant and sprays (both at Klein Point and Birkenhead), regular wetting with water and polymer sealing of unsealed surfaces.

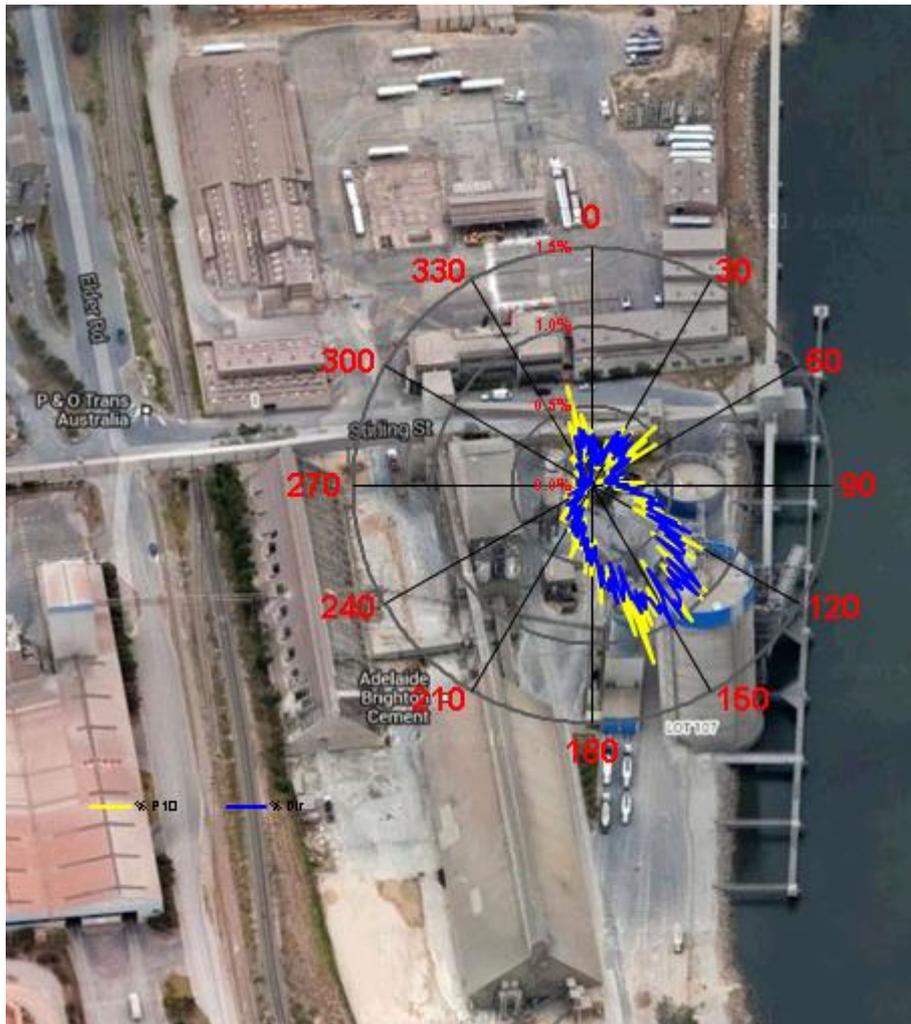
Eastern Grounds Monitor

The wind rose implies that prevailing winds originated from a north and south of the adjacent truck wash.

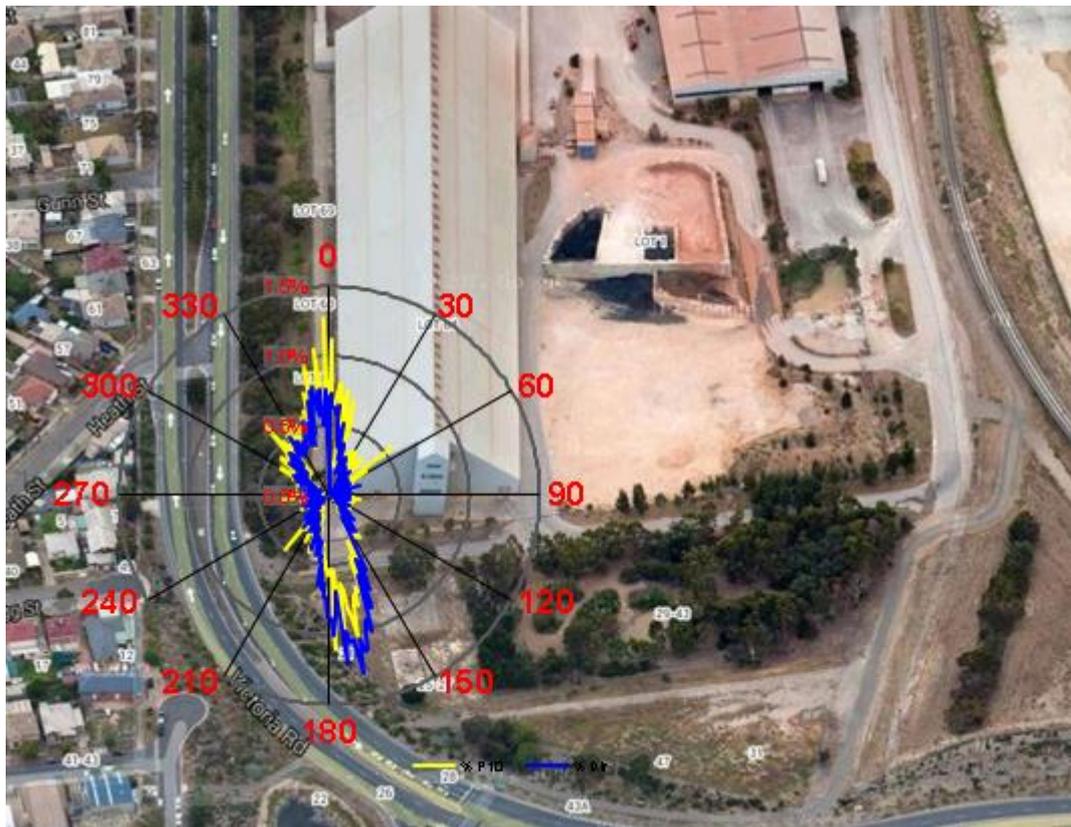
Southern Grounds Monitor

The wind rose implies that prevailing winds originated from a north and south.

Improvements in the area include: the installation of the canopy system covering the Materials Management (MM) stockpile area and the foam suppression system on the loading hopper (both EIP projects).

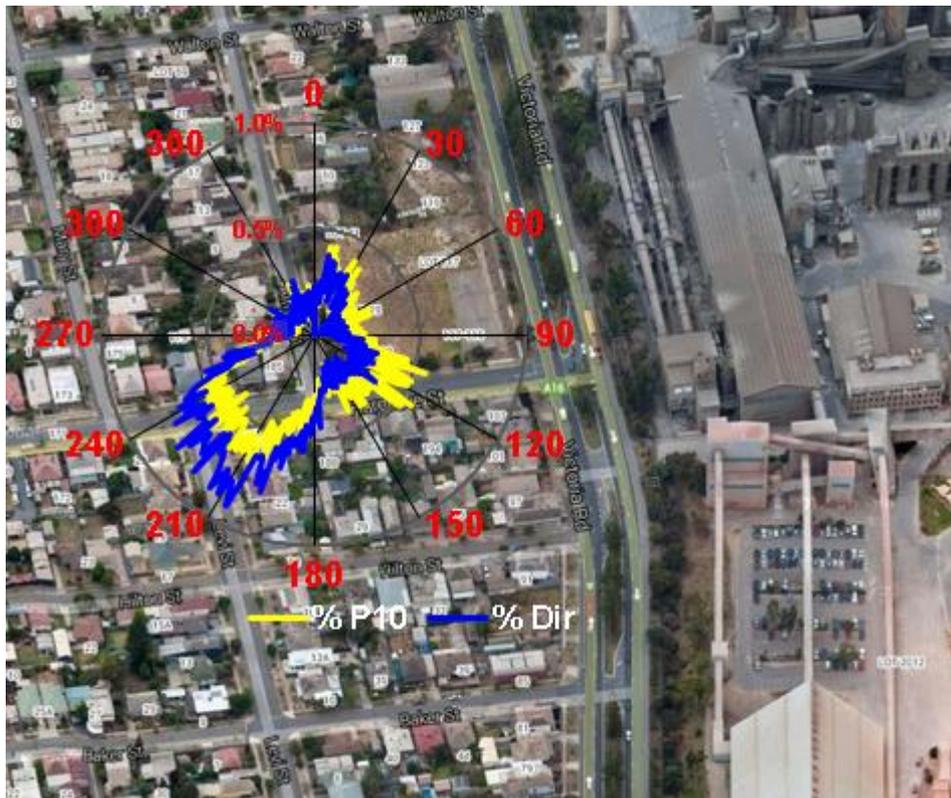
Community Park Monitor

The wind rose implies winds prevailing from all directions but predominantly from the southwest. Higher proportions of PM10 levels in comparison to wind direction originate from an easterly direction.

Possible contributors may include activities around the limestone conveying system, traffic movements along Victoria Road/Hargrave Street, council/construction works near Hargrave Street directly adjacent to the monitor.

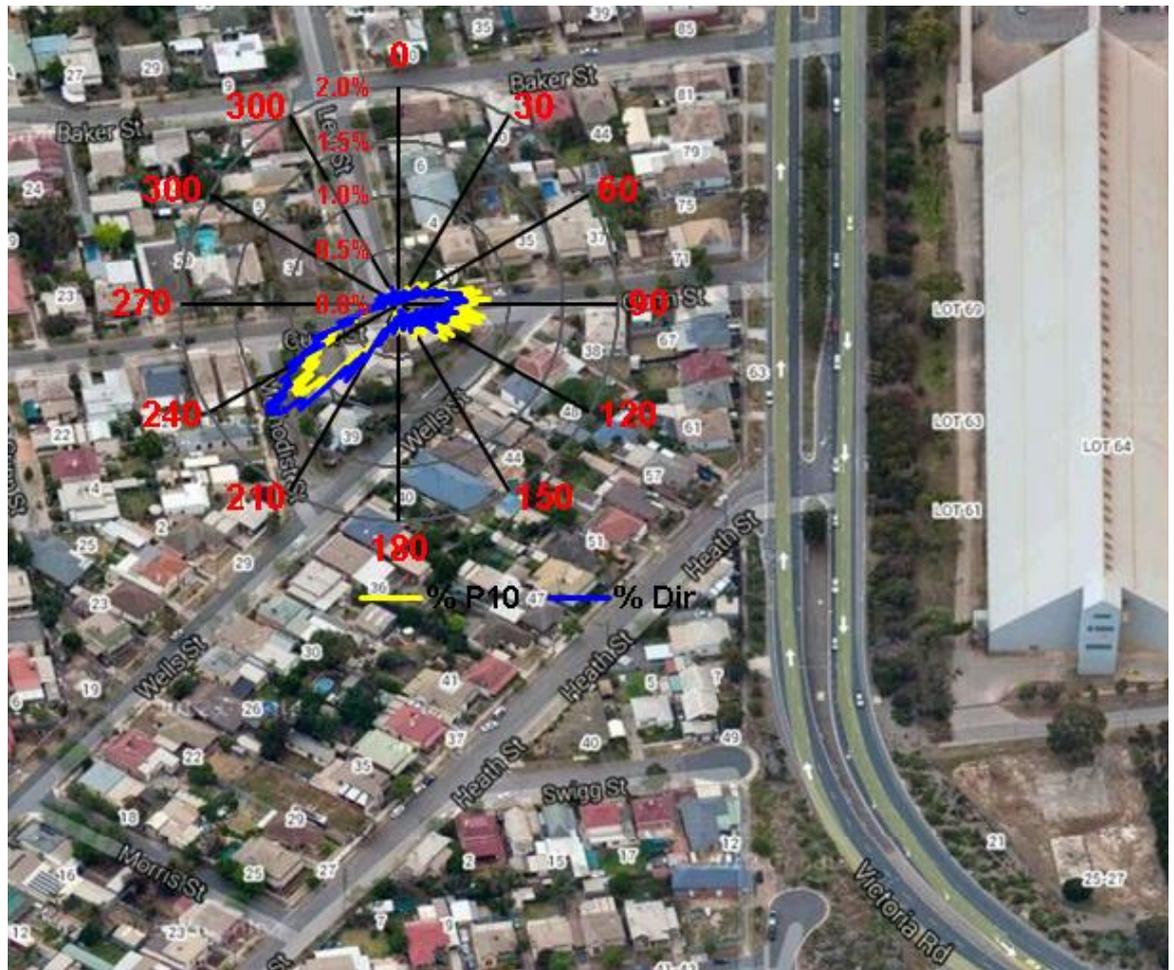
Gunn Street Monitor

The wind rose implies prevailing winds were southwesterly and easterly. The PM10 trend on the diagram implies PM10 dust originating from a predominantly eastern and southwesterly direction. The PM10 loads could be related to localised events including traffic in the area.

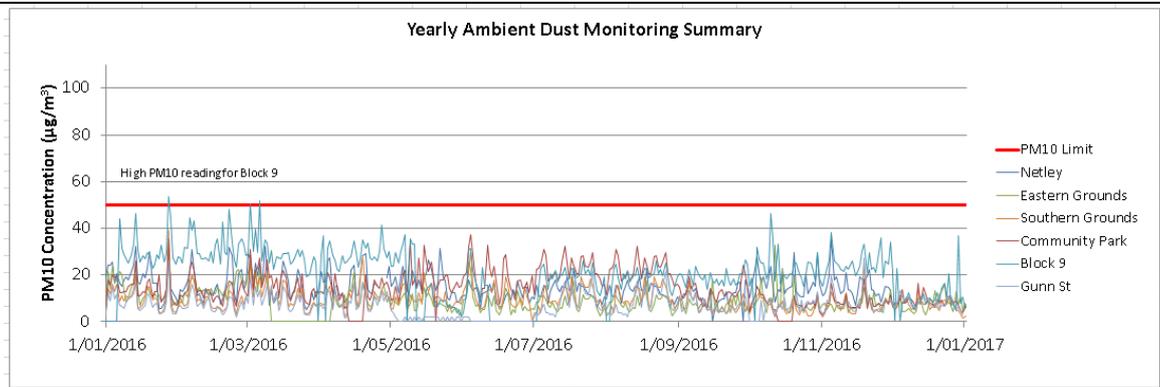
Overall progress of ambient PM10 tracking was graphed to observe what happened to the plant over the past year.

From January 2016, PM10 levels from all site monitors are following a very consistent trend.

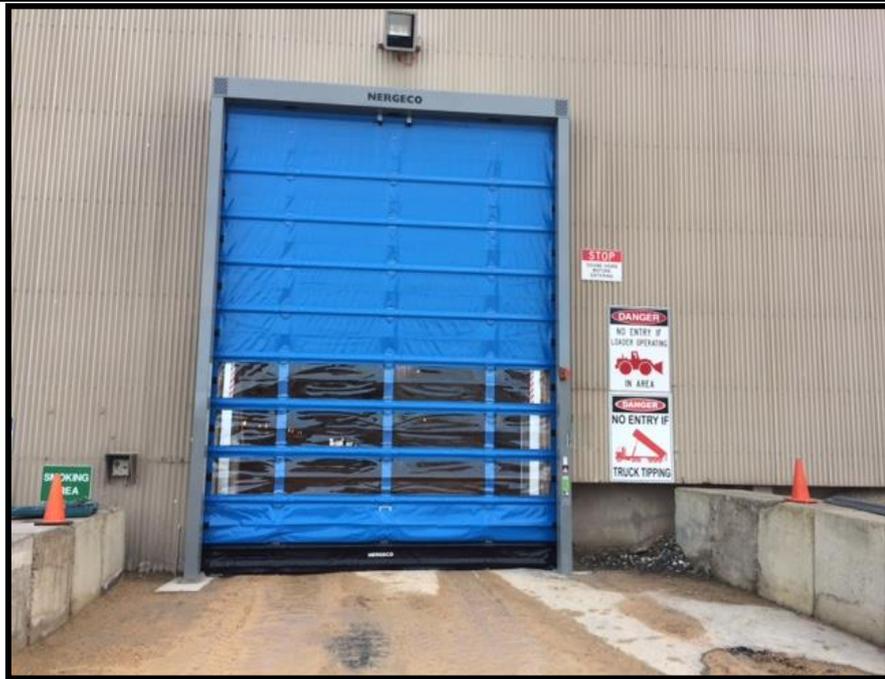
- Installation of a large rapid raise door was installed on the southern side of the Wallaroo raw material storage shed. This type of door closes automatically and quickly to minimise fugitive dust excursions.

Figure 1 - Rapid Raise door - Wallaroo shed
