**SOIL INVESTIGATION AT  
FORMER LIGHTBURN FACTORY IN  
NOVAR GARDENS, SOUTH AUSTRALIA**

*MAY 2008*

**Soil investigation at former Lightburn factory in Novar Gardens, South Australia**  
Author: Carlo Castello

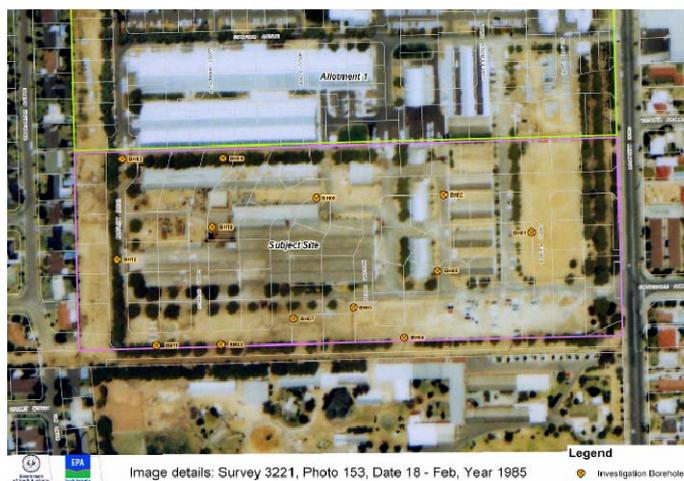
Figure 2 Stage 1 borehole locations (10/8/2006)

Stage 1 soil investigations comprised the drilling of 13 soil bores (BH01–BH13) on council land (footpaths, cul-de-sacs and road verges) across the subject site. By overlaying the current residential plans over historical aerial photographs, drilling locations were selected based on areas where any potential disposal of the prescribed wastes could most likely have occurred (eg the rear of former site buildings).

An overlay of current residential allotments over the 1985 aerial photo for the Lightburn site, and Stage 1 borehole locations are displayed in Figure 2.

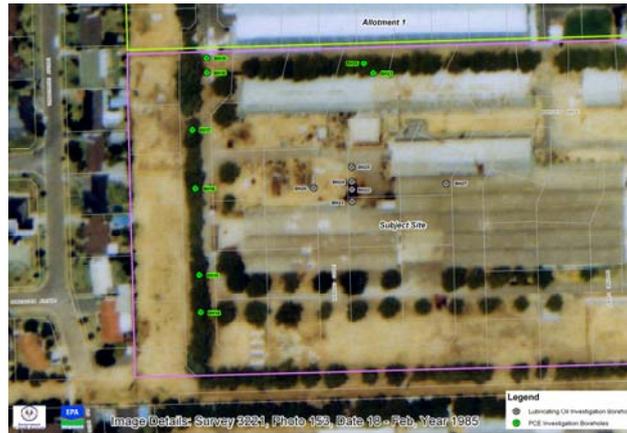
Figure 3 Stage 2 borehole locations (22/3/2007)

- drilling of surface and near-surface fill material in the cul-de-sac and road verge areas at eight locations (BH14–BH21)
- drilling from surface into natural soils at six locations (BH22–BH27).

Boreholes BH14 to BH21 were drilled in order to further characterise fill materials where PCE had previously been identified.

Boreholes BH22 to BH27 were drilled to delineate the extent of TPH previously identified in the footpath of Henning Court. Five boreholes were drilled on Henning Court and one borehole was drilled on Bartlett Drive.

Stage 2 drilling locations are displayed in Figure 3.
