ENVIRONMENT PROTECTION AUTHORITY

Ash Storage Area dust event (1st & 2nd January 2017)

24th February 2017

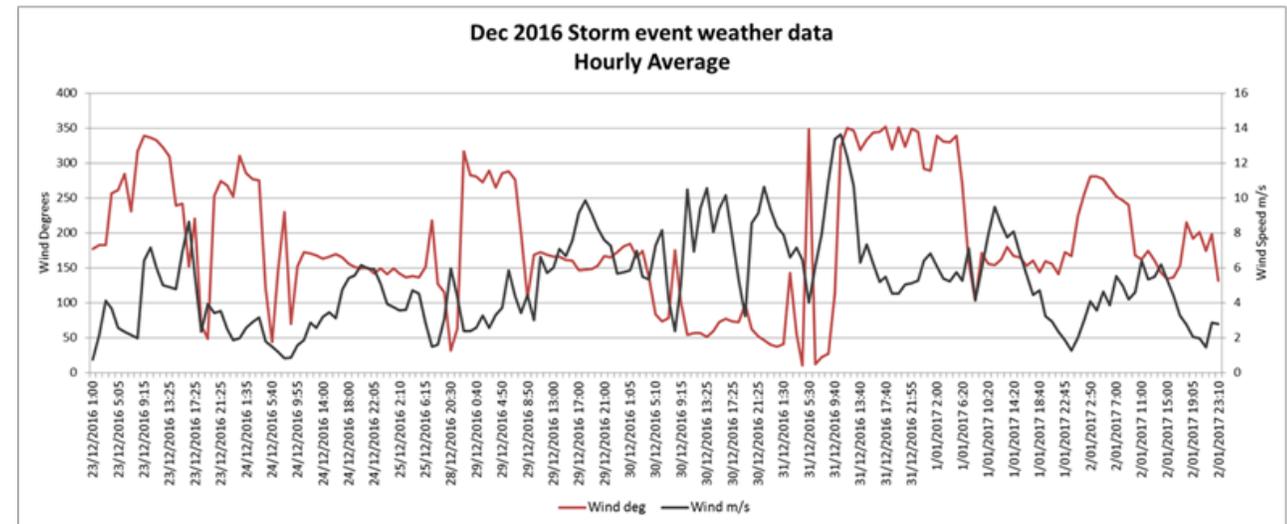
'59.6 mm of rainfall was recorded from midnight 26th to midnight 28th December 2016 at Port Augusta Aerodrome. This amount on that timeframe is close to a 20% Annual Exceedance Probability (about a 1 in 5 year Annual Recurrence Interval (ARI)) for Port Augusta.

Most of the rainfall during the 28th December 2016 fell in a 30 minute period at about 6pm from severe and localised thunderstorm activity. 24.7 mm was recorded at Port Augusta Aerodrome in the 30 minutes from 5:55pm to 6:25 pm. This amount over that timeframe has between a 10 and 5% AEP (about 20 to 10 year ARI) for Port Augusta. Consistent with this is that looking at all available 30 minute rainfall data from Port Augusta (available from 2010), this was the highest 30 minute rainfall amount on record. There is some indication from radar imagery through this event that rainfall intensity may have been higher than was recorded at Port Augusta Aerodrome on the eastern side of Port Augusta as the thunderstorm activity developed and moved and eastwards' (BOM, 2017).

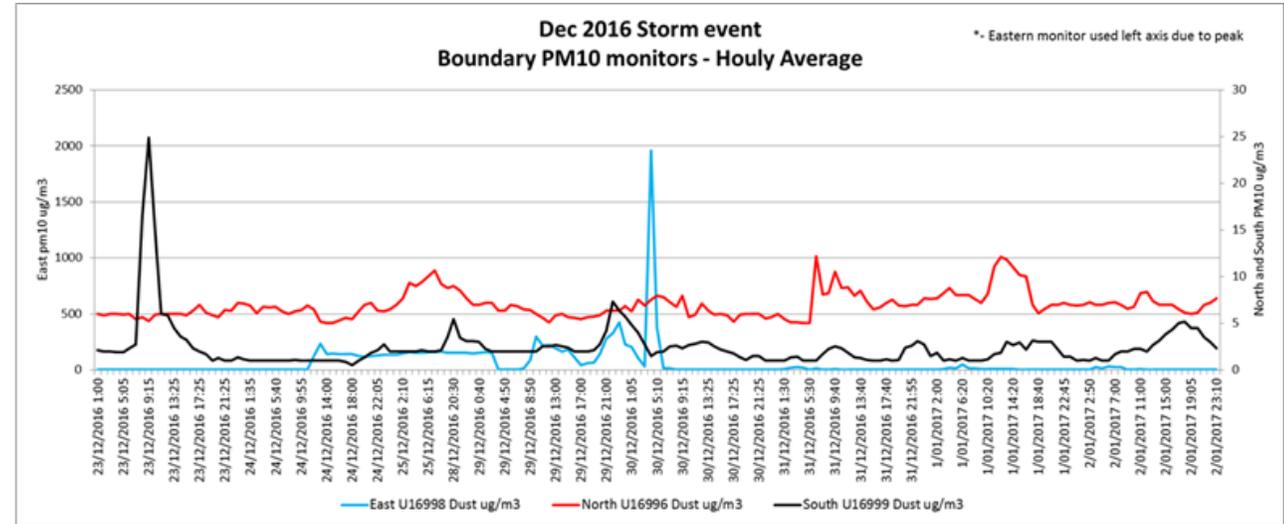
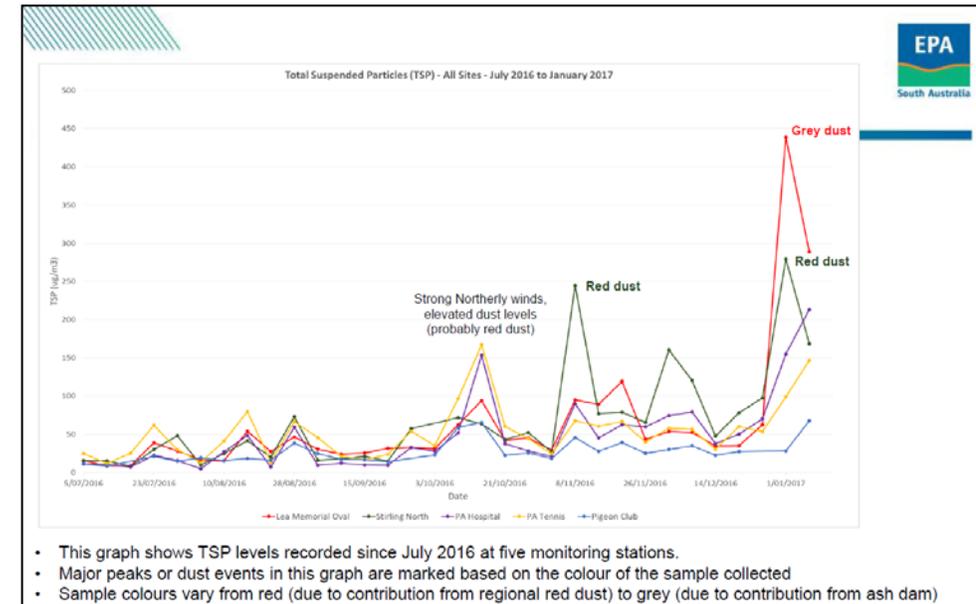
The three new Met-One PM10 Dust Monitors around the Ash Storage Area were in operation during this period. The southern monitor was subjected to harsh conditions providing erroneous results which were reviewed for QA/QC by the manufacturer/supplier and declared unusable.

On the 1st January 2017 the Total Suspended Particulate (TSP) monitoring at Lea Memorial Oval indicated 438µg/m³ and Stirling North at 279µg/m³. The Stirling North filter paper was coloured red (indicating a strong contribution from regional dust) whereas the Lea Memorial Oval was coloured grey (indicating a potential contribution from the Ash Storage Area).
