2 Renmark to border LAP area assessment

2.1 Description of the area

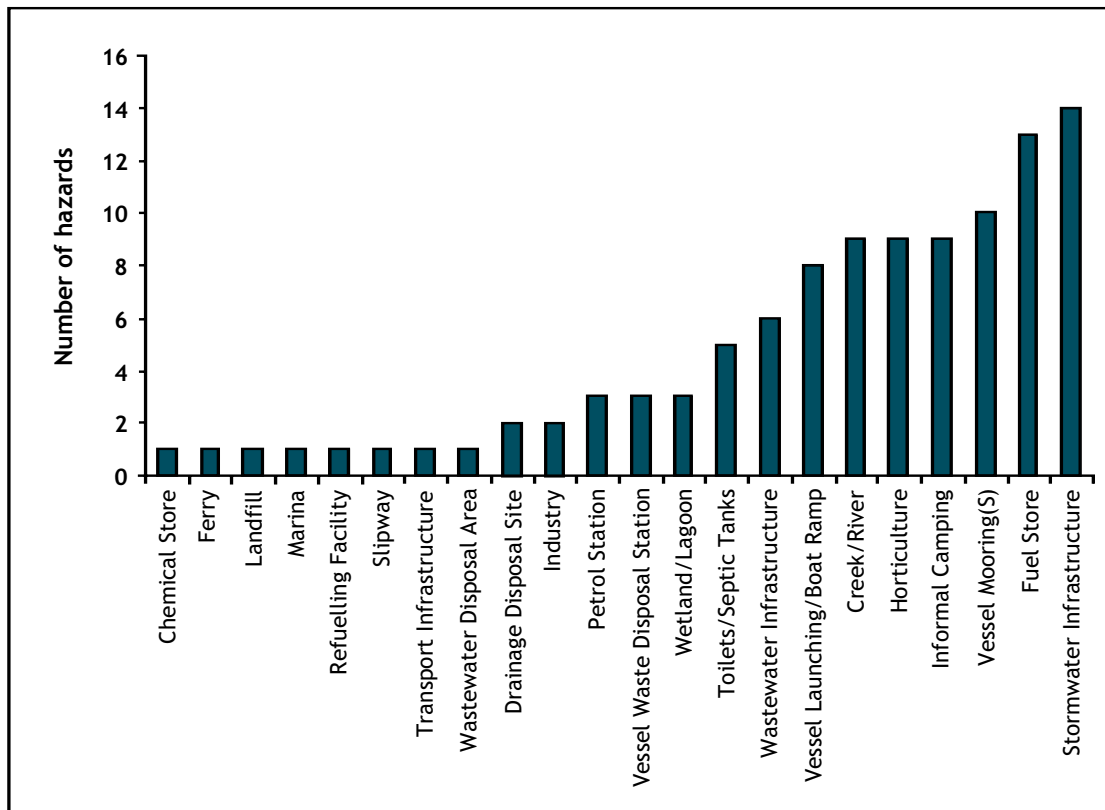
A total of 141 hazards were identified in the Renmark to border LAP area. The highest frequency hazards were stormwater discharge points, diesel pump fuel stores, vessel moorings, informal camping areas (with no facilities), horticulture areas, and creeks and rivers (Figure 2.2).

Figure 2.2 Frequency of hazards to water quality, RB LAP area

Frequency (occurrence) does not necessarily indicate risk—a hazard may have a high frequency but a low risk. The cumulative impacts of low-risk activities will be considered and assessed as part of mitigation strategy development.

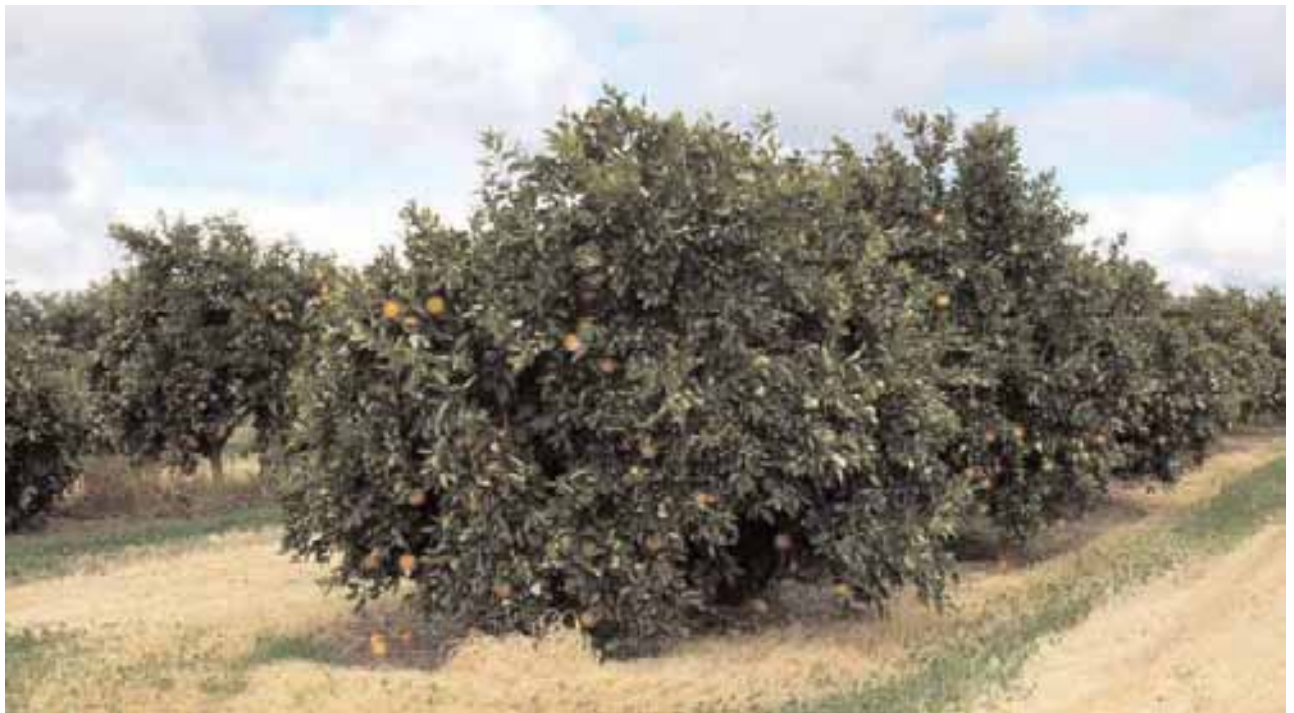
Figure 2.3 Example of hazard in the RB LAP area: irrigated horticultural area

Groundwater leakage from large horticultural/irrigation areas (Murtho, Chaffey, Simarloo, Renmark, Paringa, Pike) adjacent to the river made up most of the other moderate-high salinity risk ratings, and a pumped drainage discharge to Ral Ral Creek from Chaffey irrigation district also received a high-risk rating. Large areas of irrigated horticultural land adjacent to the river in the Renmark to Border LAP area are predominantly used to grow citrus fruit and grapes.

Several large horticulture areas (Murtho, Chaffey, Simarloo, Renmark, Paringa, Lyrup, Pike) received a high-risk ranking for leakage of nutrients through groundwater to the river as did some rivers and creeks (Ral Ral Creek, Pike River) that receive irrigation drainage and are permanently connected to the river. The disposal of drainage on the floodplain from Lyrup irrigation area was also assessed as a high risk. Several other horticultural areas received a moderate risk ranking. There was some uncertainty to these assessments due to a lack of monitoring data (other than for salt). The large-scale saline inputs that have been noted from this region led to the assumption that nutrients (in particular nitrate) would also be a significant input. Elevated levels have been reported under irrigation areas in other areas of South Australia (eg Northern Adelaide Plains, EPA 2003a).

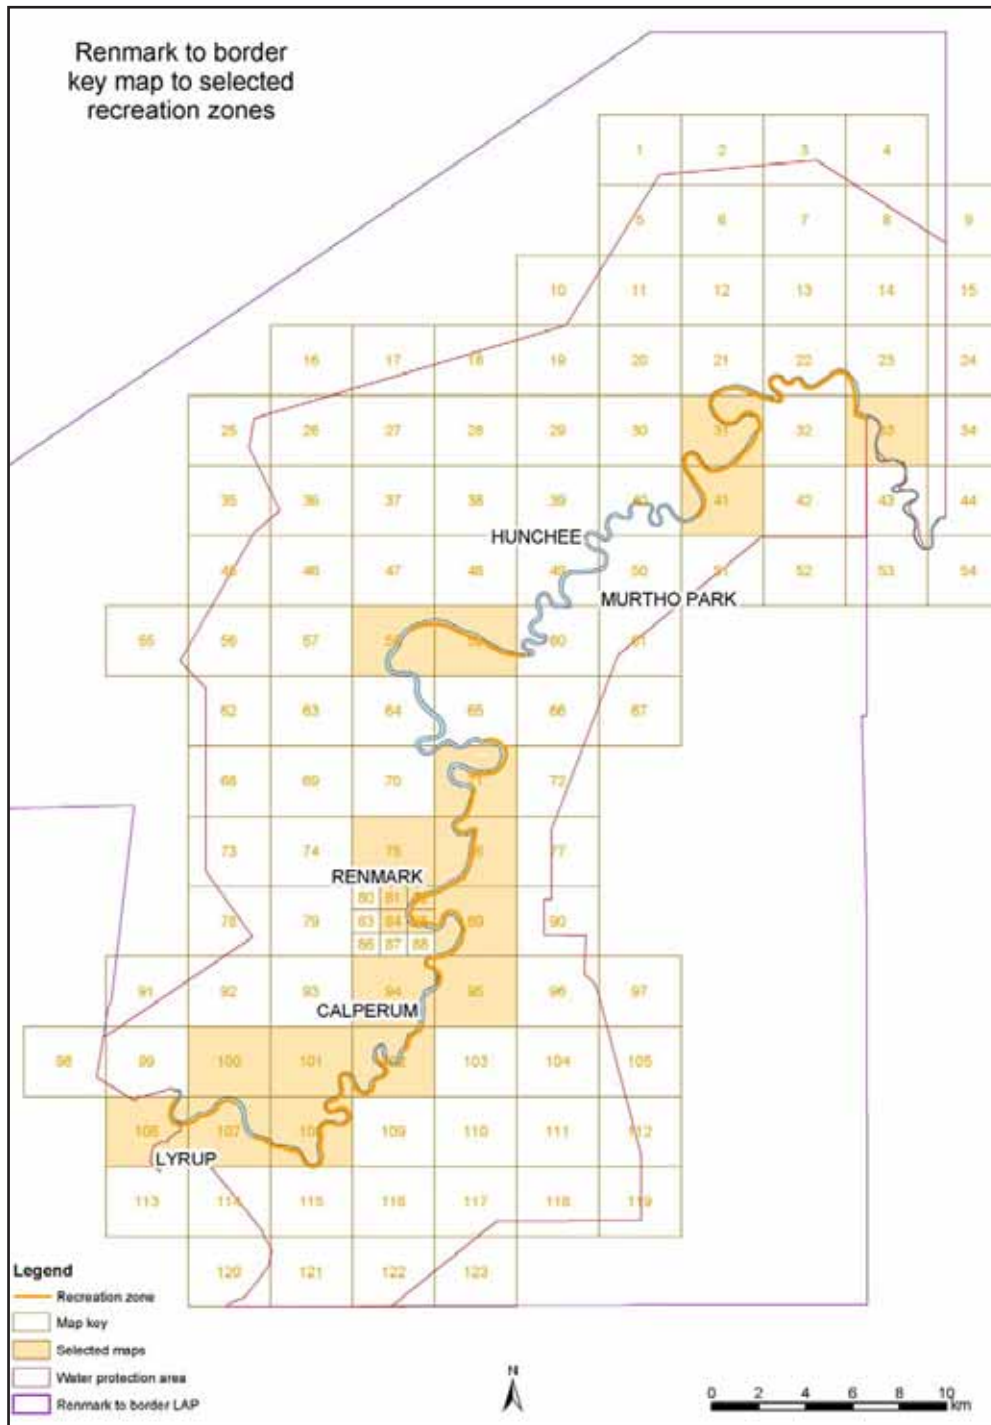
Figure 2.6 is the key map for risks to the recreational environmental value in the RB LAP area. The attached DVD has individual maps numbered according to the key map.

Note: only hazards identified in the shaded areas were assessed for risk to recreation

Figure 2.6 Key map for recreation zones, RB LAP area

Seven recreational zones were identified in the RB LAP area:
