3 Berri-Barmera and Loxton-Bookpurnong LAP areas assessment

3.1 Description of the area

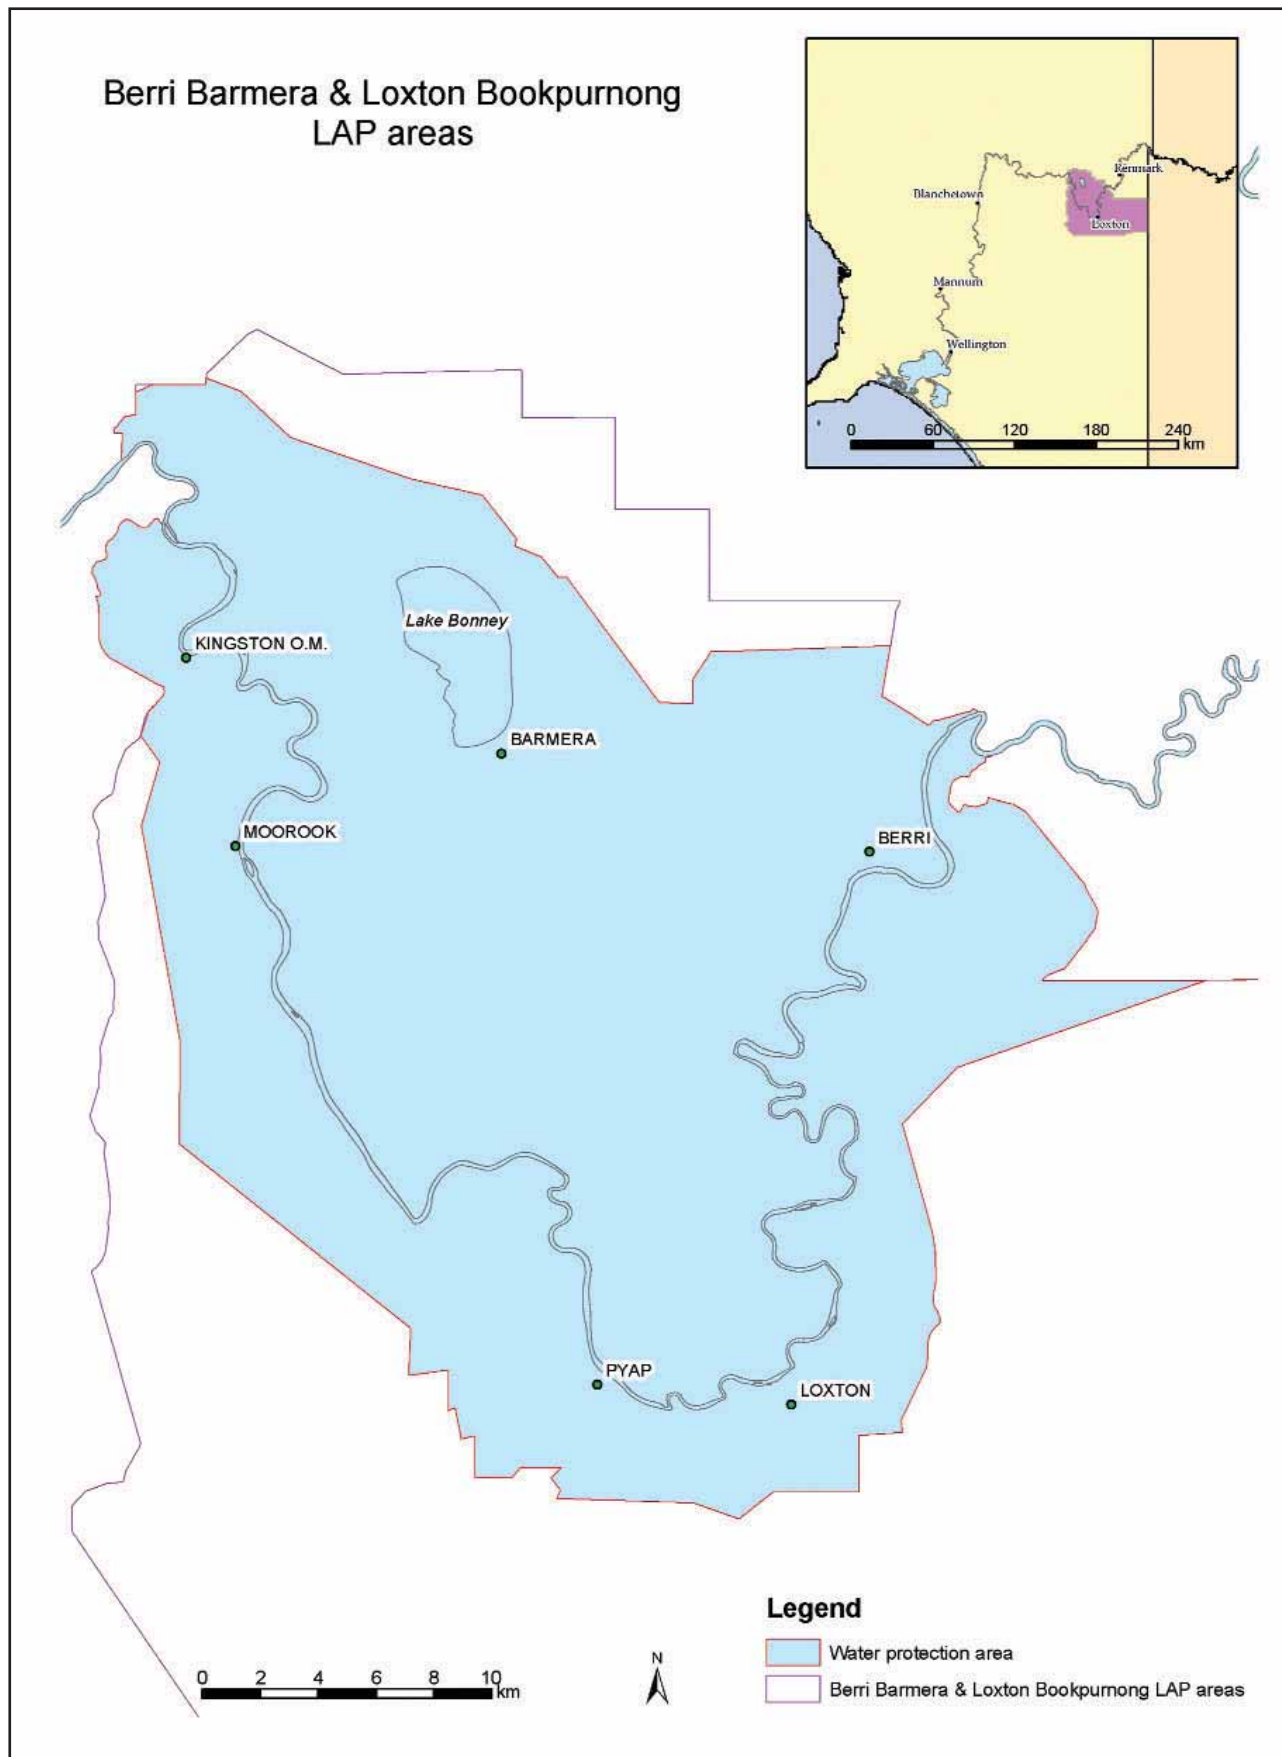
Figure 3.1 Berri-Barmera and Loxton-Bookpurnong LAP areas

The Berri-Barmera and Loxton-Bookpurnong (BB & LB) Local Action Planning (LAP) areas are located in the South Australian Riverland, approximately 220 kilometres north-east of Adelaide (Figure 3.1). The boundaries are directly aligned with those of the Berri Barmera Council above the River Murray and part of the Loxton Waikerie Council below. The LAP area north of the river (between the Lyrup ferry and Overland Corner) includes the townships of Berri, Barmera, Glossop, Cobdogla, Winkie, Monash and Gerard. South of the river the area includes Loxton, Moorook and Kingston-on-Murray.

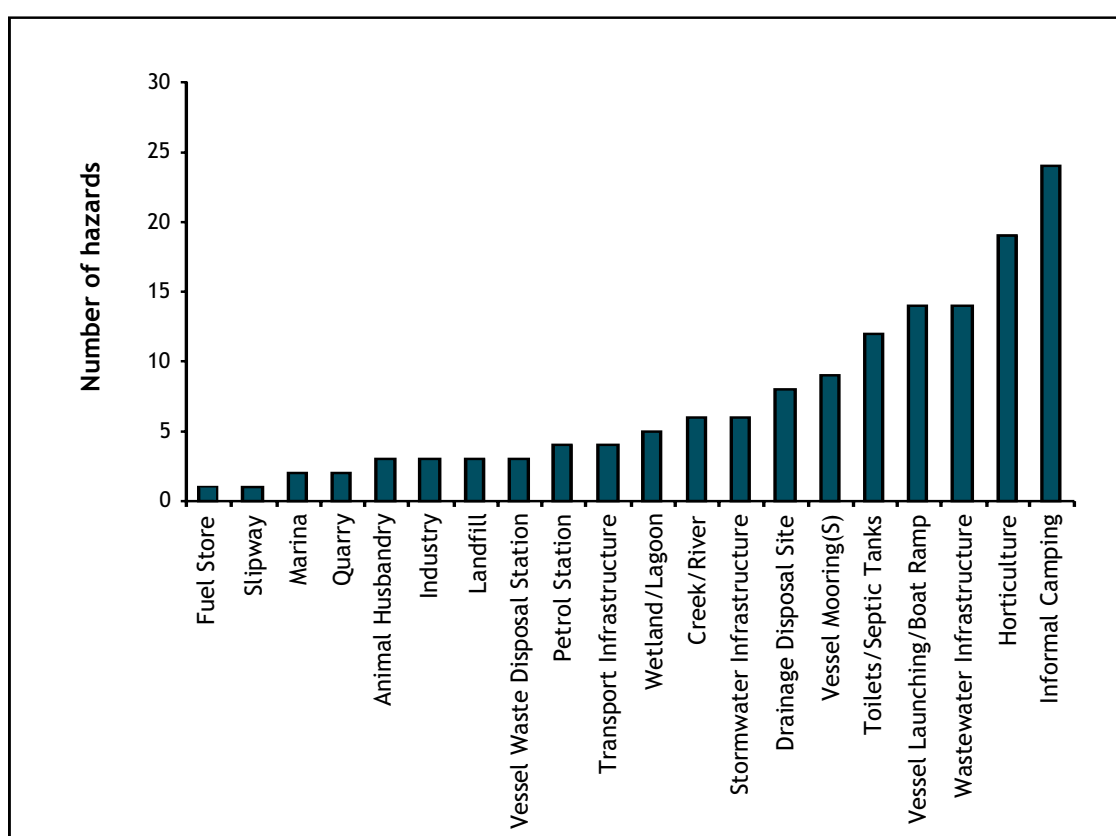
Figure 3.2 Frequency of hazards to water quality, BB & LB LAP areas

A total of 143 hazards were identified in the BB & LB LAP areas. The highest frequency hazards were informal camping areas (no sanitation facilities), horticulture drainage, wastewater infrastructure (eg STEDS pumps), vessel launching facilities (boat ramps), toilets/septic tanks, and vessel moorings (Figure 3.2).

Frequency (occurrence) does not necessarily indicate risk—a hazard may have a high frequency but a low risk. The cumulative impacts of low-risk activities will be considered and assessed as part of mitigation strategy development.

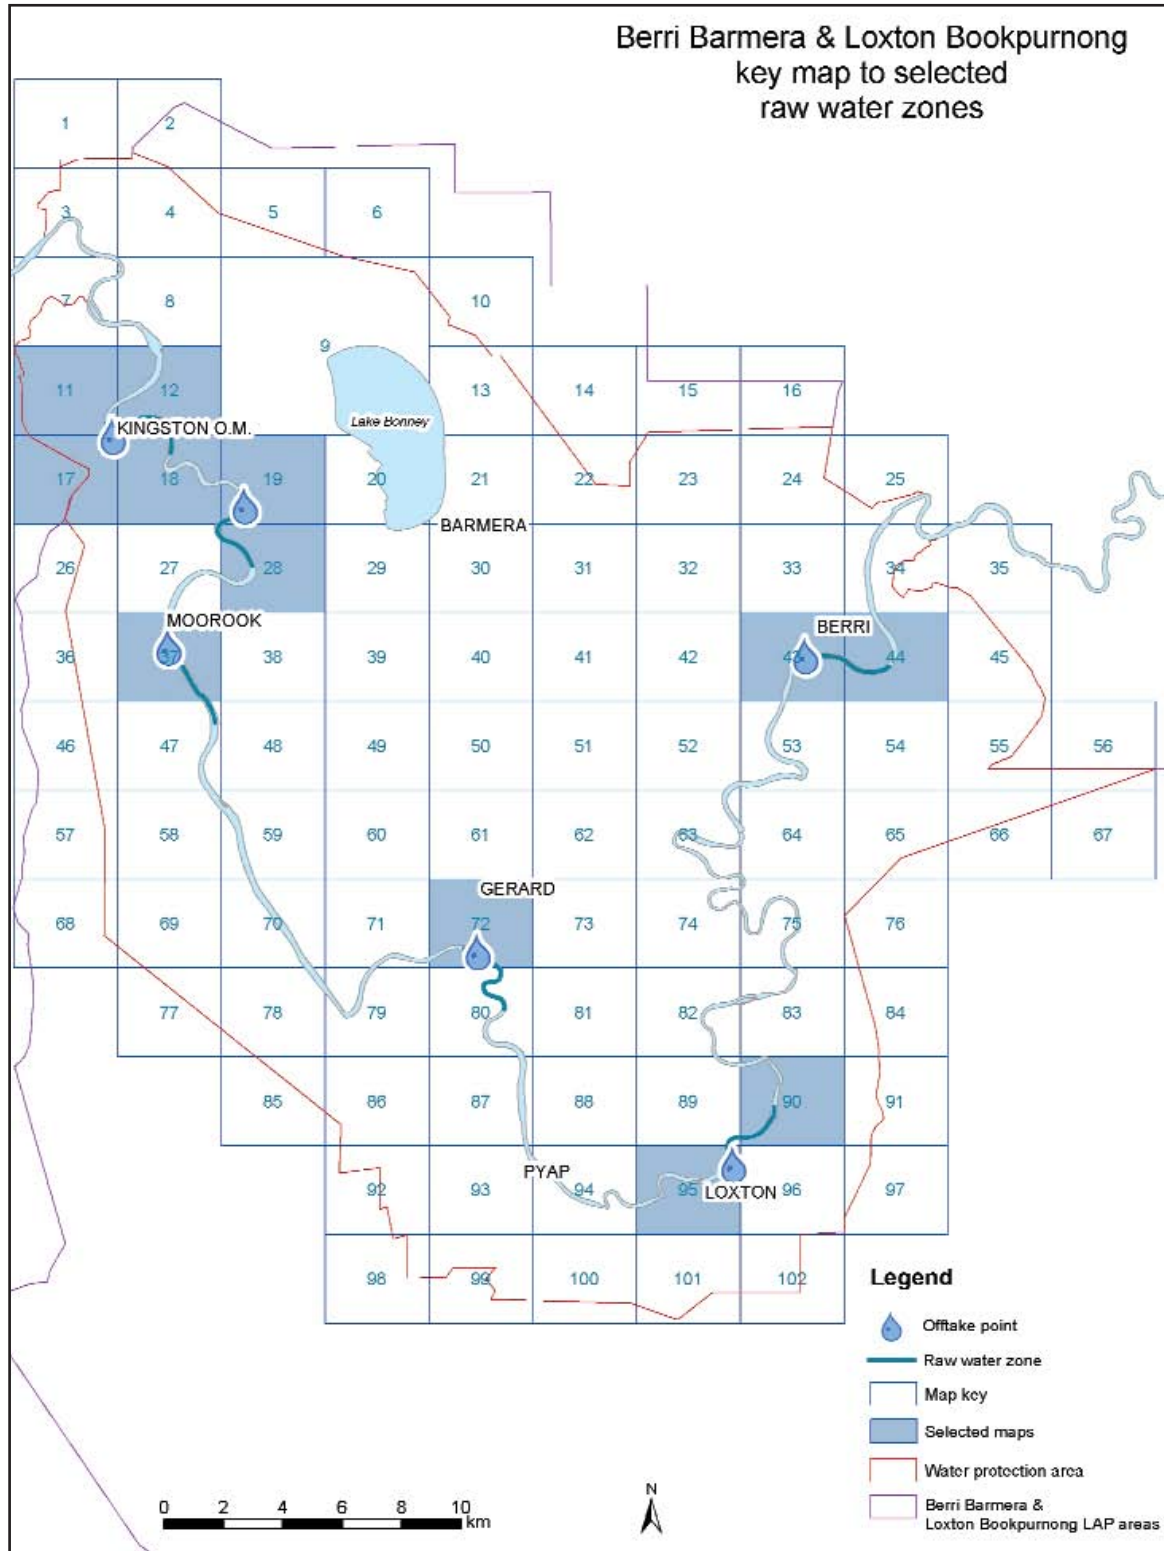
Figure 3.5 Key map for raw water supply zones, BB & LB LAP areas

Figure 3.4 is the key map for risks to the raw water supply environmental value in the BB & LB LAP areas. The attached DVD has individual maps numbered according to the key map.

Note: only hazards identified in shaded areas were assessed for risk to raw water supplies

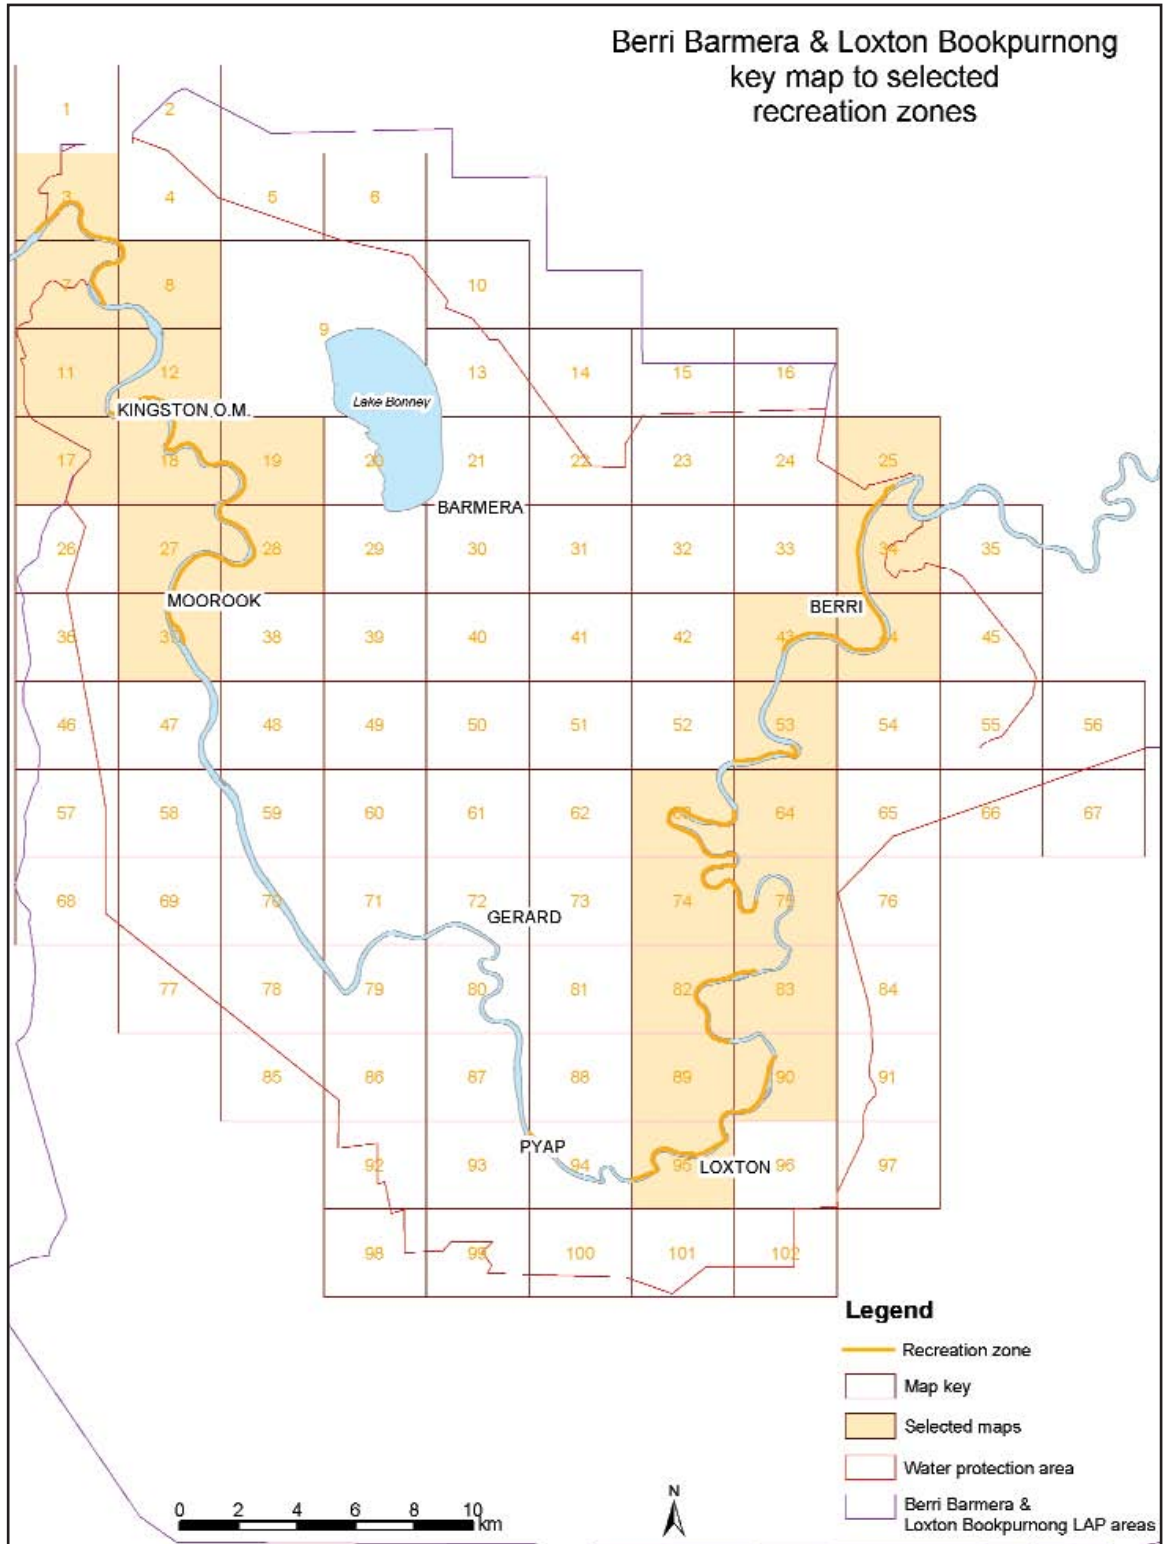
Figure 3.6 Key map for recreation zones, BB & LB LAP areas

Figure 3.6 is the key map for the risks to the recreational environmental value in the BB & LB LAP areas. The attached DVD has individual maps numbered according to the key map.

Note: only hazards identified in the shaded areas were assessed for risks to recreation
